ROOF OPENING PANEL STICKING IN TILT OPERATION

Defender

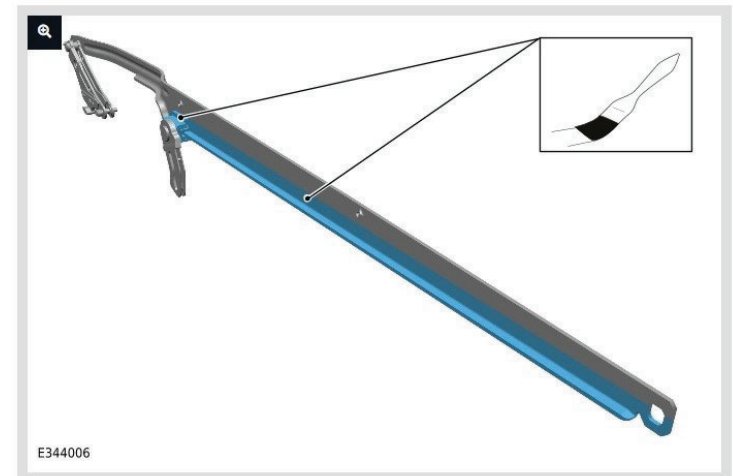
- This may be caused by the lubricating grease for the tilt arm assemblies failing during high temperatures, causing the tilt mechanical lever to stick.
