Technical Service Bulletin

GROUP CAMPAIGN	NUMBER 23-01-067H-1
DATE OCTOBER 2023	MODEL(S) IONIQ 5 (NE1) IONIQ 6 (CE1)

SUBJECT: VCU UPDATE AND OWNER'S MANUAL SUPPLEMENT (CAMPAIGN 9A1)

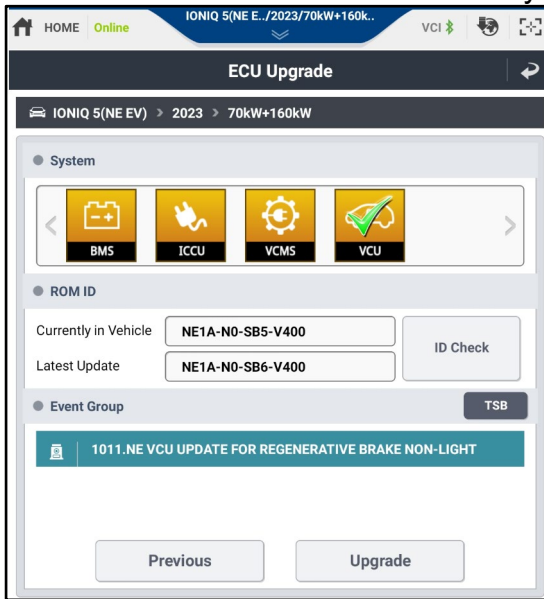
a) Use the Auto Mode ID Check to verify the VCU ROM ID before updating the software.

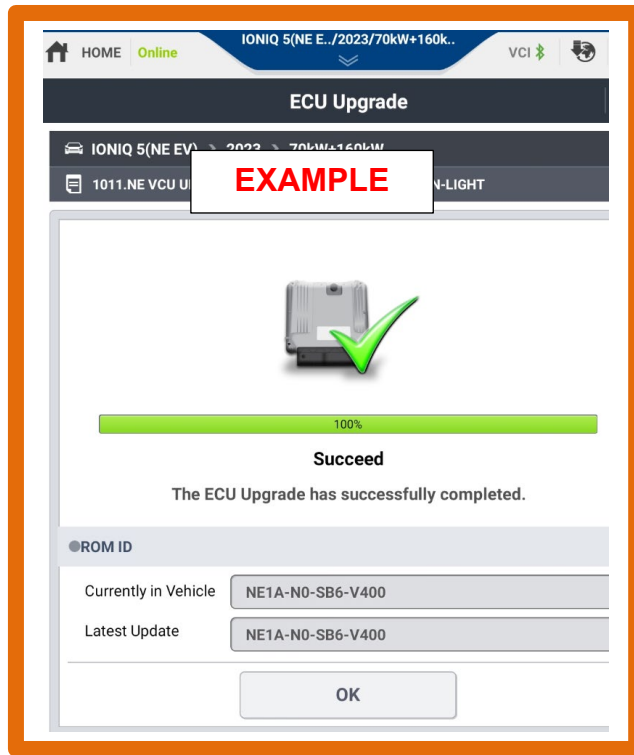
- b) After the ECU Upgrade process shows 100% complete, cycle the ignition key to **OFF** for at least 10 seconds to reset the control unit.
- c) Take a screenshot of the ECU Update complete screen and upload to STUI.

Take a screenshot of the ECU Update Complete screen using your particular tablet's screenshot save method and upload to STUI.
