Technical Service Bulletin

| CAMPAIGN | 23-01-073H-1 |
| October 2023 | KONA ELECTRIC (OS EV) |

SUBJECT: KONA EV DTC INSPECTION AND BMS UPDATE (SERVICE CAMPAIGN 9A4)

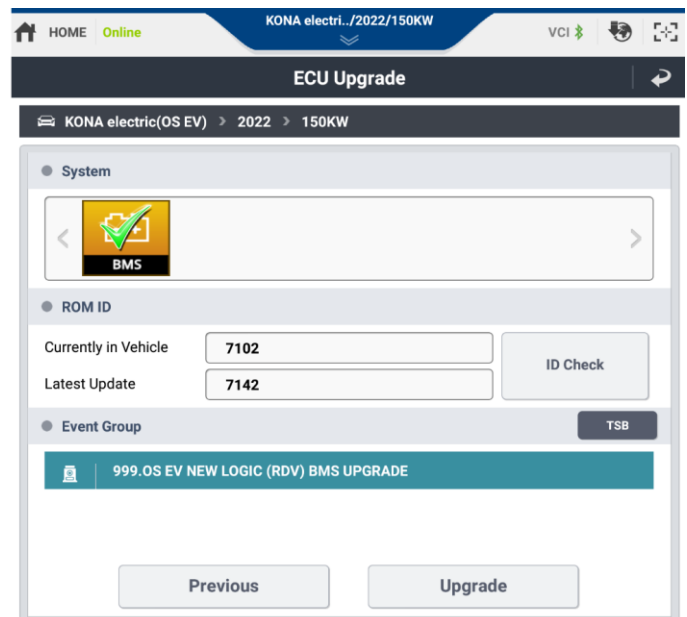
B2. Perform the BMS Update in Auto Mode.

Use the Auto Mode ID Check to verify the BMS ROM ID before updating the software.

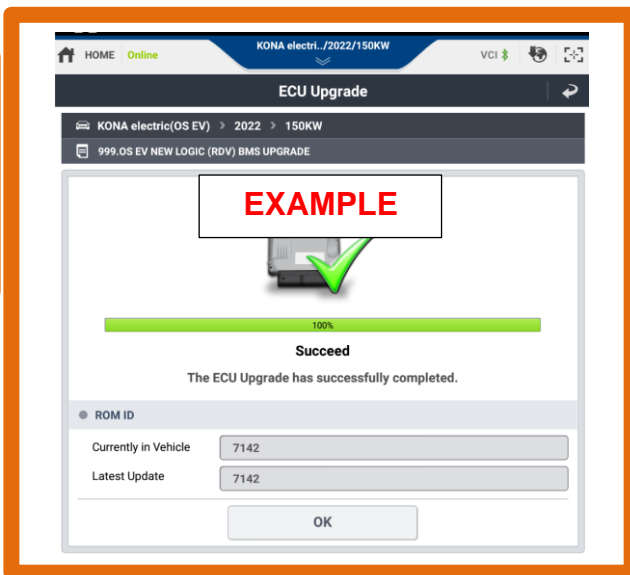
- B3. After the ECU Upgrade process shows 100% complete, cycle the ignition key to OFF for at least 10 seconds to reset the control unit.
- B4. Take a screenshot of the ECU Update complete screen and upload to STUI.

Take a screenshot of the ECU Update Complete screen using your particular tablet's screenshot save method and upload to STUI.

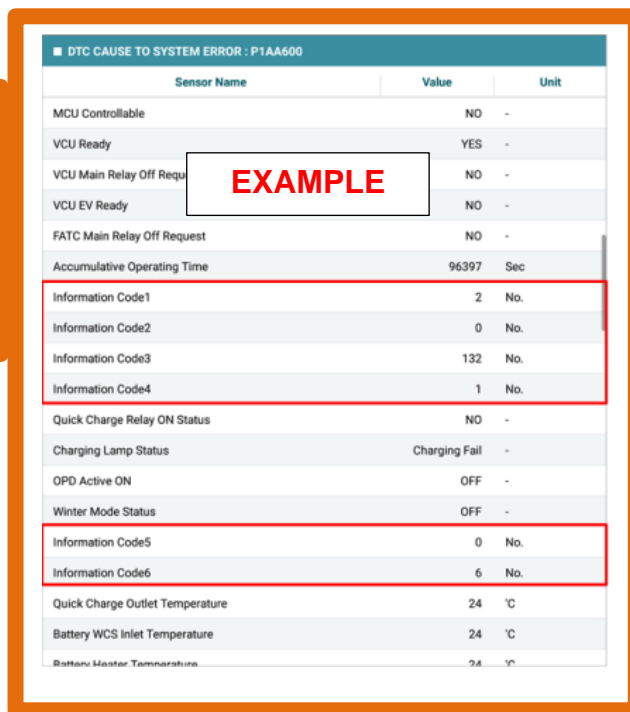
Take a screenshot of the **DTC Freeze Frame Data showing Information Codes 1-5** using your particular tablet's screenshot save method and upload to STUI.
