GROUP	MODEL
ELE	2023-2024MY EV6 GT (CV GT)
NUMBER	DATE
305 (Rev 1, 11/02/2023)	August 2023

TECHNICAL SERVICE BULLETIN

VCU SOFTWARE LOGIC UPGRADE (SA541)

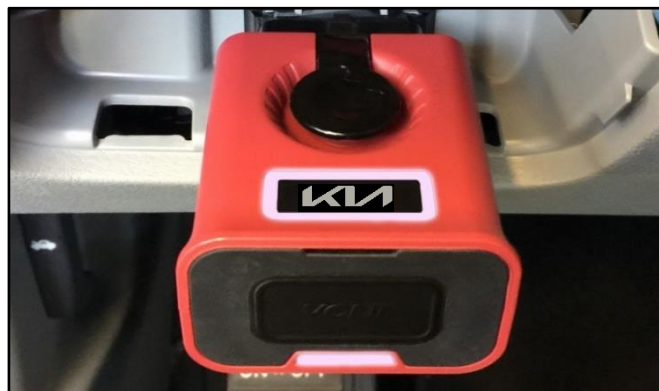
The ECU upgrade function on KDS operates wirelessly. It is not necessary to perform the upgrade via USB cable.

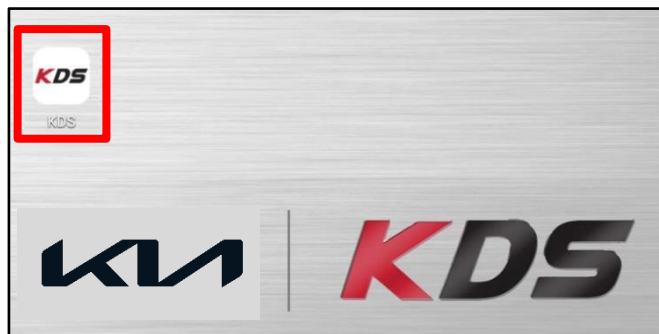
2. With the ignition ON, turn ON the KDS tablet. Select 'KDS' from the home screen.

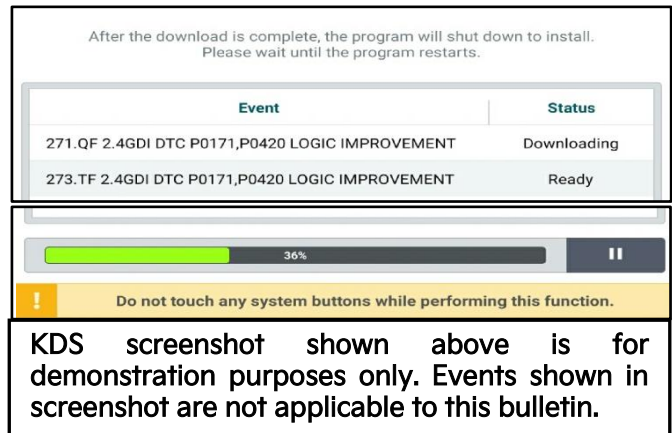
- 5. The KDS will check the server for recently uploaded Events and then automatically download Upgrade Event #693.

The vehicle must be identified in Vehicle Selection to download an Event for that vehicle.

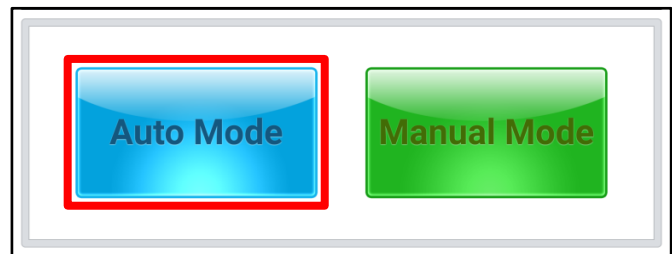
- 6. Select Auto Mode.

Do NOT attempt to perform a Manual Mode upgrade UNLESS Auto Mode fails. Always follow the instructions given on the KDS in either Auto or Manual mode.

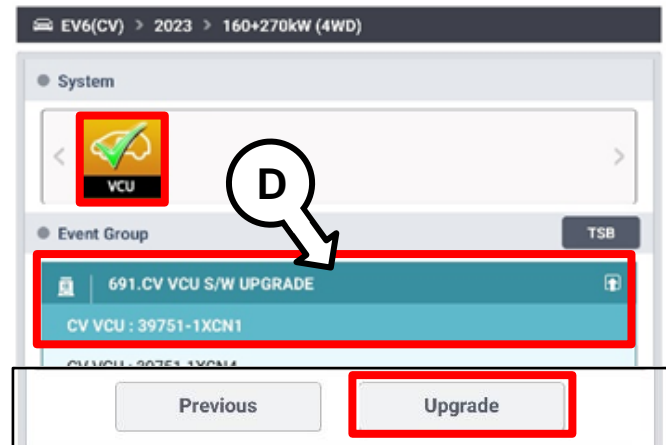
- 7a. Select the 'VCU' system under the System selection menu.
- 7b. Select the applicable Upgrade Event #693.CV GT VCU S/W UPGRADE and select 'Upgrade' to continue.

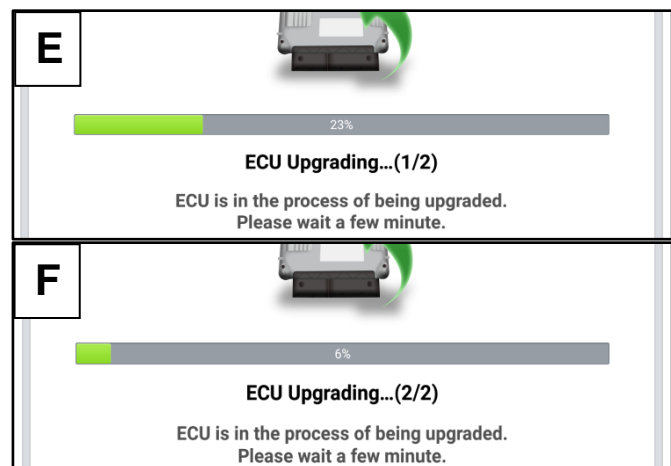
8. The ECU upgrade will begin and the progress of the upgrade will appear on the bar graph. Upgrade part (1/2) (E) will download the upgrade event to the VCI-II. Upgrade part (2/2) (F) will upgrade the ECU.

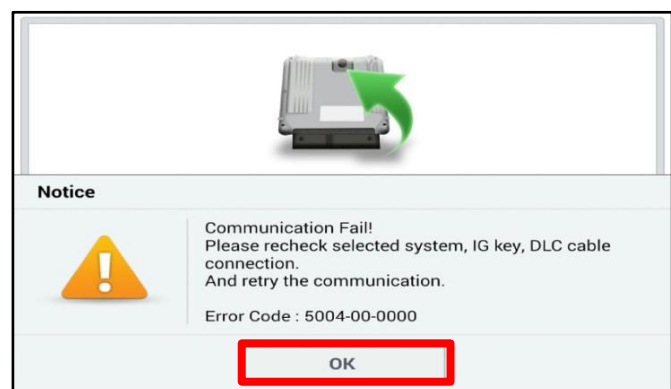
9. If a "Communication Fail" screen appears, verify that the VCI-II and KDS are communicating properly. Select 'OK' and restart the from step 4.

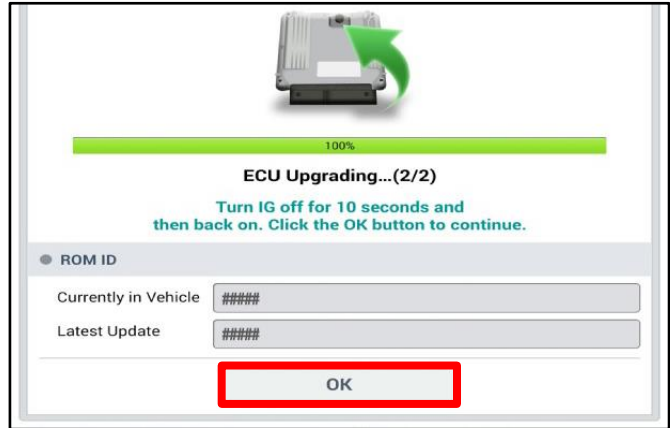
- When instructed on the KDS, turn the ignition **OFF** for ten (10) seconds then back on. Select **'OK'** to continue.

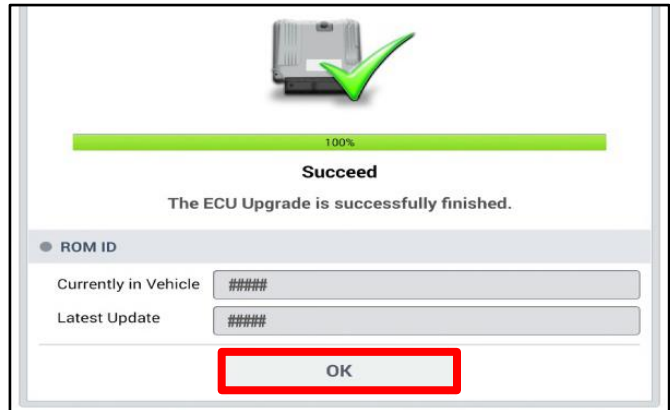
- Once the upgrade is complete, select **'OK'** to finalize the procedure.

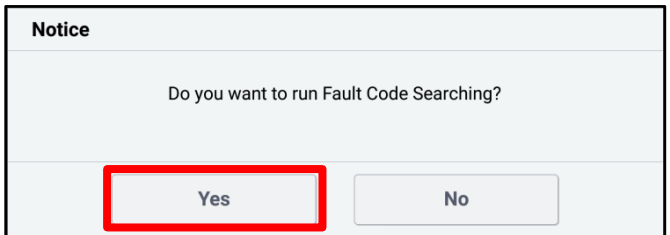
- When prompted, select **'YES'** to check for Diagnostic Trouble Codes (DTC) and erase any DTCs stored such as EPS, ESC, and TPMS that may have been set during the upgrade.
