GROUP	MODEL
ELE	2023MY Sorento (MQ4a) w/ AVN5W
NUMBER	DATE
316 (Rev 1, 11/08/2023)	October 2023

## TECHNICAL SERVICE BULLETIN

### AVN 5.0 WIDE NON-RESPONSIVE RADIO ICON (AM, FM, SXM) (SA550)

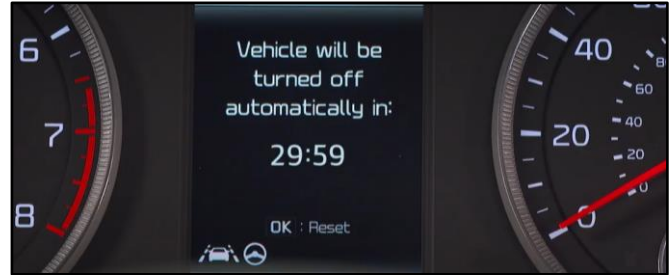
1. Turn the ignition switch to the 'ON' position.

**Note:** If vehicle is equipped with the ['Vehicle Auto-Shut Off'](#) feature, be sure to turn the feature 'OFF' before proceeding to step 2.

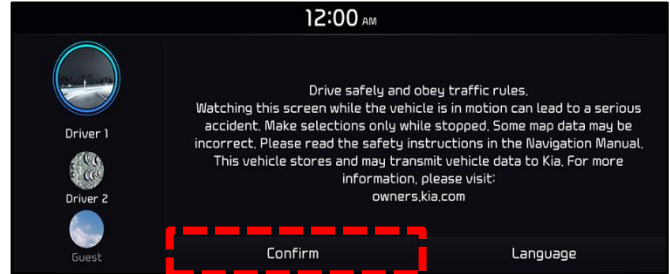
2. Select 'Confirm' on the AVN screen.

**Note:** The software update is possible with the AVN 'OFF'.

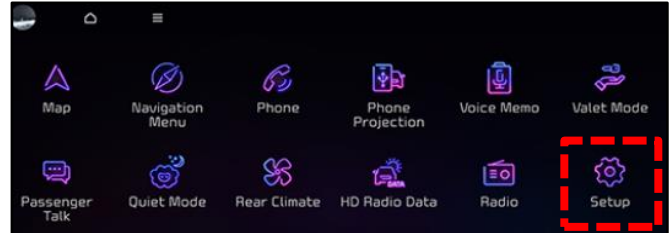
4. Select 'Setup'.

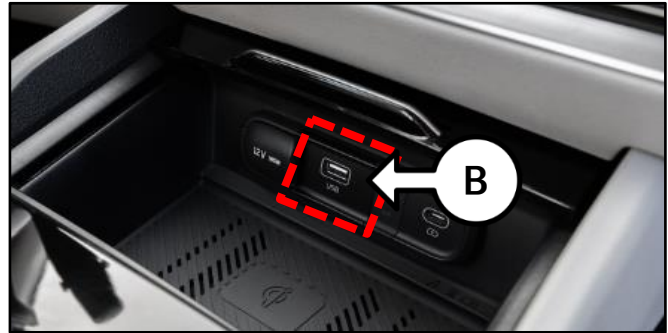
7. Insert the USB Flash Drive (refer to the table below) into the USB slot (B) located underneath the AVN unit.

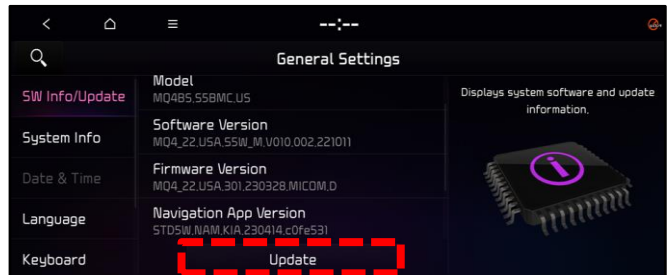
8. On the 'General Settings' screen, select 'SW Info/Update', then select 'Update'.

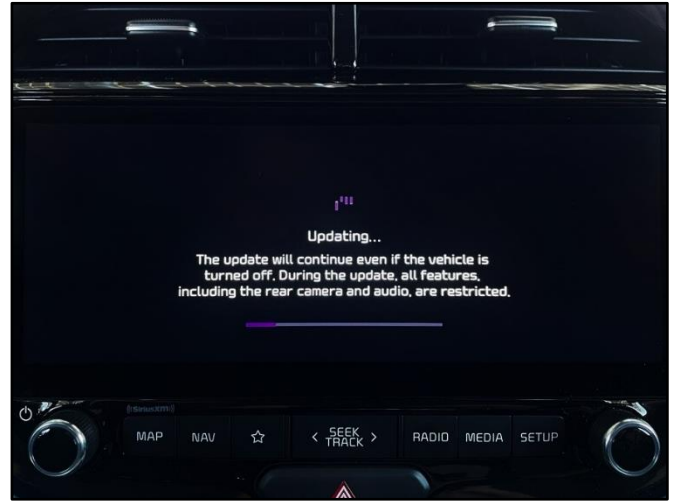
**Note:** In some cases, the software update may take up to two (2) hours and thirty (30) minutes to complete. During this dwell time, it is acceptable to work on other vehicles.

There will be multiple occurrences where the Kia logo will appear, the display will be black during the update process and/or display "Preparing System Update" for an extended period of time. This is normal.
