Service Update

N232408732 Surveillance Mode Not Enabled

Condition	Certain 2023 model year Chevrolet Tahoe Police Vehicles may not have surveillance mode enabled.
Correction	Dealers are to reprogram the body control module.

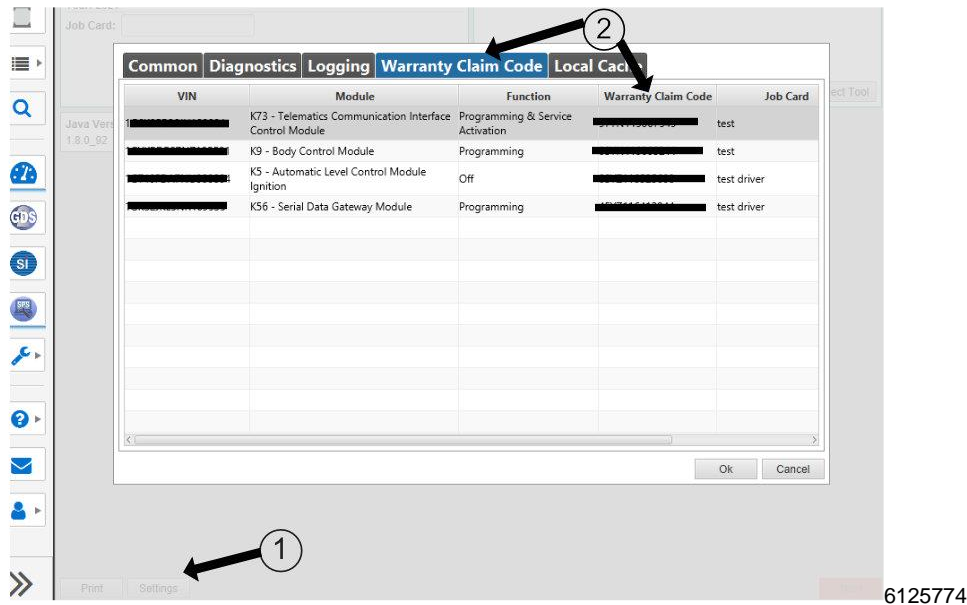
Warranty Claim Code Information Retrieval

If the Warranty Claim Code was not recorded on the Job Card, the code can be retrieved in the SPS2 system as follows:

1. Open TLC on the computer used to program the vehicle.
2. Select and start SPS2.
3. Select Settings (1).
4. Select the Warranty Claim Code tab (2).

The VIN, Warranty Claim Code and Date/Time will be listed on a roster of recent programming events. If the code is retrievable, dealers should resubmit the transaction making sure to include the code in the SPS Warranty Claim Code field.

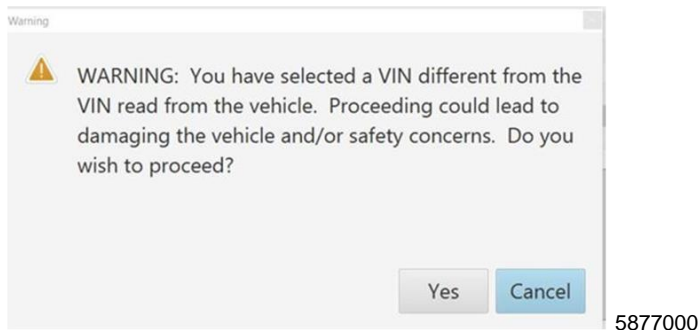
Important: If the vehicle VIN DOES NOT match, the message below will be shown.

Important: Techline Connect screens shown above.

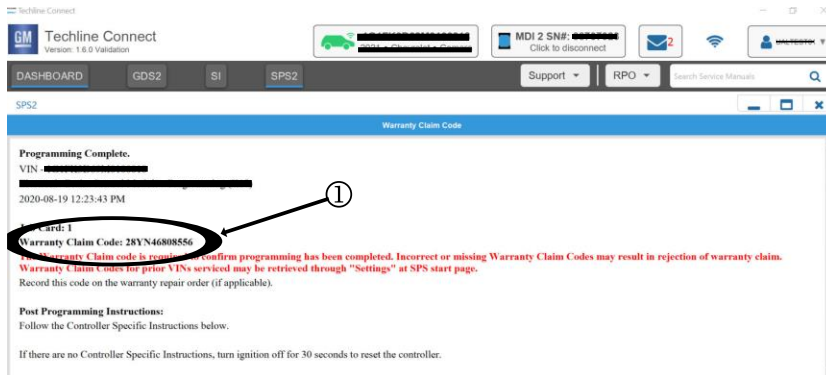
5644478

1. Reprogram the Body Control Module. Refer to *K9 Body Control Module: Programming and Setup* in SI.

Note: The screenshot above is an example of module programming and may not be indicative of the specific module that is being programmed. Module selection and VIN information have been blacked out.
