GROUP	MODEL
ELE	2023-2024MY Niro HEV (SG2 HEV) <u>and</u> 2023-2024MY Sportage HEV (NQ5 HEV)
NUMBER	DATE
318	November 2023

TECHNICAL SERVICE BULLETIN

SUBJECT: SERVICE ACTION: BMS SOFTWARE LOGIC IMPROVEMENT FOR DTC P1BB2 (SA553)

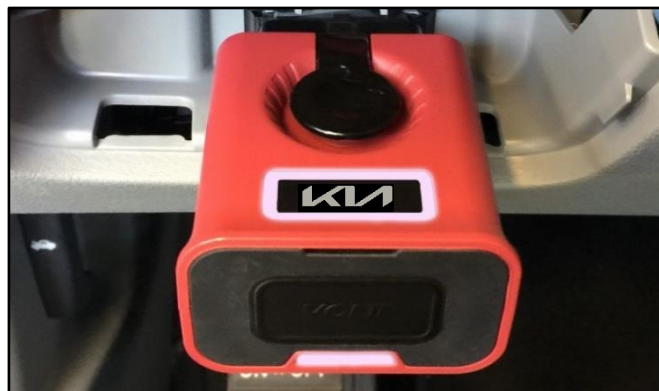
- With the ignition ON, turn ON the KDS tablet. Select 'KDS' from the home screen.

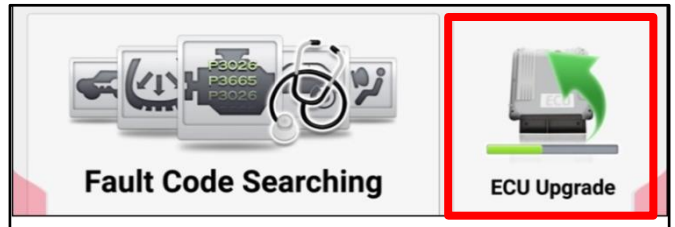
- The KDS will check the server for recently uploaded Events and then automatically download Upgrade Event #698 (Niro HEV) or #700 (Sportage HEV).

Event	Status
271.QF 2.4GDI DTC P0171,P0420 LOGIC IMPROVEMENT	Downloading
273.TF 2.4GDI DTC P0171,P0420 LOGIC IMPROVEMENT	Ready

KDS screenshot shown above is for demonstration purposes only. Events shown in screenshot are not applicable to this bulletin.
