GLOBAL SAFETY FIELD INVESTIGATIONS

Service Update

N232408730 Emergency Light Flashers Not Enabled

Condition	Certain 2021 model year Chevrolet Tahoe Police Vehicles may not have the emergency light flashers enabled.
Correction	Dealers are to reprogram the body control module and lighting control module.

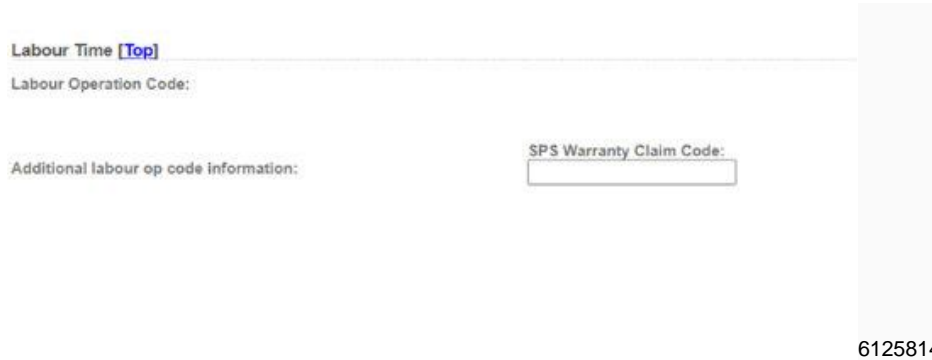
Important: * To avoid warranty transaction rejections, carefully read and follow the instructions below:

- The Warranty Claim Code from the programming event must be accurately entered in the "Warranty Claim Code" field of the transaction.
- When more than one Warranty Claim Code is generated for a programming event, it is required to document all Warranty Claim Codes in the "Correction" field on the job card. Dealers must also enter one of the codes in the "Warranty Claim Code" field of the transaction, otherwise the transaction will reject. It is best practice to enter the FINAL code provided by SPS2.
