# Service Bulletin

Bulletin No.: 23-NA-033

**Subject: Rattle Noise During Cold Start, Malfunction Indicator Lamp (MIL) Illuminated - DTC P2261 Set**

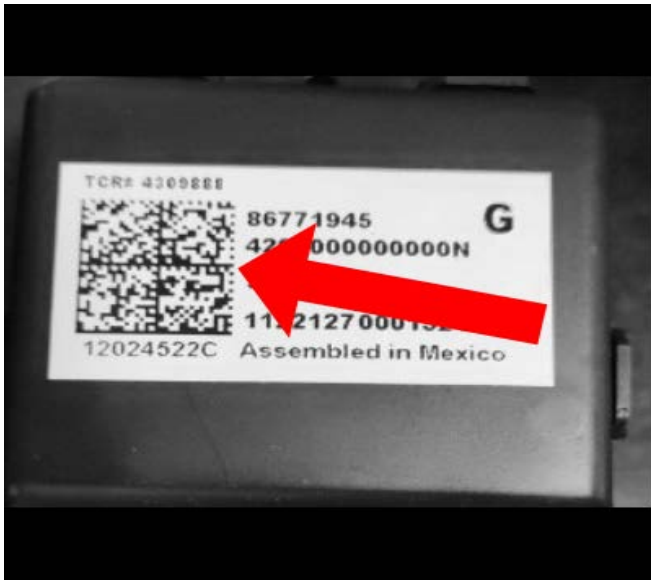
6098077

Refer to TSB 22-NA-070 for specific information on downloading the App to your mobile phone, and how to use/submit the new part serial number/QR code information claim and other related Q and A.

By scanning critical part numbers using the Replacement Part Traceability function, GM will be able to reference replaced parts in the future. The exact parts that are on a vehicle will be known, even after a service part replacement.
