# Service Bulletin

Bulletin No.: 23-NA-194

**Subject: Unwanted Vibration Or Booming Noise Heard Through Speakers**

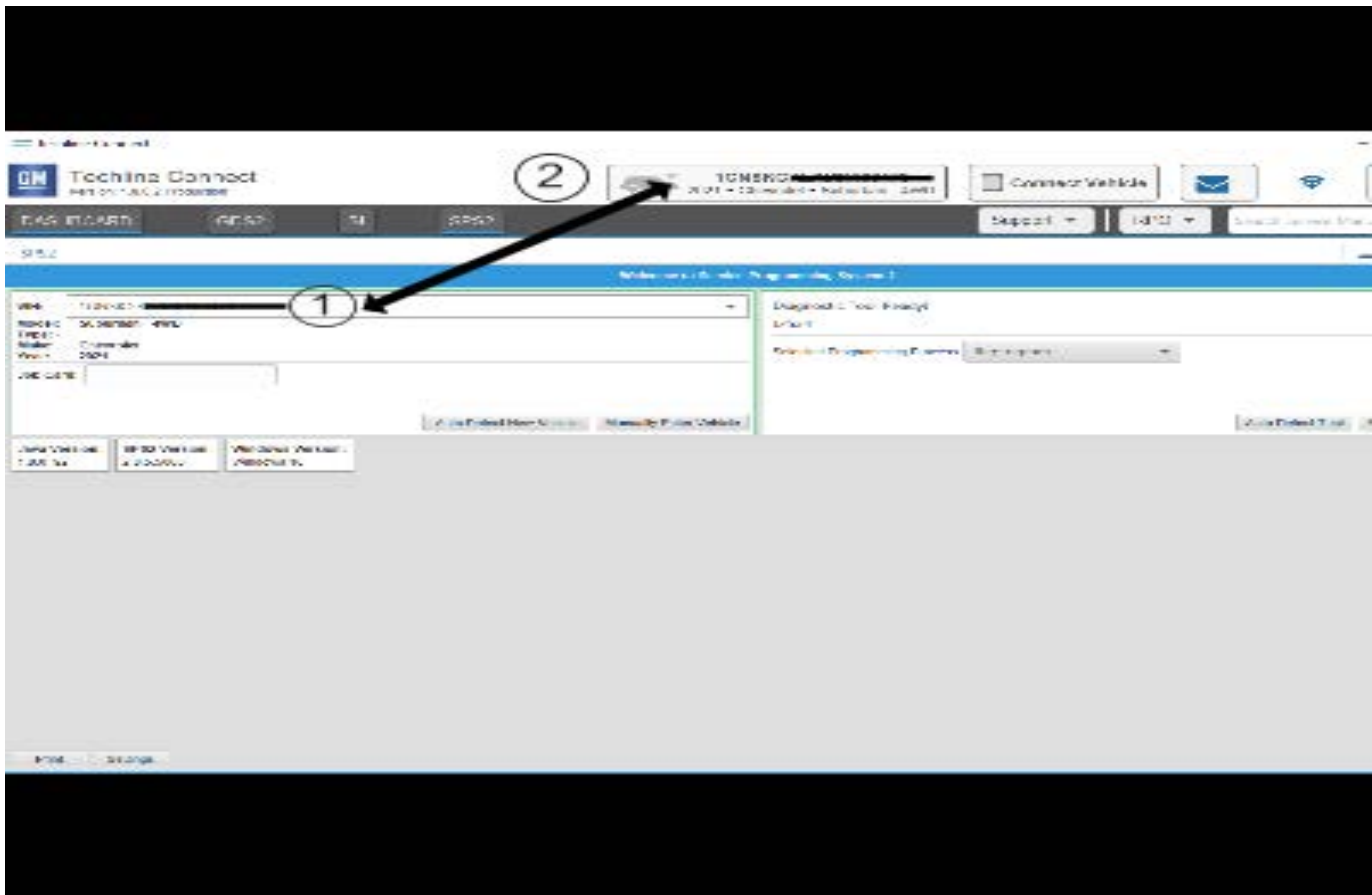
**Caution:** Be sure the VIN selected in the drop down menu (1) is the same as the vehicle connected (2) before beginning programming.

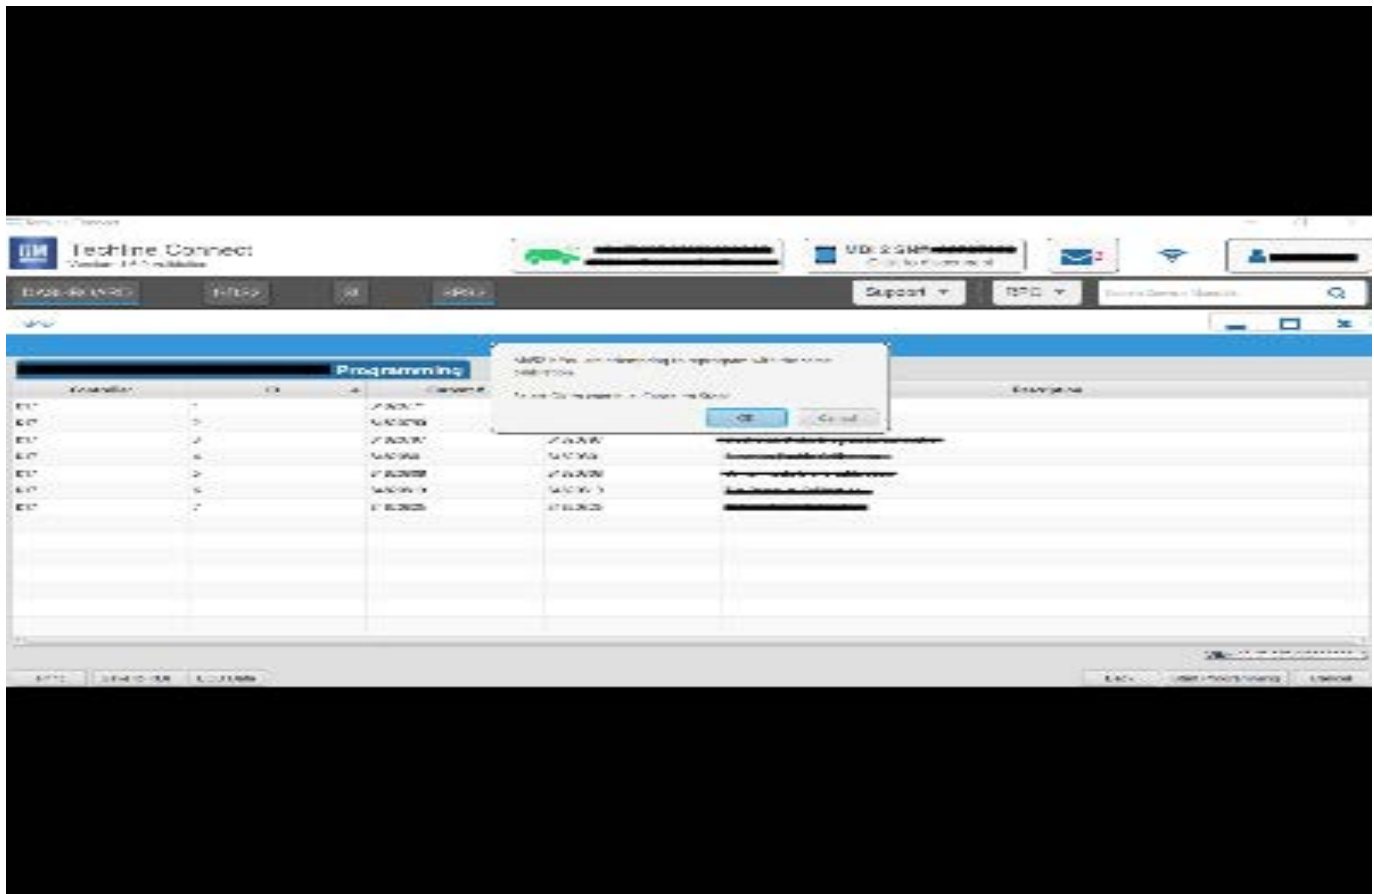
5644477

**Important:** Techline Connect screen shown above.

**Important:** If the same calibration/software warning is noted on the TLC Summary screen, select OK and follow screen instructions. After a successful programming event, the WCC is located in the Service Programming System dialogue box of the SPS
