# TECHNICAL INSTRUCTIONS

22LC01

## DATA COMMUNICATION MODULE (DCM) REPROGRAMMING

2021 MODEL YEAR IS300, IS350, LC500, LC500h, LC500C, LS500, LS500h, NX300, NX300h, RC300, RC350, RC F

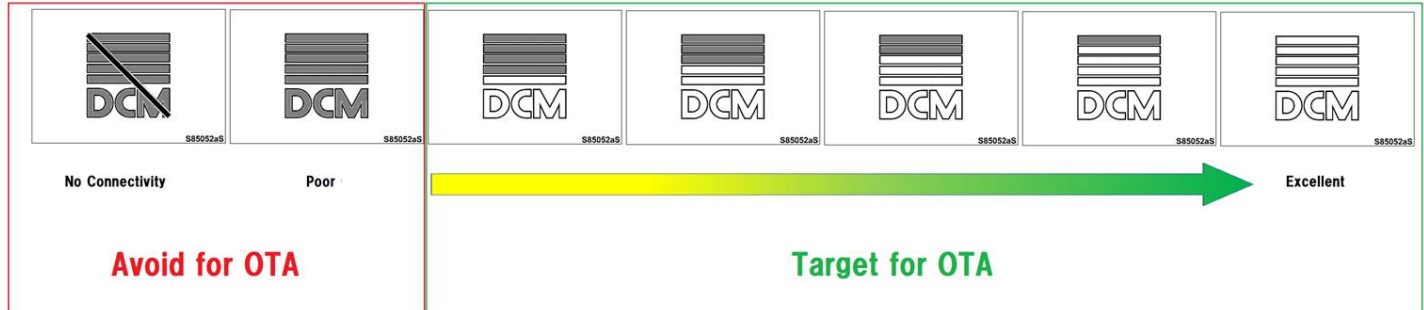
- a) Confirm that the DCM signal reception level shown in the upper right corner of the head unit display is not out of range. If the display shows poor or no connectivity, move the vehicle to another safe location with adequate signal reception.

- Refer to the image below for target signal reception.
- Full signal is not required but you must have at least one bar.

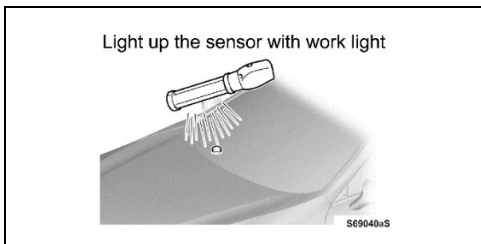
- b) When the vehicle has no "off position" in the light control switch:
- 1) Turn the IG ON.
  - 2) Set the light control switch to the AUTO position and make sure that the exterior lights are turned on.
  - 3) Light up the automatic light control sensor with work light to keep the exterior lights turned off.

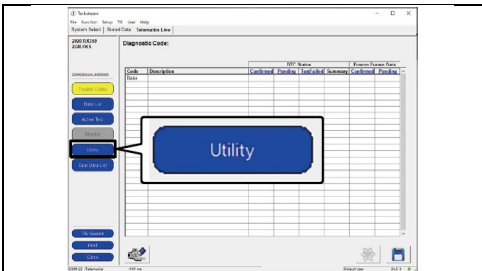
- c) Click "Utility".

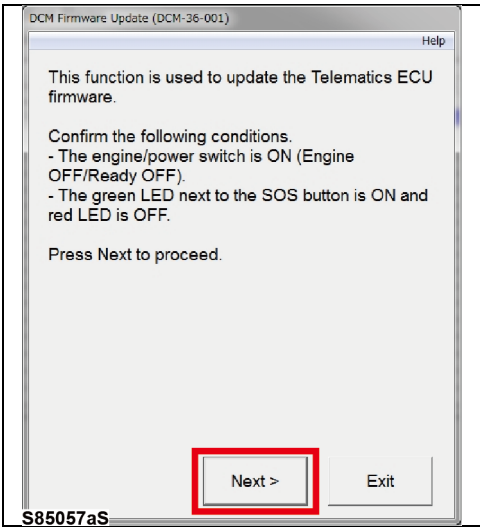
e) Click "Next".

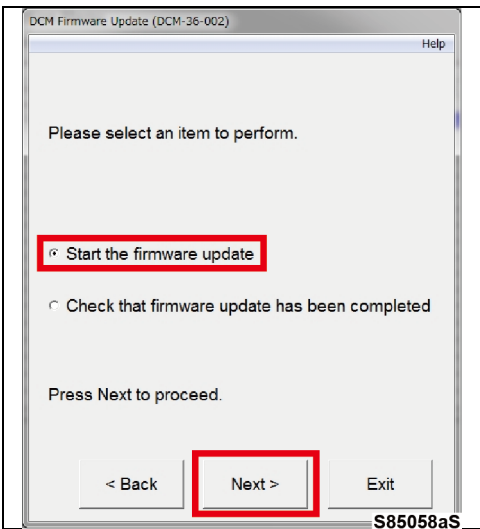
f) Select "Start the firmware update" and click "Next".

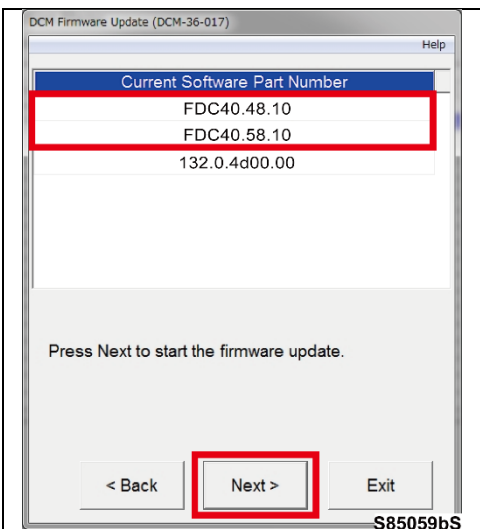
g) Confirm that the displayed software part number (Calibration ID) is the one to be reprogrammed, then click "Next".

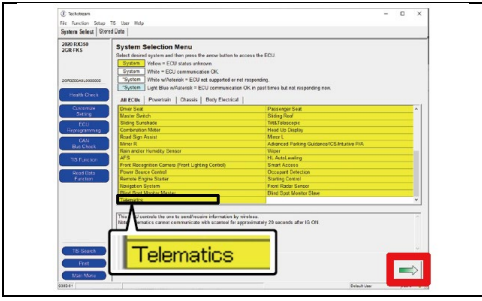
- a) Launch the left-side display, select “Telematics” and click the right-arrow.

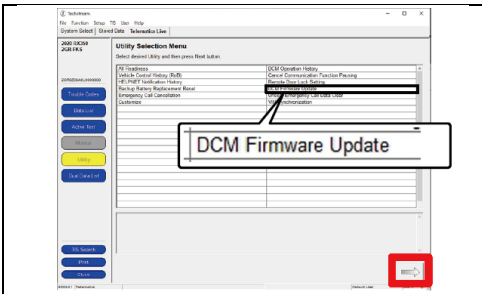
- c) Select “DCM Firmware Update” and click the right-arrow.

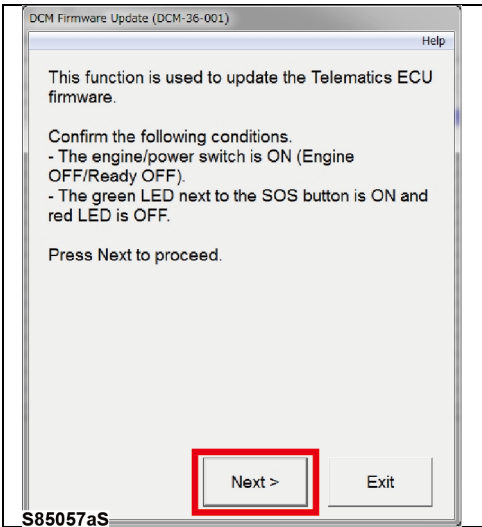
- d) Click “Next”.

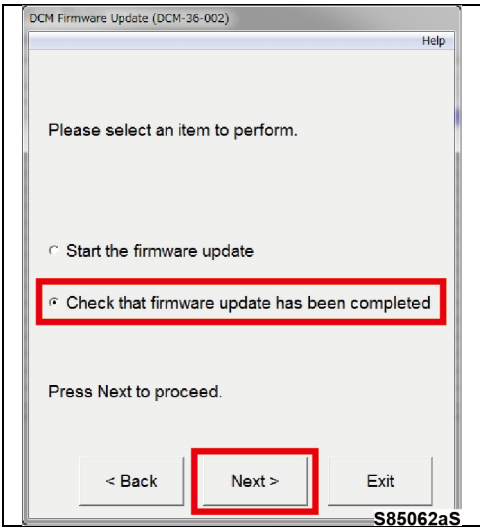
e) Select “Check that firmware update has been completed” and click “Next”.

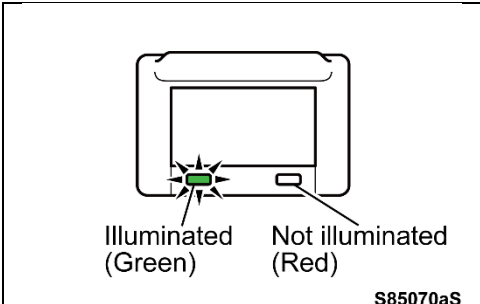
- Turn the IG ON.
- To confirm that the Safety Connect services are available, check that the green indicator is illuminated and the red indicator is not illuminated after approximately 2 seconds from the IG ON.

- Green and red indicators turn on for approximately 2 seconds after the IG ON.
- If the contract of Safety Connect services has expired, the green and red indicators will turn off.

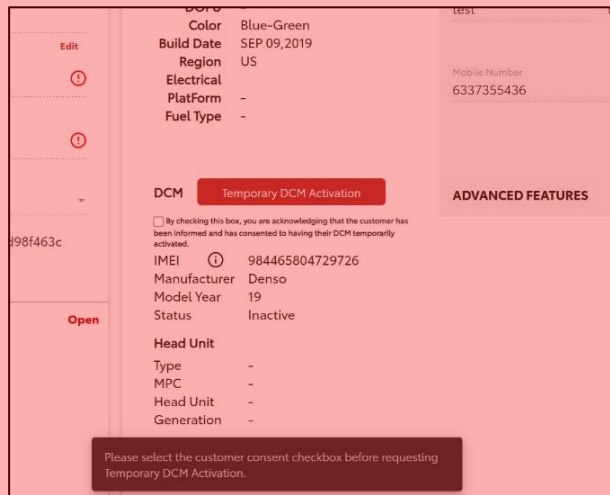
Figure.1 Dealer Portal Temporary DCM Activation button

1. Confirm the guest's subscription status and verify that the account is either not active or in a "waived" status.
2. Enter the VIN into the Dealer Portal, check the customer consent check box, and click the "Temporary DCM Activation" button (Figure 1). The service will be active for **72 hours**.
3. Once active, the DCM firmware OTA update may be installed.
4. After the 72 hours has elapsed, the vehicle will be put back into whatever status it was previously.
