TECHNICAL INSTRUCTIONS
FOR
LIMITED SERVICE CAMPAIGN K0P
CUSTOMER SUPPORT PROGRAM 19TE12

SAFETY CONNECT SYSTEM – VEHICLE LOCATION INACCURATE

CERTAIN
2013 – 2019 MODEL YEAR 4RUNNER
2011 – 2017 MODEL YEAR LAND CRUISER
2013 – 2017 MODEL YEAR PRIUS
2012 – 2017 MODEL YEAR PRIUS V
2016 – 2017 MODEL YEAR MIRAI

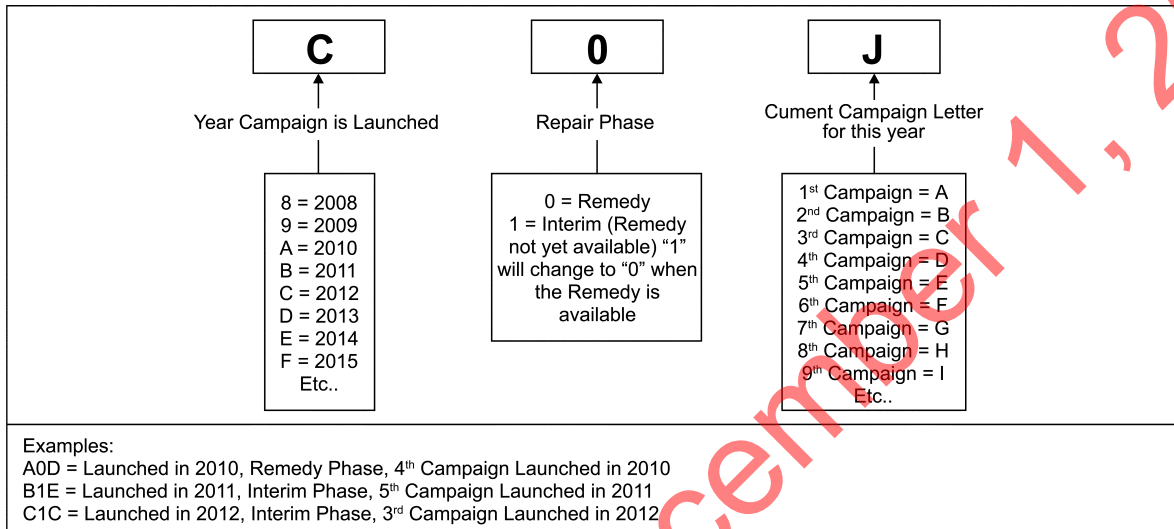
A. CAMPAIGN DESIGNATION DECODER

Examples:

19TA01 = Launched in 2019, Toyota, Safety Recall Remedy Phase, 1st Safety Recall Launched in 2019
