# Service Action

## Code: 34L4

<b>Subject</b>	<b>Transmission Control Module (TCM) Software</b>																																		
<b>Document History</b>	<table border="1"> <thead> <tr> <th style="background-color: #c00000; color: white;">Date</th> <th colspan="4" style="background-color: #c00000; color: white;">Summary</th> </tr> </thead> <tbody> <tr> <td>11/03/2023</td> <td colspan="4">Updated repair steps after software update is completed. Added example photos of transmission damage.</td> </tr> <tr> <td>08/03/2023</td> <td colspan="4">Original publication</td> </tr> </tbody> </table>					Date	Summary				11/03/2023	Updated repair steps after software update is completed. Added example photos of transmission damage.				08/03/2023	Original publication																		
Date	Summary																																		
11/03/2023	Updated repair steps after software update is completed. Added example photos of transmission damage.

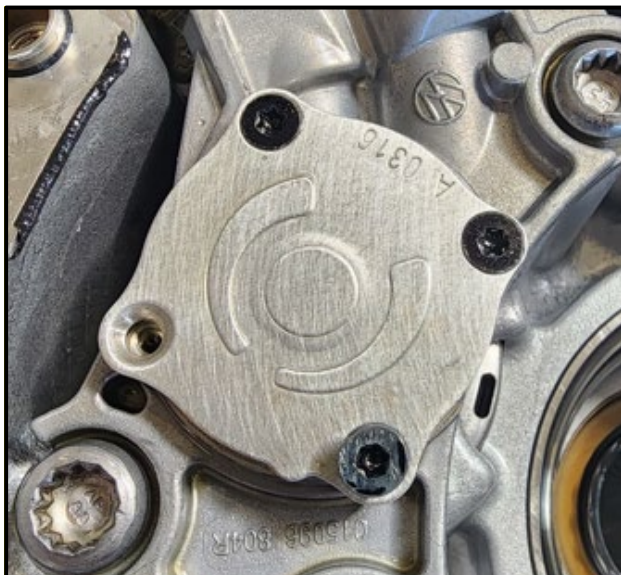
If internal or external damage caused by the auxiliary hydraulic pump bolts coming loose is found before or during the repair:

A missing bolt or damaged bolt is considered internal transmission damage.

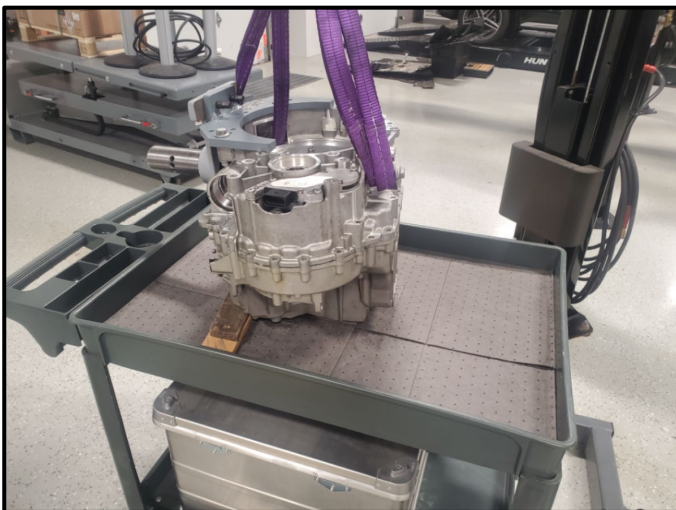
**Move transmission:**

- Move transmission to a suitable work bench or cart.
- The splined shaft must face upward.
- Support the transmission from tipping using wood blocks as needed.

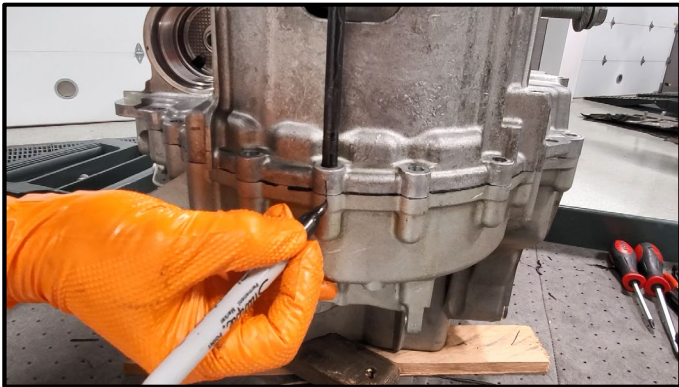
- To aid in re-assembly, mark the position of both guide pins on gearbox housing with a felt-tip pen.

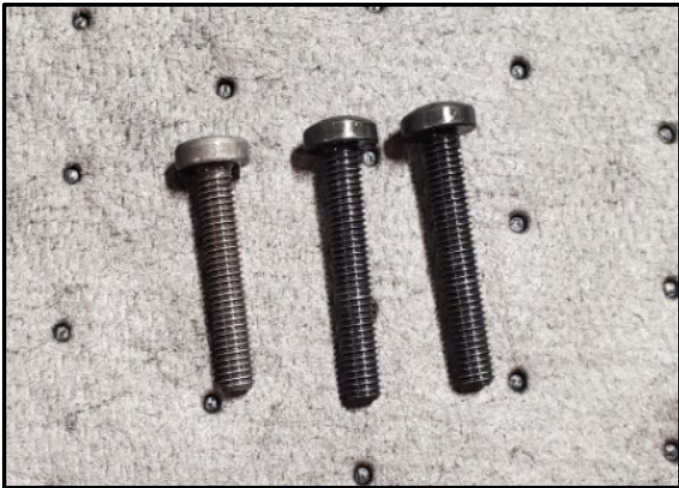
- Install new bolts <arrows> from the repair kit and torque to 8 Nm + 90°.

Please note that the bolt for the oil pipe is shorter than the two bolts for the changeover valve.

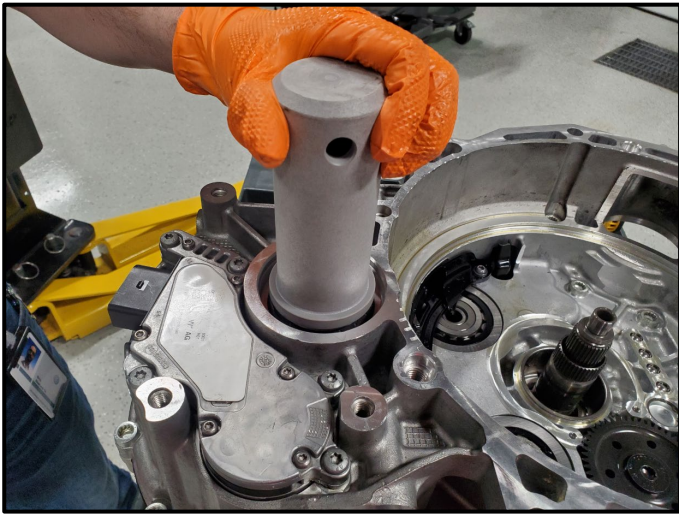
#### Install dual clutch:

- See ELSA Repair Manual: *Repair manual > Drivetrain > 7-Speed Dual Clutch Transmission OGC > 30 Clutch > Clutch > Dual Clutch, Installing*
- Use new circlip from repair kit.

The dual clutch does not need to be re-adjusted; the retaining ring can be re-used, contrary to the information in the Repair Manual.

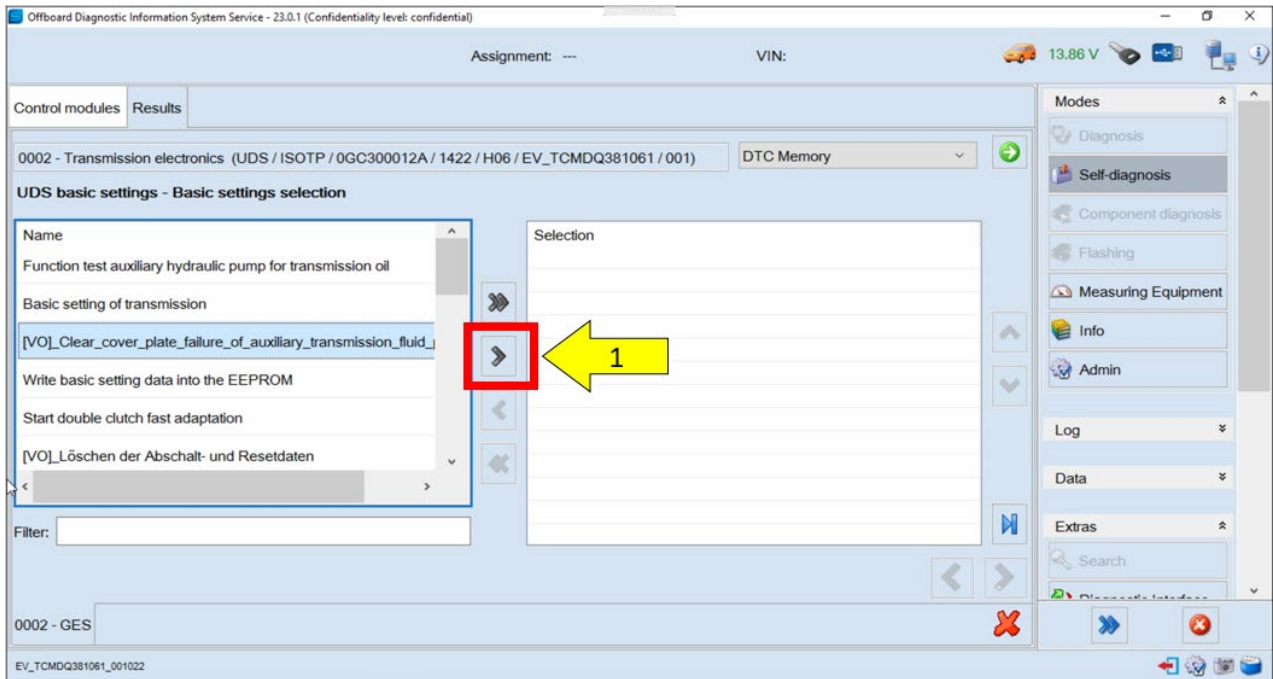
- Move basic setting, “[VO]\_Clear\_cover\_plate\_failure\_of\_auxilliary\_fluid\_pump” to the selection box.
  - The basic setting can be moved by double clicking the basic setting, or by clicking on arrow <1>.

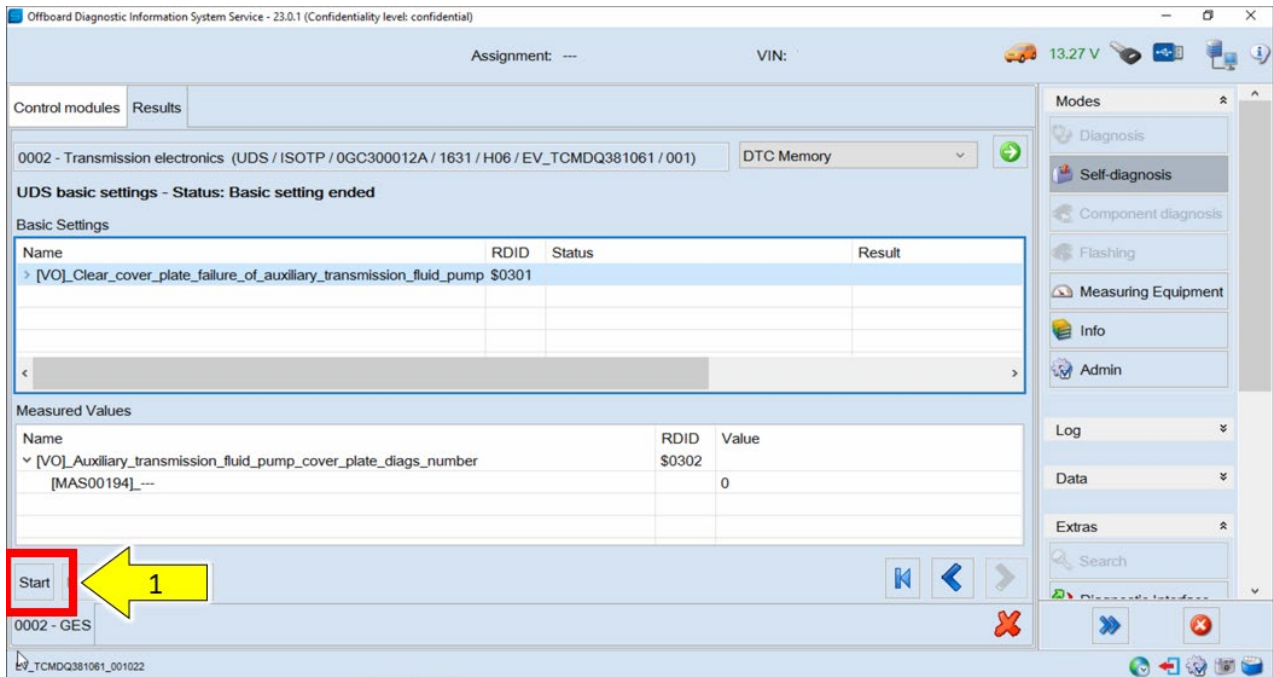
- Click “Start” <1> to begin the basic setting routine.
- Once the basic setting is complete, the event memory entry will then be set to “intermittent” and can be erased.
