# Customer Satisfaction Program

## N232413960 Vehicles Built Without Passenger Seats

| <b>Condition</b> | Certain 2023 model year BrightDrop Zevo 600 vehicles may have been built without the passenger side jump seat. |
| <b>Correction</b> | Dealers are to install the passenger side jump seat. |

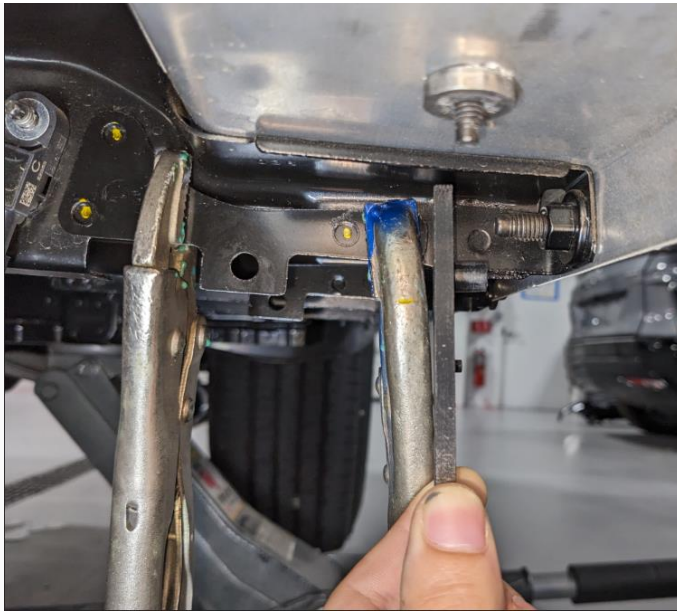
6431341

34. Position doubler plate to the bracket rearward of the newly installed bracket like illustrated above and secure with vice grips. Ensure doubler plate is perfectly flush with the bottom of the bracket, and use Template A as a spacer as shown to space it out from the outside of the vehicle.

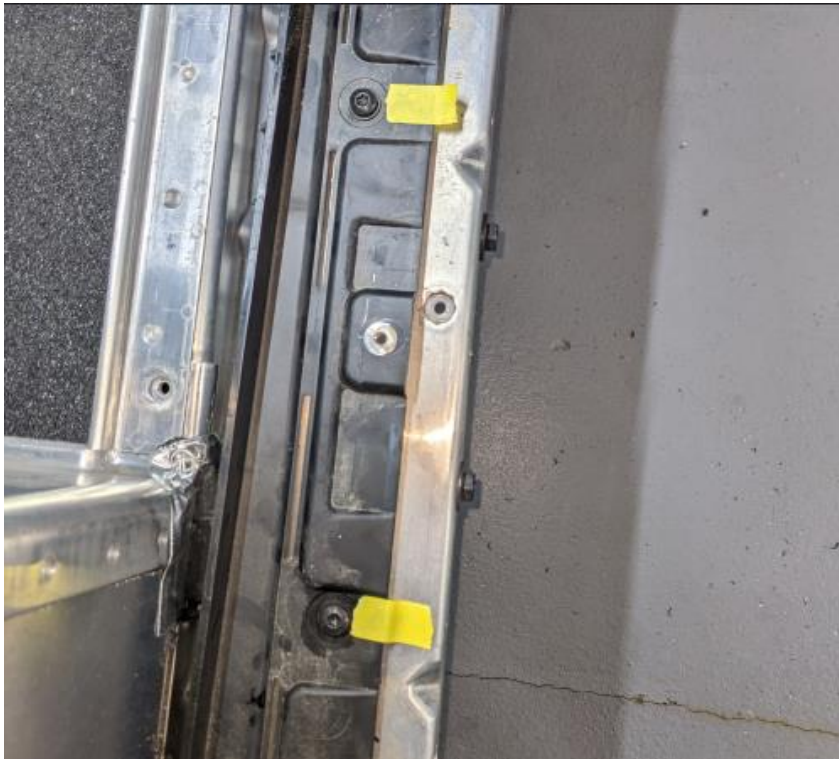
6431351

41. Remove the two Front Side Door Lower Guide bolts indicated by tape above, align & insert Template B pins into guide holes & sill plate nuts.

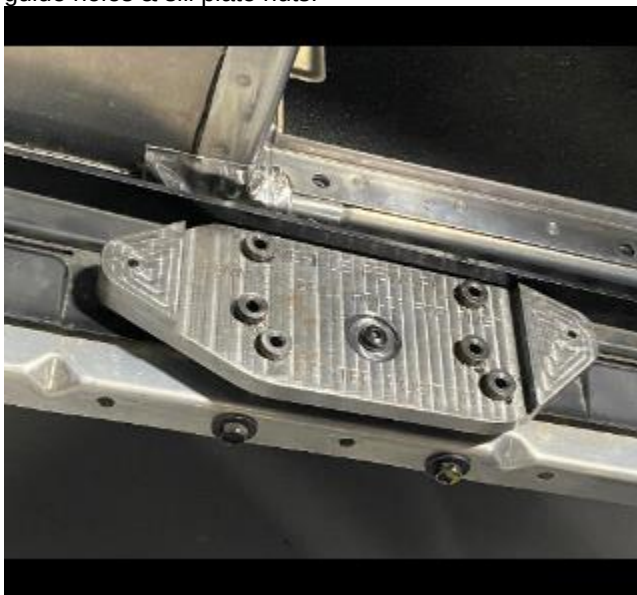
6411290

42. Use one of the removed Front Side Door Lower Guide bolt to tighten Template B into place (finger tight).

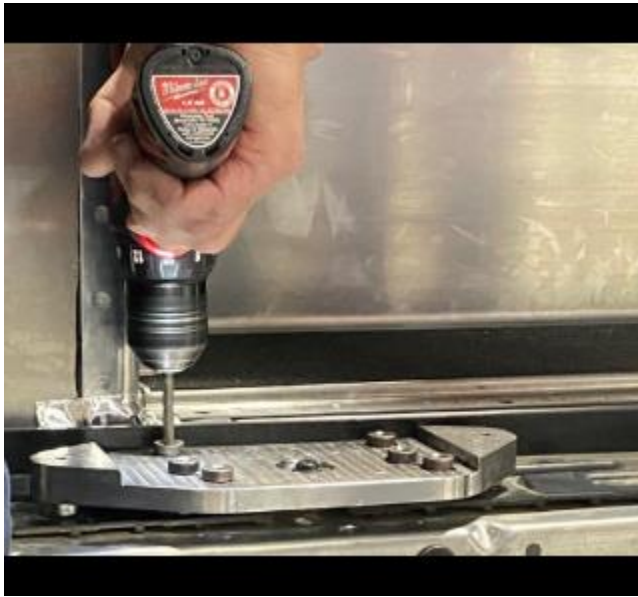
6411291

43. Drill 6 1/4 inch holes using Template B guide holes from the top down (holes must go through the guide, the sill plate and bracket). Remove Template B from the vehicle.
44. Redrill the 1/4 inch holes using a 6.7mm (17/64ths) drill and then deburr all drilled holes.

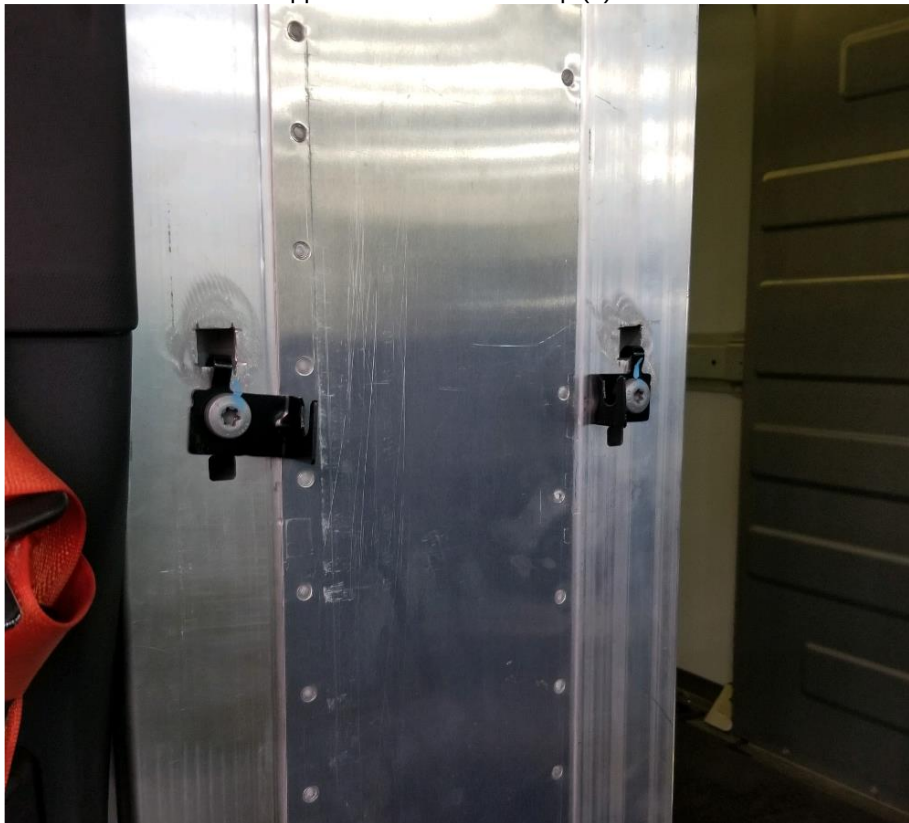
5879004

- 133. Feed the seat belt through the panel
- 134. Install NEW Center Pillar Upper Trim Panel (3)
- 135. Install Center Pillar Upper Garnish Molding Bolt (2)
- 136. Tighten to 9 Nm (80 lb in)
- 137. Install Center Pillar Upper Trim Panel Bolt Cap (1)

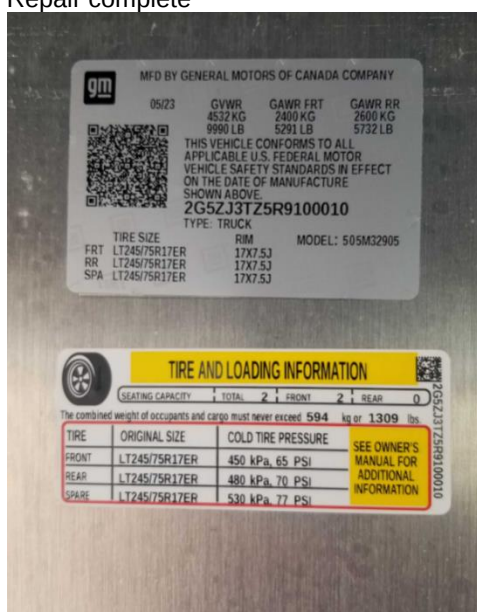
5901951

162. Install Front Floor Auxiliary Mat (2)
163. Install Front Floor Auxiliary Mat Retainer (1)
164. Properly dispose of the airbag modules. Refer to *Inflatable Restraint Module Handling and Scrapping* in the "Deployment Outside Vehicle" section in SI.
165. Reprogram the Restraints Control Module. Refer to *K36 Restraints Control Module: Programming and Setup* in SI.
166. Clear codes from all modules after programming via GDS2.
167. Once the vehicle jumpseat retrofit is complete please send a clear picture of the Tire and Loading information sticker via text message to BrightDrop at the following number: **415-692-0135**. Example text message below:
