Release Date	11/17/2023	Technical Service Bulletin	
OUF7 - Over-the-Air (OTA) Software Update (SW Level 3.2.11) Software Installation Not Successful

Applicable Vehicles		
Beginning Model Year	Ending Model Year	Vehicle
2021	2022	ID.4

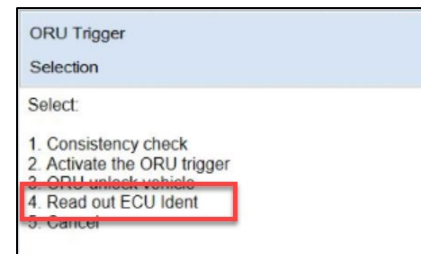
Step 3 - Read out identification data

- Read out the required extended identification data as follows:
 - Select the “Test Plan” tab.
 - Select “Self test.”
 - Select “Software version management.”
 - Select “Special actions.”
 - Select “8124 – Application server 1 system 2 Java.”
 - Select “8124 – Activate ORU trigger.”
 - Attach to the test plan and start the test plan.
- Select the option to “Read out ECU ident.”
- When prompted, enter the diagnostic address that has not yet been updated via OTA.
- Ensure the diagnostic log is sent to GFF Paperless.
- Continue to Step 4.
