GROUP	MODEL
ELE	2024MY Seltos (SP2) w/ AVN5W
NUMBER	DATE
317	November 2023

TECHNICAL SERVICE BULLETIN

SUBJECT: **AVN 5.0 WIDE NON-RESPONSIVE RADIO ICON (AM, FM, SXM)**

This bulletin provides information to update the software on 5th Generation AVN wide on certain 2024MY Seltos (SP2) vehicles to remedy a 'non-responsive' or 'inoperative' radio (FM, AM, SXM, etc.) and/or AVN screen freezing while using Apple CarPlay®/Android Auto™ concern(s). The affected AVN unit on the vehicles may not respond when pressing the 'RADIO' hard key/button on the AVN unit or when selecting the 'RADIO' icon on the AVN menu screen and/or when a cellular phone is connected to Apple CarPlay®/Android Auto™. Follow the procedure outlined in this publication to update the software on 5th Generation AVN wide units.

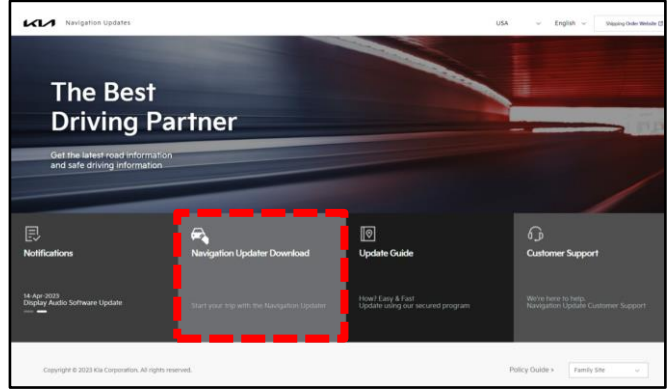
- 1. Go to '<https://update.kia.com/US/EN/Main>'.
- 2. Select 'Navigation Updater Download'.

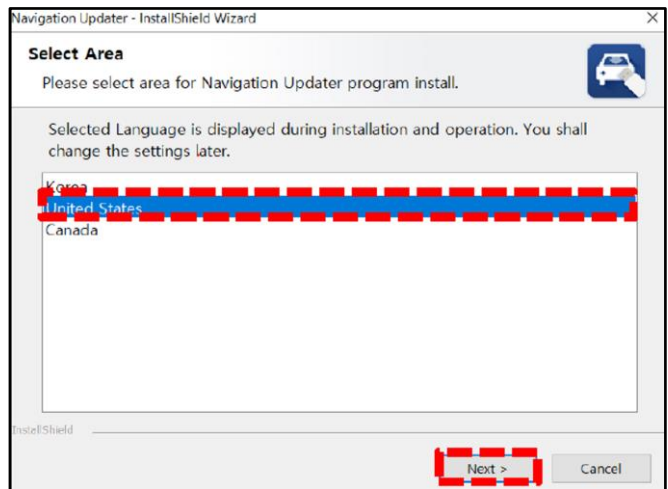
- 4a. Select 'United States'.
- 4b. Select 'Next'.

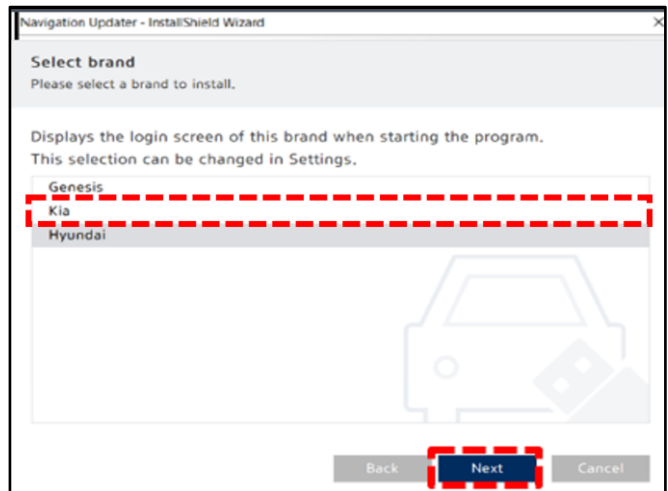
- 5a. Select 'Kia'.
- 5b. Select 'Next'.

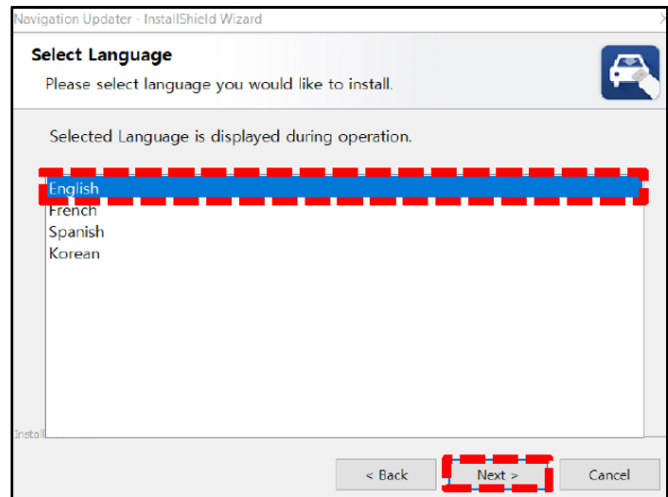
- 6a. Select a language (ex. 'English').
- 6b. Select 'Next'.

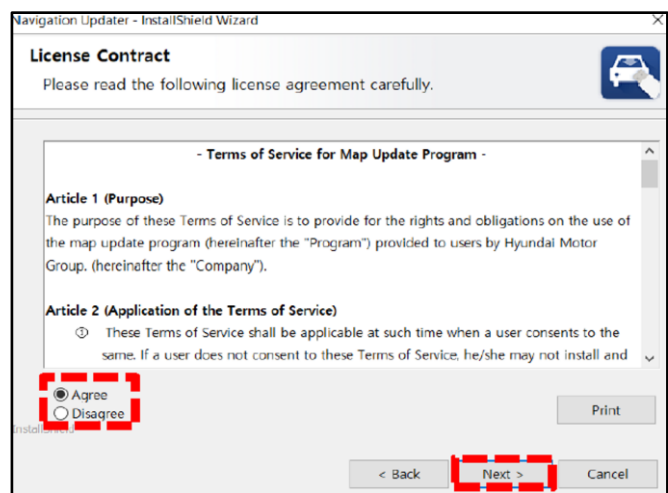
- 7a. Select 'Agree' to agree to the 'Terms & Conditions'.
- 7b. Select 'Next'.

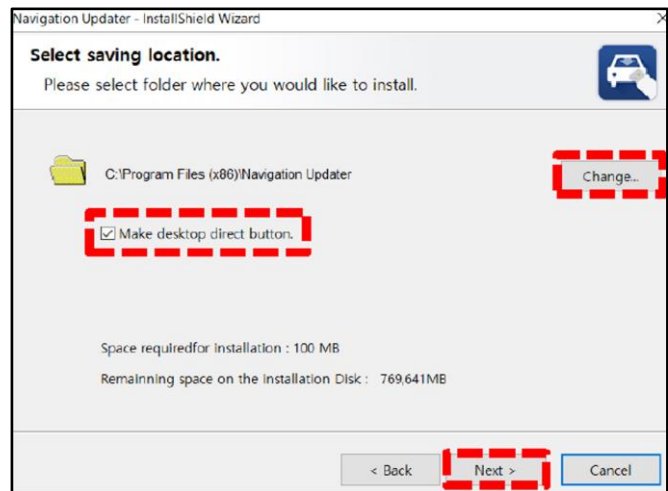
- 8a. Select 'Change' to save the file in a different location.
- 8b. Check the box 'Make desktop direct button.'.
- 8c. Select 'Next'.

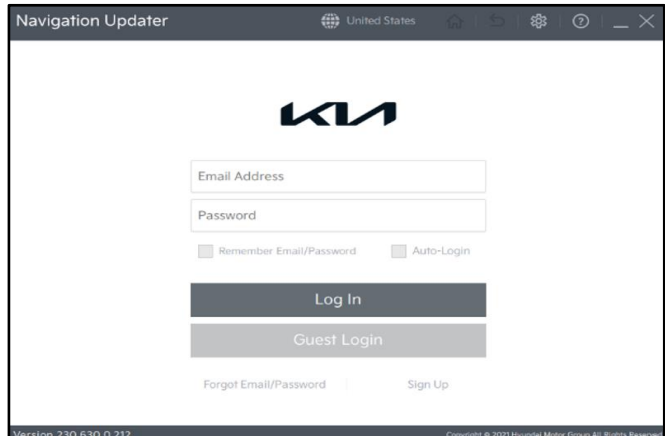
- 10a. Open the 'Navigation Updater'.
- 10b. Log in using Kia Connect (formerly UVO) credentials or log in as a guest using 'Guest Login'.

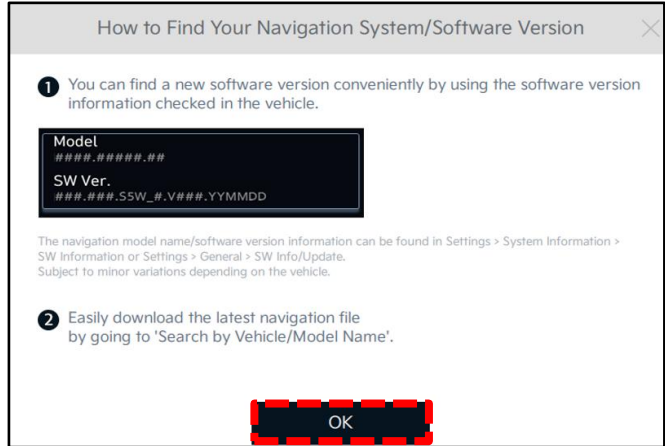
- 11. Select 'OK'.

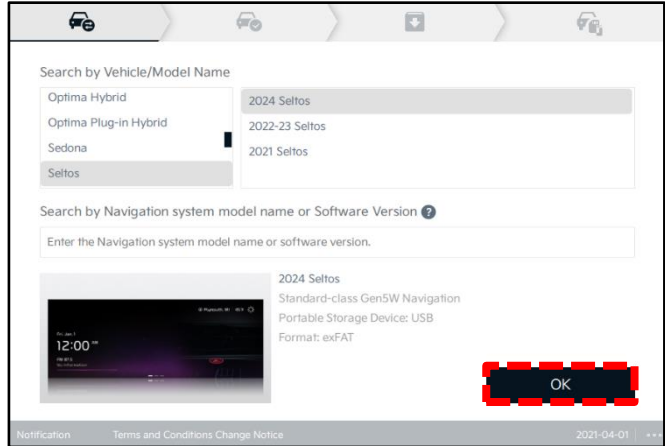
- 12a. Scroll and select 'Seltos'.

- 12b. Select '2024 Seltos'.

- 12c. Select 'OK'.

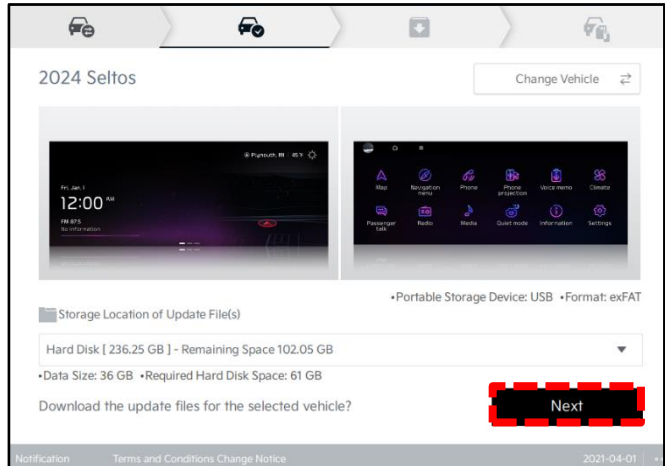
- 13. Verify the 'Storage Location of Updated File(s)', then select 'Next'.

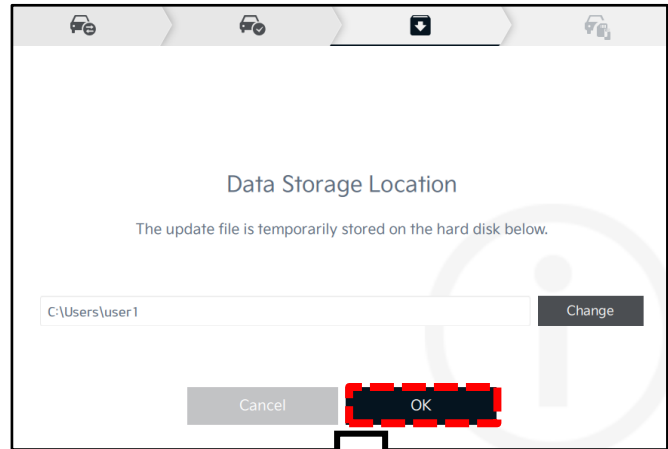
14. Select 'OK'.

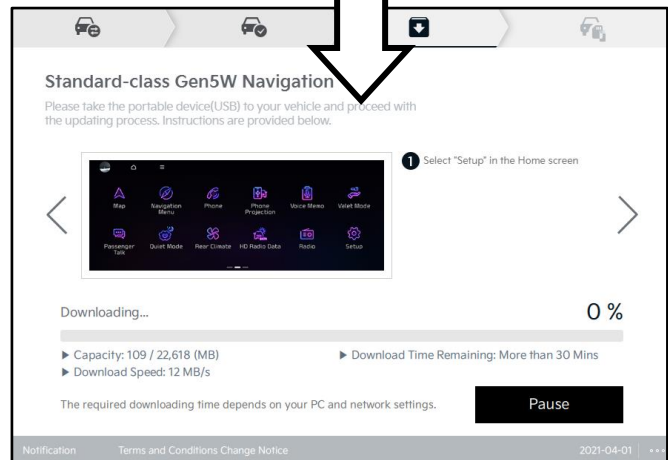
Note: Once download has completed, continue to step 15a.

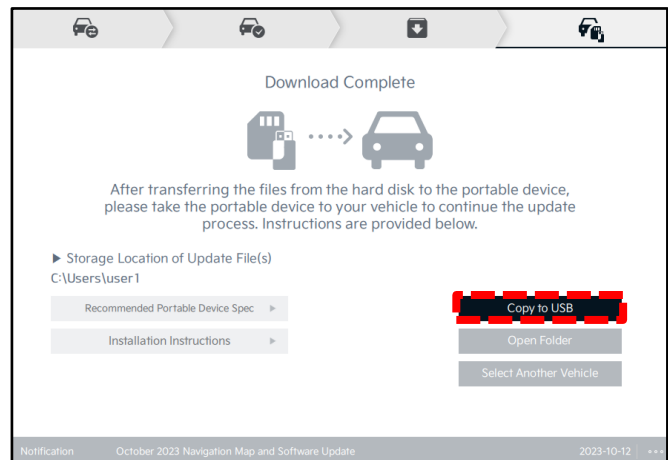
15a. Insert a new or formatted USB flash drive to the computer.

15b. Select 'Copy to USB'.

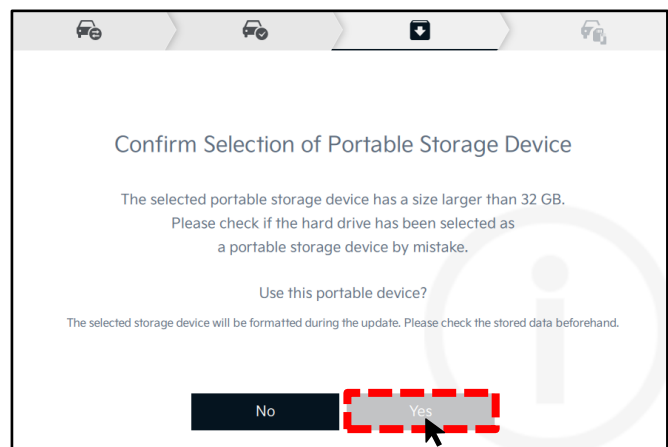
16. Select 'Yes'.

Note: By default, 'NO' is highlighted. Once 'YES' is selected, the pop-up on step 17 will populate.

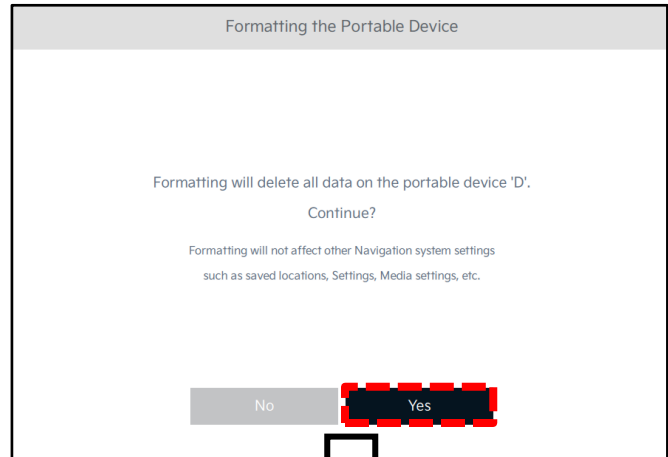
17. Select 'Yes'.

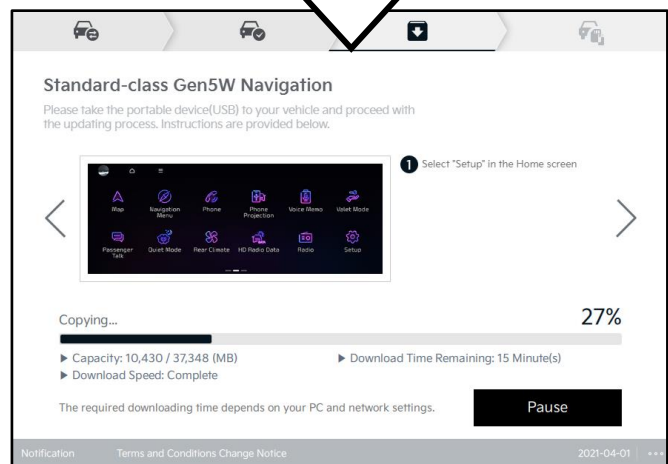
18. Once the downloaded files have completed downloading to the USB, proceed to the 'Update Procedure'.

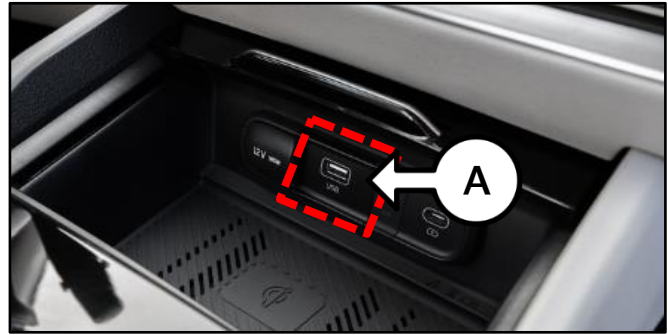
6. Insert the USB Flash Drive (refer to the table below) into the USB slot (A) located underneath the AVN unit.

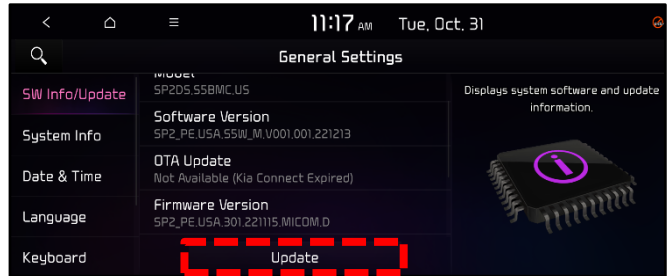
7. On the 'General Settings' screen, select 'SW Info/Update', then select 'Update'.

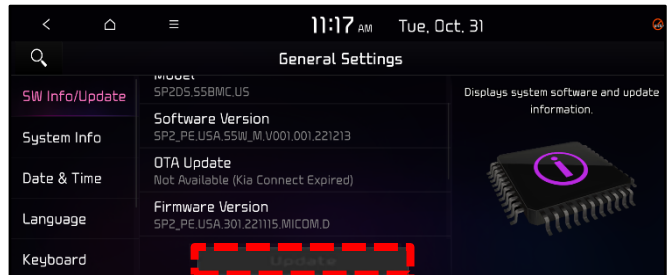
Note: If the USB Flash Drive is not recognized, the 'Update' button will not be activated, as shown. If this occurs, remove the USB Flash Drive, and repeat steps 3-7.

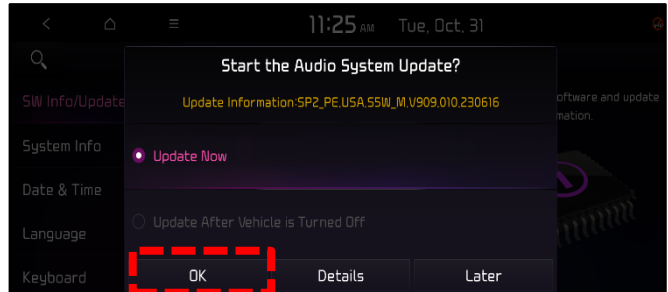
8. Select 'OK' on the pop-up screen.

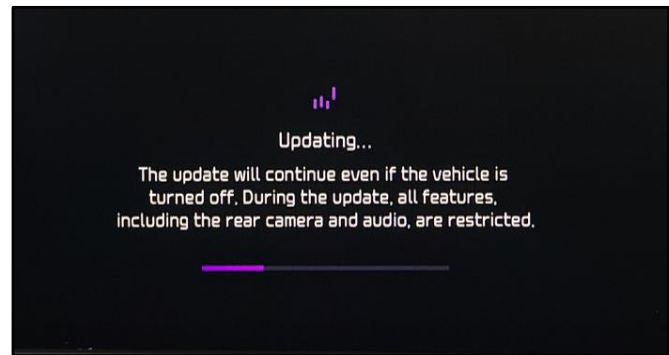
There will be multiple occurrences where the Kia logo will appear, the display will be black during the update process and/or display "Preparing System Update" for an extended period of time. This is normal.

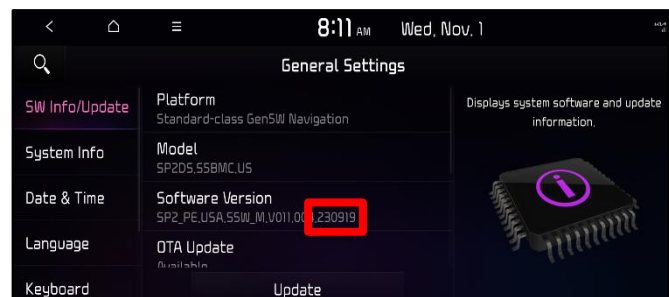
9. Once the update has completed, repeat steps 3-5 to confirm the Software Version has been correctly updated.
