June 2023
SF672 A-B
(Revised November 2023)

Subject: Common Telematics Platform Software Update

Models Affected: Specific model years 2018-2024 Freightliner 108SD, 114SD, M2 106, Cascadia, eCascadia; and Western Star 47X, 48X, 49X, 57X vehicles, manufactured February 10, 2017, through March 3, 2023.

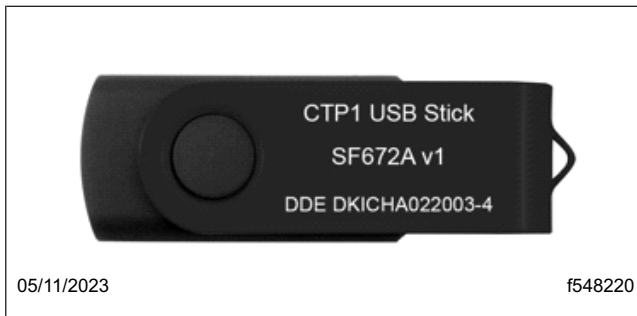
Fig. 1, CTP1 USB Stick with SF672A v1 (DDE DKICHA022003-4)

IMPORTANT: New tools are required for SF672 A-B. Both USB sticks are pre-loaded with the correct software: SF672A/CTP1 (DDE DKICHA022003-4), and SF672B/CTP2 (DDE DKICHA022003-5). These USB sticks, along with the USB Stick-to-CTP Adaptor Harness (DDE DKICHA022003-1), which is on-the-go (OTG) protocol compliant, can be purchased through your facing Parts Distribution Center (PDC). See [Fig. 1](#), [Fig. 2](#), and [Fig. 3](#).

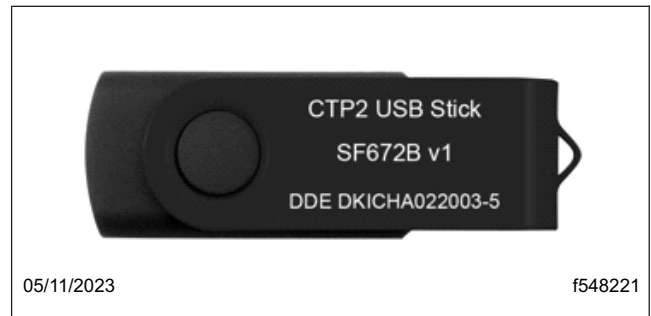
Fig. 2, CTP2 USB Stick with SF672B v1 (DDE DKICHA022003-5)

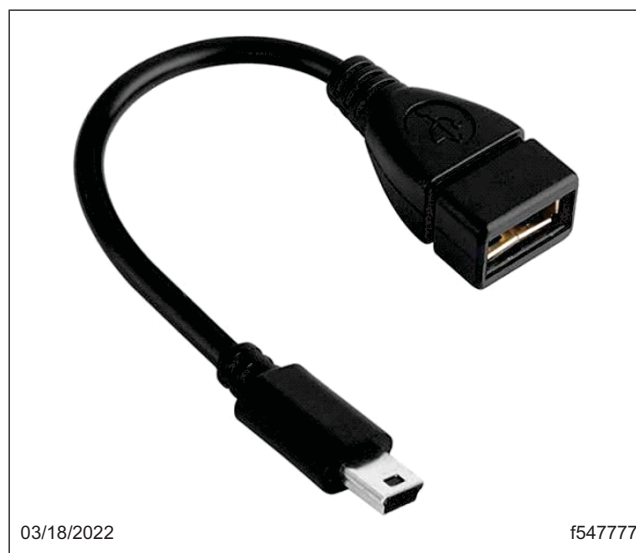
Fig. 3, USB Stick-to-CTP Adaptor Harness (DDE DKICHA022003-1)

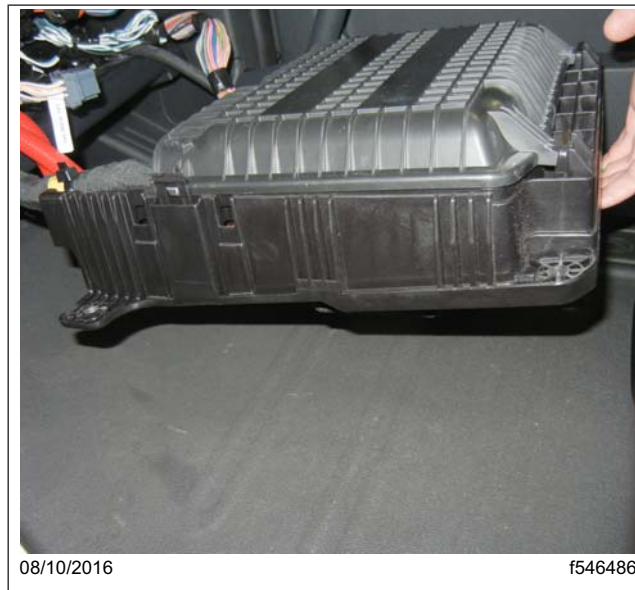
13. Remove the four VPDM mounting fasteners, then gently lower the VPDM on to the cab floor. See [Fig. 11](#).

Fig. 11, Lowering the VPDM to the Cab Floor

IMPORTANT: The VPDM is positioned on the mounting tabs to assist with retaining the VPDM in position while mounting fasteners are removed. Care should be taken so the VPDM does not fall to the floor after all four mounting fasteners have been removed.

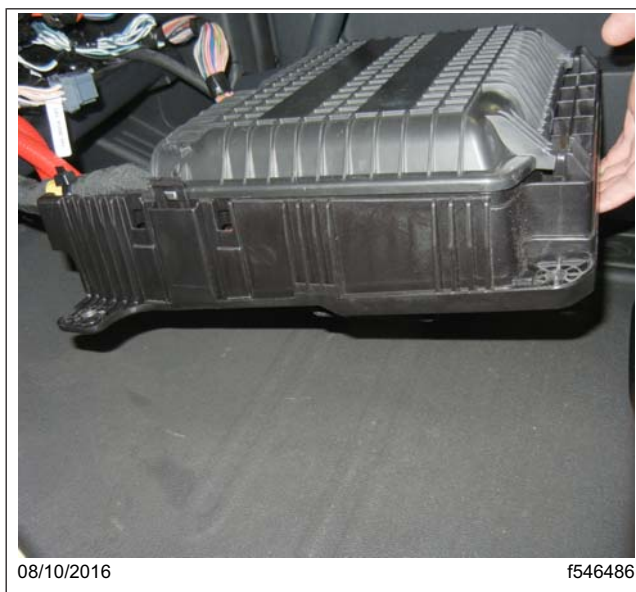
13. Remove the four VPDM mounting fasteners, then gently lower the VPDM on to the cab floor. See [Fig. 27](#).

Fig. 27, Lowering the VPDM to the Cab Floor

IMPORTANT: The VPDM is positioned on the mounting tabs to assist with retaining the VPDM in position while mounting fasteners are removed. Care should be taken so the VPDM does not fall to the floor after all four mounting fasteners have been removed.

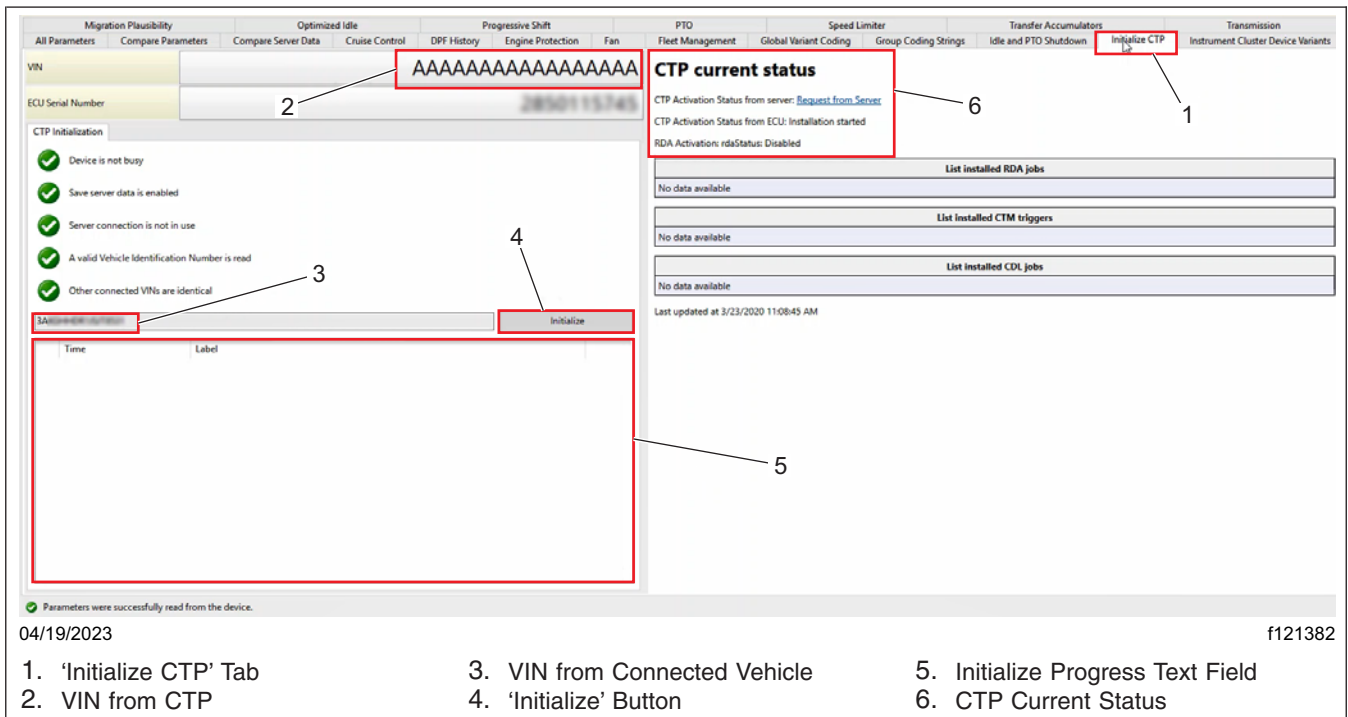
17. Go to the 'Parameters' tab. DiagnosticLink will read the parameters of the connected ECUs. Wait until the 'Reading parameters' bar indicates this process is complete.
18. Select the 'Initialize CTP' tab. Verify the vehicle identification number (VIN) from the new CTP2 reads the default AAAAAAAAAAAAAAAAAA, or the VIN from the connected vehicle. See Fig. 43. If not, remove the CTP, and install a new CTP.
19. Select 'Initialize' to run the initialization process.

Fig. 43, CTP Initialization
