Subject: SPECIAL SERVICE PROGRAM - SSPD1 – 2024 CX-90 (ALL) - iACTIVSENSE SYSTEM WARNING CONCERN	Campaign No.: SSPD1
	Last Issued : 10/26/2023

SSPD1 - 2024 CX-90 (All) - i-ACTIVSENSE System Warning Concern: On certain CX-90 vehicles, due to inappropriate control program of side radar sensor, the angle correction value of electric wave emitted from the sensor may be lost while the power is shut down, which may cause the SBS OFF indication and i-ACTIVSENSE warning light to turn on. There are 8,041 vehicles in the campaign.

MULTIPLE CAMPAIGNS REPAIR PROCEDURE AND MULTIPLE MODULE REPROGRAMMING

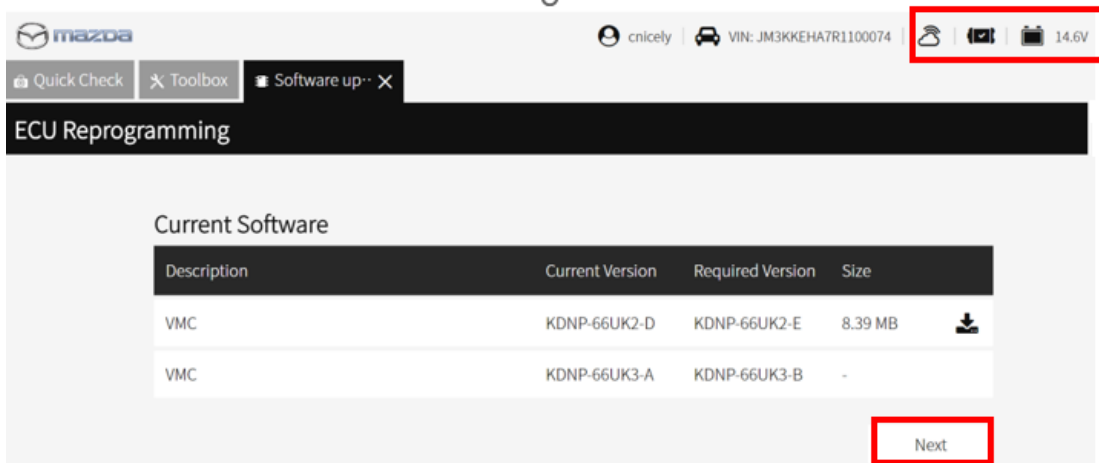
6. After completion of software update, the previous and current software version are shown. Check current version at "Calibration File information" below. Then, click on "Finish" to exit the ECU reprogramming and disconnect the 12V battery charger.

The screenshot shows the Mazda software update interface. At the top, there is a navigation bar with 'Quick Check', 'Toolbox', and 'Software up...' tabs. The main heading is 'ECU Reprogramming'. Below this, a section titled 'Current Software' contains a table with the following data:

Description	Current Version	Required Version	Size	
VMC	KDNP-66UK2-D	KDNP-66UK2-E	8.39 MB

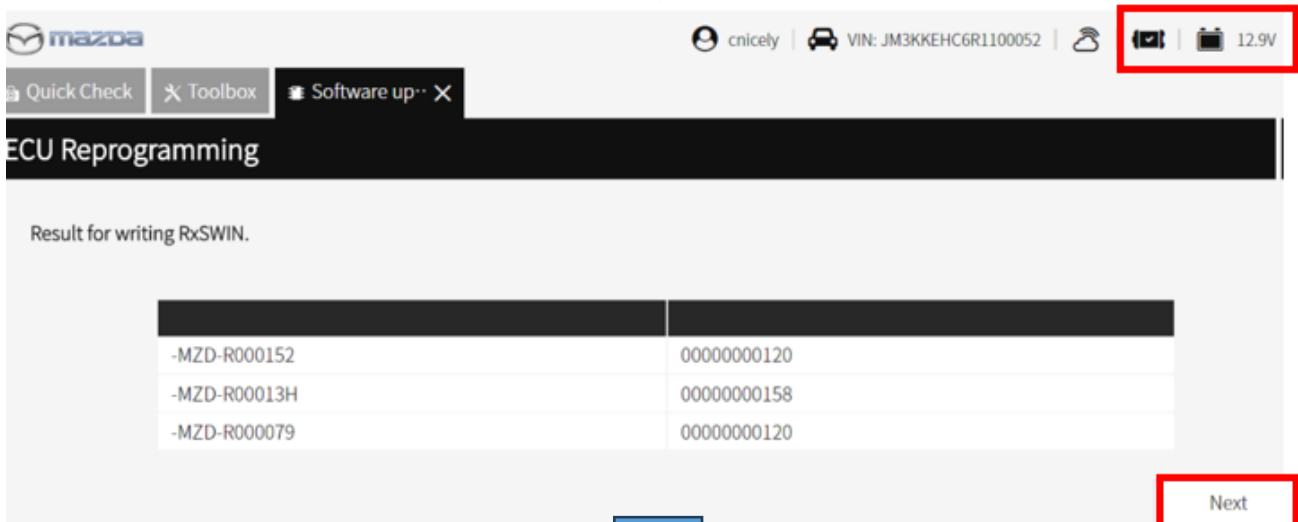
The screenshot shows the Mazda software update interface after the software update. The main heading is 'ECU Reprogramming'. Below this, a section titled 'Result for writing RxSWIN' contains a table with the following data:

-MZD-R000152	00000000120
-MZD-R00013H	00000000158
-MZD-R000079	00000000120

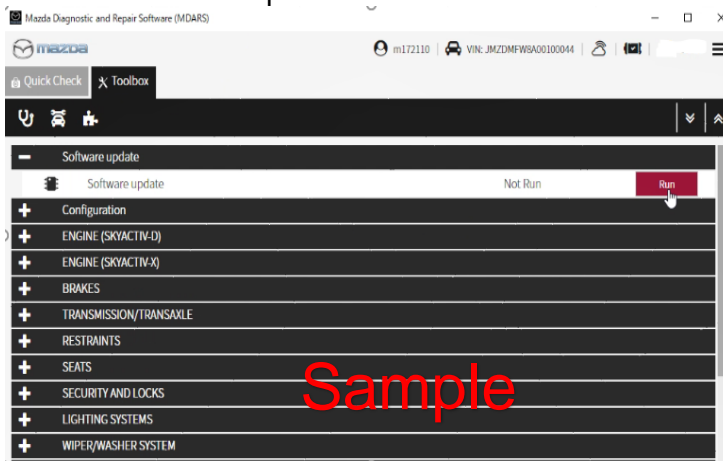
- Reprogram PCM and ECM as below
There is 'Software update' on 'Toolbox' tab. Select 'Run'.

- Select required module on 'ECU Reprogramming' screen.
Start Reprogramming.
 - **PCM**
 - **ECM**

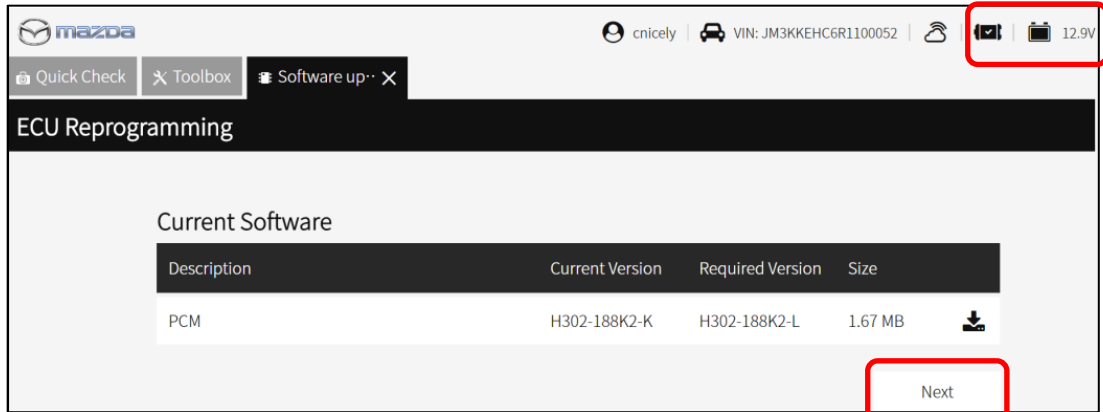
Current Software

Description	Current Version	Required Version	Size
PCM	H302-188K2-K	H302-188K2-L	1.67 MB

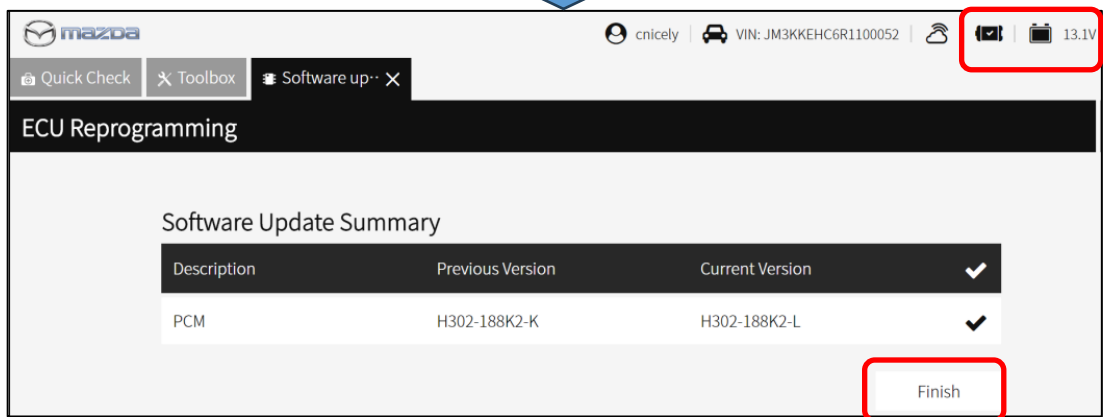
Software Update Summary

Description	Previous Version	Current Version
PCM	H302-188K2-K	H302-188K2-L

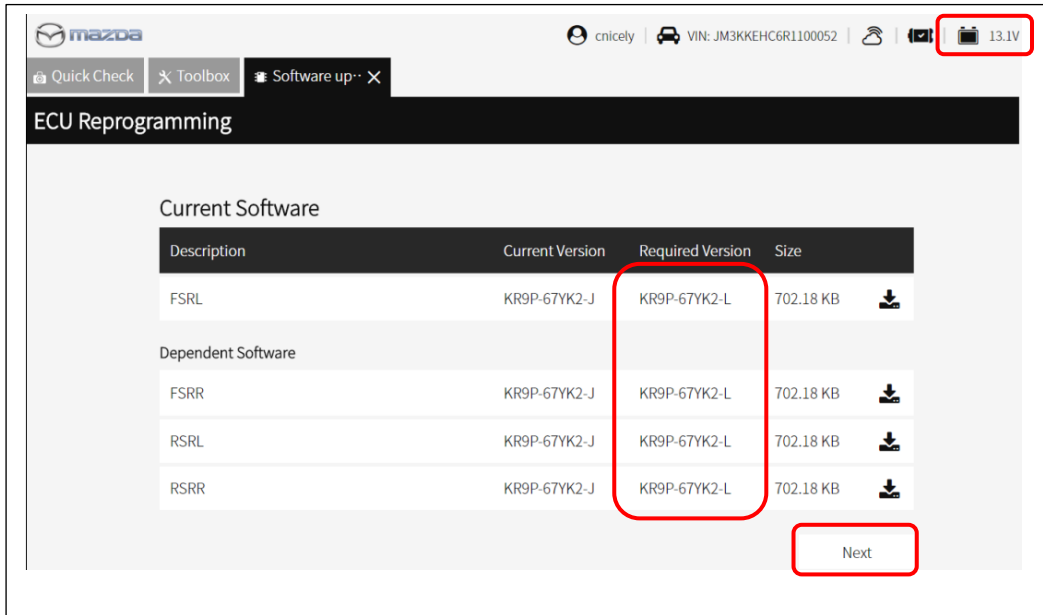
5. Select required module on 'ECU Reprogramming' screen.
6. Start Reprogramming.

Side Radar Sensor ECU Programming	Applicable Vehicle	Not Applicable
<p><u>NOTE: Not all trims have Front Side Radar</u></p> <ul style="list-style-type: none"> • FSRR (Front Side Radar Right) • FSRL (Front Side Radar Left) 	<p>Standard PT</p> <ul style="list-style-type: none"> • 3.3 Turbo Premium Plus <p>High PT</p> <ul style="list-style-type: none"> • 3.3 Turbo S Premium Plus <p>PHEV</p> <ul style="list-style-type: none"> • PHEV Premium Plus 	<p>Standard PT</p> <ul style="list-style-type: none"> • 3.3 Turbo Select • 3.3 Turbo Preferred • 3.3 Turbo Preferred Plus • 3.3 Turbo Premium <p>High PT</p> <ul style="list-style-type: none"> • 3.3 Turbo S <p>PHEV</p> <ul style="list-style-type: none"> • PHEV Preferred • PHEV Premium
<ul style="list-style-type: none"> • RSRR (Rear Side Radar Right) • RSRL (Rear Side Radar Left) 	<p>All</p>	<p>N/A – All vehicles have Rear Side Radar Sensors</p>

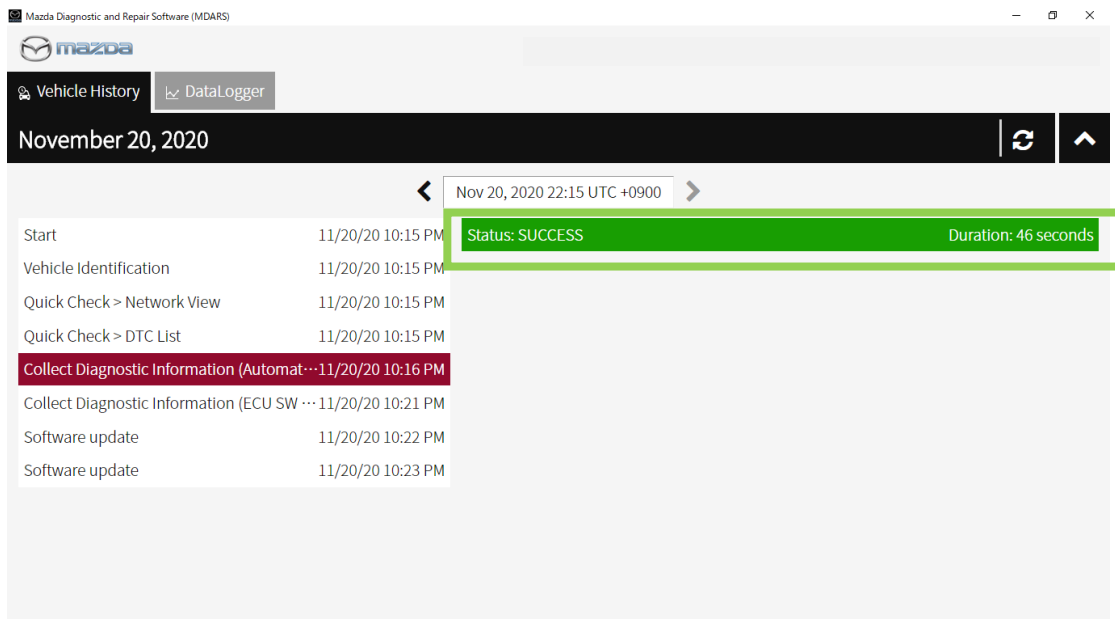
- Click the 'Collect Diagnostic Information' and the status has 'SUCCESS' on green.

Only the latest "Collect Diagnostic Information" is the valid one and that needs to show "SUCCESS"
