Technical Service Bulletin

SUBJECT: LOUD ELECTRIC COMPRESSOR SOUND WHILE USING HEATER		No: TSB-23-55-007	
		DATE: November 2023	
		MODEL: See below	
CIRCULATE TO:	<input type="checkbox"/> GENERAL MANAGER	<input checked="" type="checkbox"/> PARTS MANAGER	<input checked="" type="checkbox"/> TECHNICIAN
<input checked="" type="checkbox"/> SERVICE ADVISOR	<input checked="" type="checkbox"/> SERVICE MANAGER	<input checked="" type="checkbox"/> WARRANTY PROCESSOR	<input checked="" type="checkbox"/> SALES MANAGER

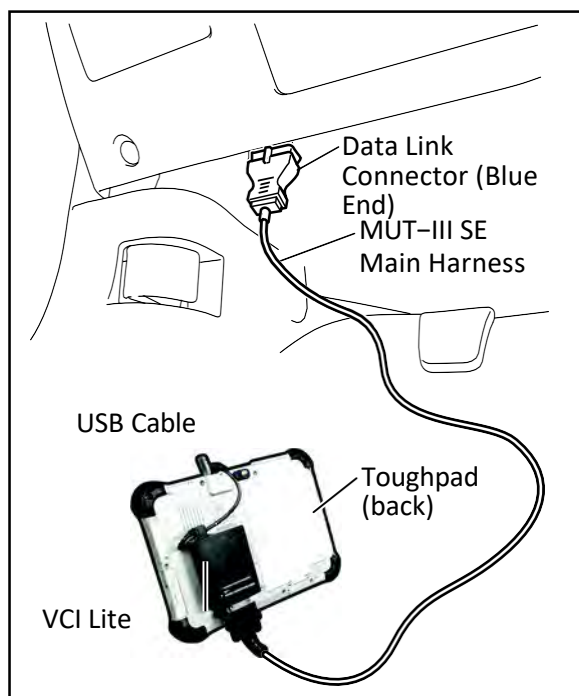
1. Connect the equipment as follows:

NOTE: VCI Lite and MEDIC 4.0 Toughpad shown for illustration purposes only.

- Turn the MEDIC PC/tablet on. If the battery indicator in the lower right hand corner of the screen does not show a full charge, it is recommended that either the battery be charged prior to beginning or be used with the A/C power adaptor connected.
- Connect the USB cable to the VCI/VCI Lite. When the laptop/tablet displays the MUT-III SE main screen, connect the USB cable to the device.
- Connect the MUT-III SE main harness with the blue DLC connection to the VCI/VCI Lite. Connect the blue connection of the MUT-III SE main harness to the vehicle's data link connector.
- For VCI only (p/n MB991824): Turn the VCI power switch ON. Verify that the indicator lamp in the upper right corner of the screen is green.

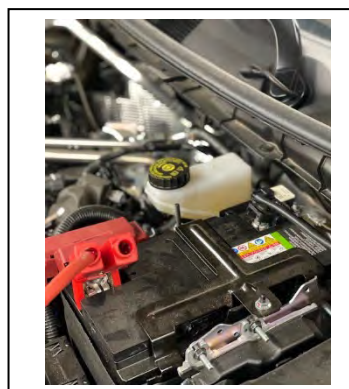
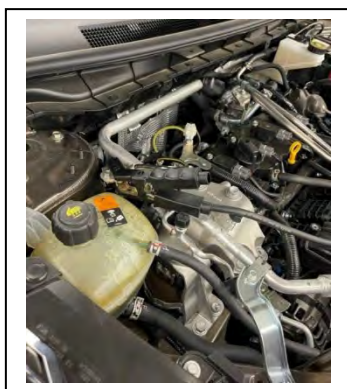
NOTE: Due to limited space it may be easiest to connect cable onto negative ground post and ground strap as shown below.

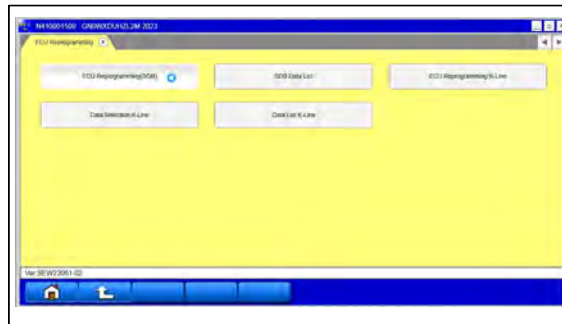
a. Select ECU Reprogramming (SDB).

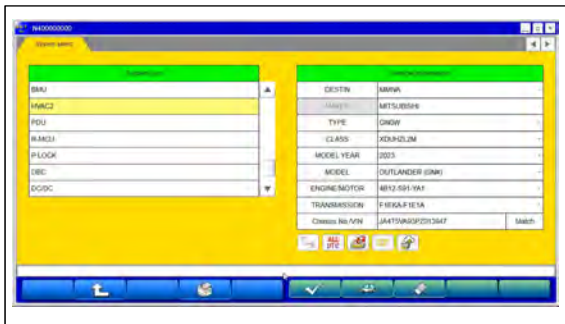
b. Select "HVAC2" in the System List and press the OK button.
