Subject: N232412712 - Service Update  
ECM OBD – Catalytic Converter Fault Detection

Models: 2021 Cadillac CT4  
2021 Cadillac CT5  
Equipped with ENGINE-GAS, 4 CYL, 2.0L (RPO LSY)

# Service Update

## N232412712 ECM OBD – Catalytic Converter Fault Detection

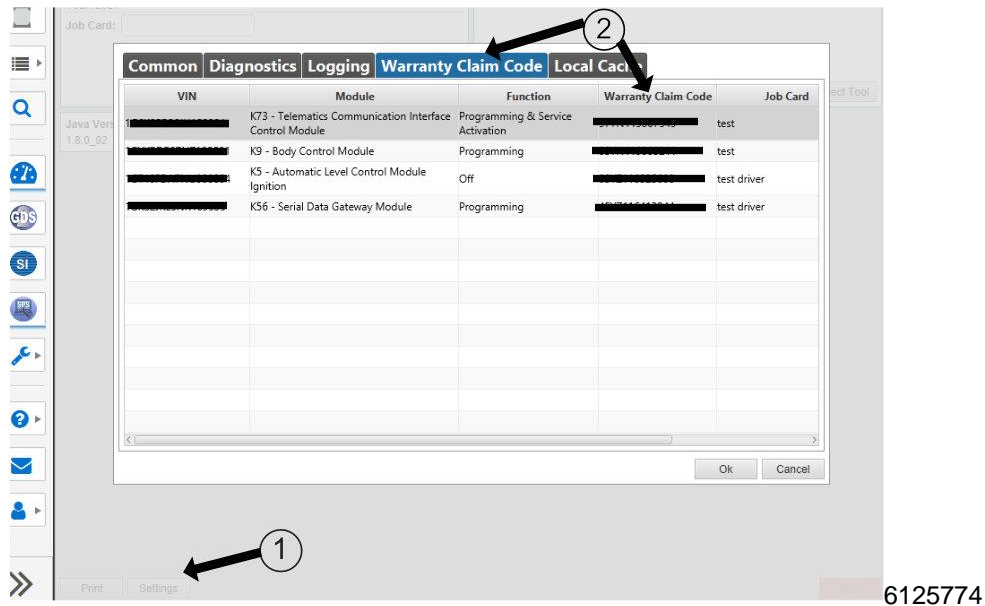
### Warranty Claim Code Information Retrieval

If the Warranty Claim Code was not recorded on the Job Card, the code can be retrieved in the SPS2 system as follows:

1. Open TLC on the computer used to program the vehicle.
2. Select and start SPS2.
3. Select Settings (1).
4. Select the Warranty Claim Code tab (2).

The VIN, Warranty Claim Code and Date/Time will be listed on a roster of recent programming events. If the code is retrievable, dealers should resubmit the transaction making sure to include the code in the SPS Warranty Claim Code field.

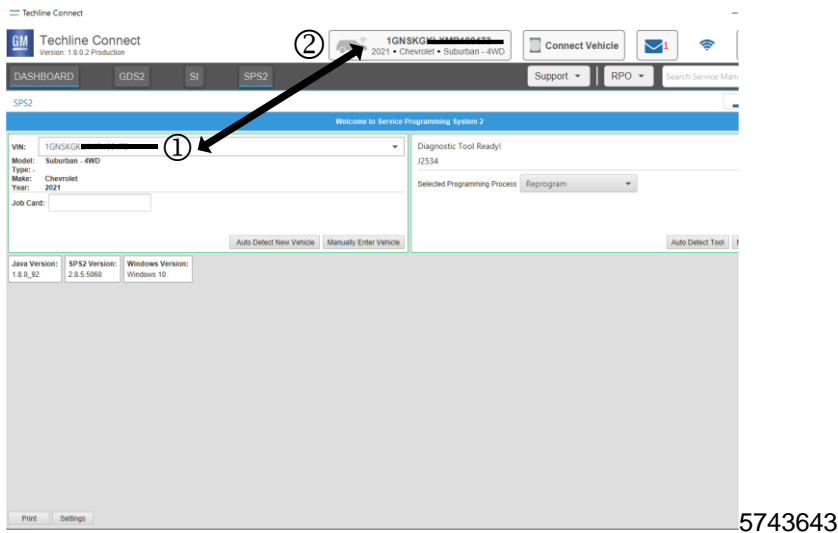
**Caution:** Be sure the VIN selected in the drop down menu (1) is the same as the vehicle connected (2) before beginning programming.

**Important:** Techline Connect screens shown above.

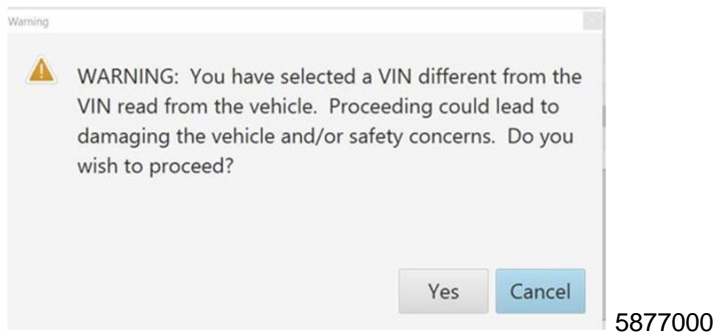
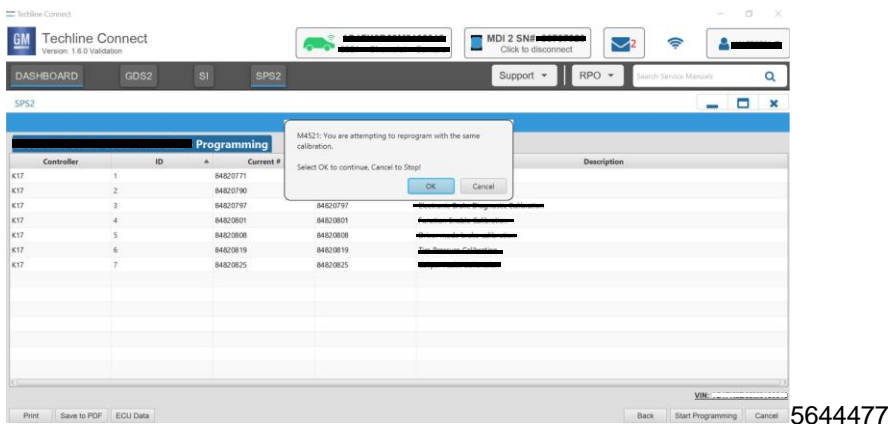
**Important:** If the vehicle VIN DOES NOT match, the message below will be shown.

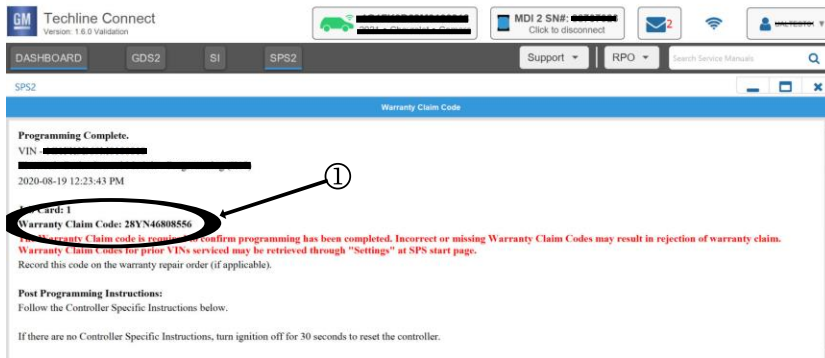
5644478

1. Reprogram the Engine Control Module. Refer to *K20 Engine Control Module: Programming and Setup* in SI.

**Note:** The screenshot above is an example of module programming and may not be indicative of the specific module that is being programmed. Module selection and VIN information have been blacked out.

**Important:** If the same calibration/software warning is noted on the TLC Summary screen, select OK and follow screen instructions. After a successful programming event, the WCC is located in the Service Programming System dialogue box of the SPS Summary screen. No further action is required. Refer to the Warranty section of the bulletin.
