**Symptom - Rattling Noises from Around the Rear Axle: Checking Engine Mount (SY 183/21)**

Model Line: **911 (992)**

Concerns: **Rear engine mount**

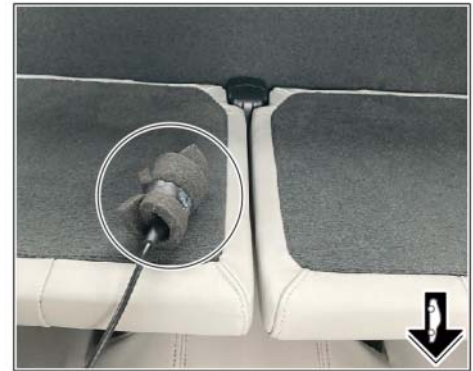
- Work Procedure: 1 Remove rear wheels.  
⇒ *Workshop Manual '440519 Removing and fitting wheel'*
- 2 Remove rear wheel housing liners (rear section).  
⇒ *Workshop Manual '53691903 Removing and installing rear wheel housing liner (rear section)'*
- 3 Install / route microphone and vibration and noise analysis system sensors as follows:
- 3.1 Microphone **channel A** rear-seat backrest
- Sensor type: Microphone
  - Item: Passenger compartment
  - Fastening on the vehicle: Rear-seat backrest area directed backwards ⇒ *Item microphone in channel A*

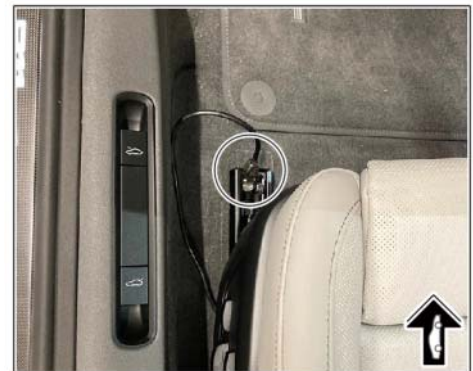
3.2 Sensor **channel B** seat rail for driver seat

- Sensor type: Acceleration sensor
- Item: Passenger compartment
- Fastening on the vehicle: Seat rail for driver seat at **left** ⇒ *Item sensor channel B*

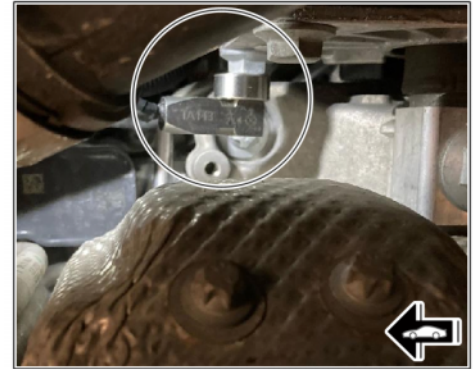
3.3 Sensor **channel C** for left PADM bearing

- Sensor type: Acceleration sensor
- Item: Engine compartment
- Fastening on the vehicle: Screw on PADM bearing on the **left** on longitudinal member ⇒ *Item sensor channel C*

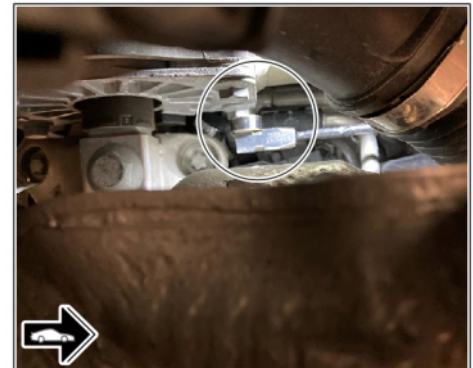
3.4 Sensor **channel D** for right PADM bearing

- Sensor type: Acceleration sensor
- Item: Engine compartment
- Fastening on the vehicle: Screw on PADM bearing on the **right** on longitudinal member  
⇒ *Item sensor channel D*

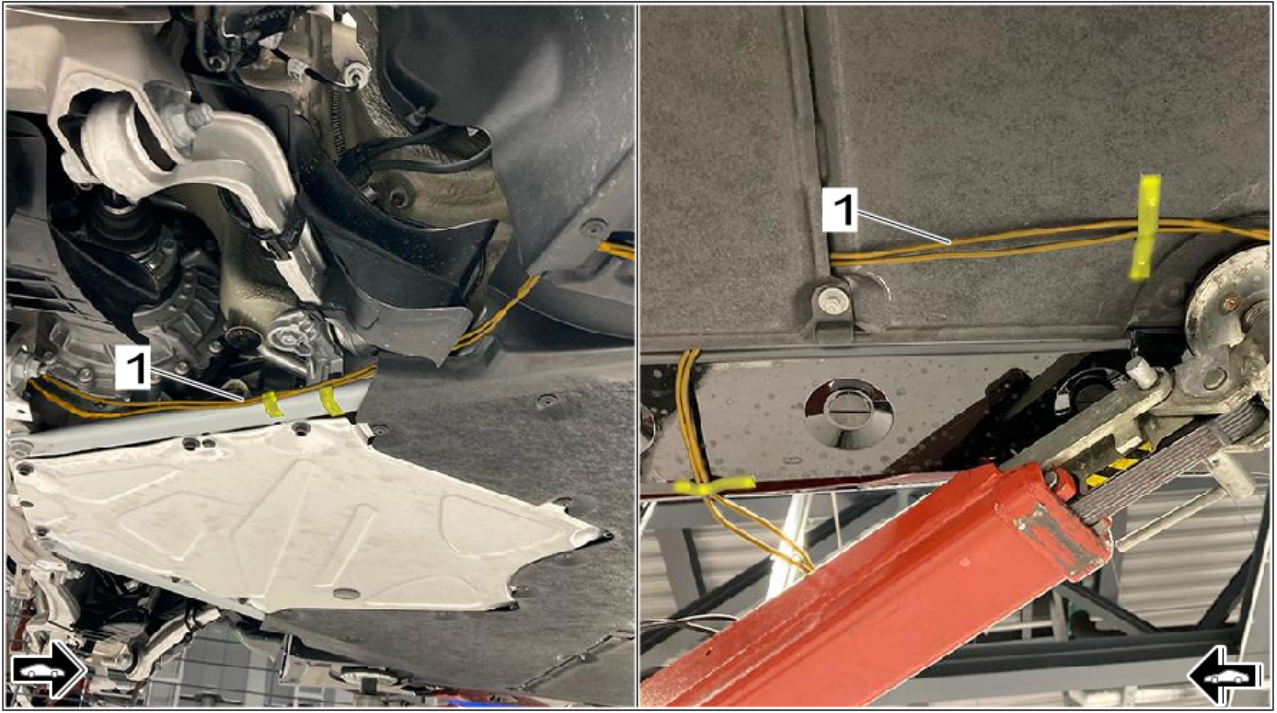
*Example of routing / fastening underbody*

- 4 Route the test leads ⇒ *Example of routing / fastening underbody -1-* in such a way that they are not damaged during the analytical run.

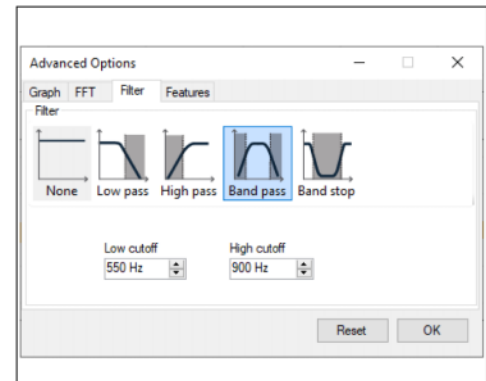
- 6.3 Open the "Record and Analyse" tab.
  - 6.4 Switch view from "Frequency" to "Time Domain".
  - 6.5 Set filter to 550 Hz–900 Hz if not already done. ⇒ *Frequency filter*
