Service Bulletin

Bulletin No.: 23-NA-194

Subject: IOR Radio ONLY – Unwanted Vibration or Booming Noise Heard through Speakers

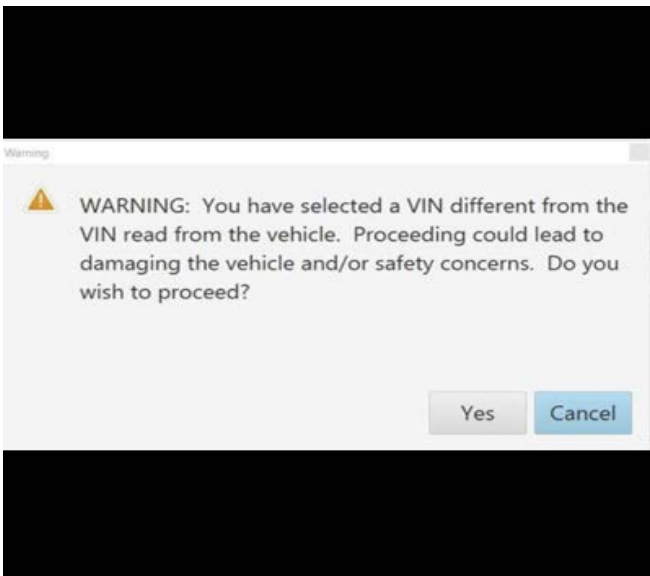
5877000

Important: If the vehicle VIN DOES NOT match, the message below will be shown.
