REFERENCE:	TSB: 08-232-23 GROUP: 08 - Electrical	Date:	October 18, 2023	REVISION:	08-107-22
VEHICLES AFFECTED:	2021 - **2022** (M6 - Japan) Jeep Compass This bulletin applies to vehicles built on and after **May 01, 2021 (MDH 0501XX) and on and before September 01, 2022 (MDH 0901XX)** equipped with a Uconnect 5 NAV W 10.1" Display (Sales Code UTN).			MARKET APPLICABILITY: <input type="checkbox"/> NA <input type="checkbox"/> MEA <input type="checkbox"/> SA <input checked="" type="checkbox"/> IAP <input type="checkbox"/> EE <input type="checkbox"/> CH	
CUSTOMER SYMPTOM:	The customer may describe one or more of the following: <ul style="list-style-type: none"> **Customer not receiving the map updates via the USB.** Menu for Active Lane Management is missing two settings, Lane Warning and Steering Assist Strength. 				
CAUSE:	Radio software

This bulletin involves updating the radio software with USB to ****S27.10.****

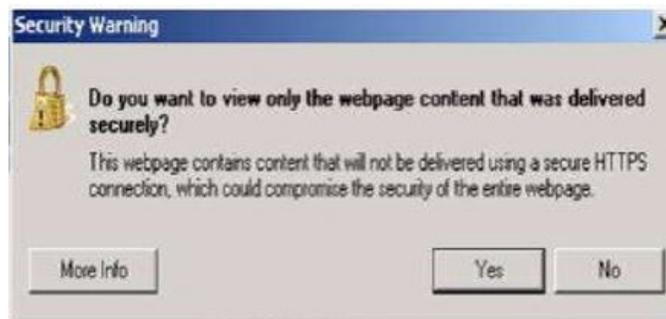
Fig. 1
Pop-Up Security Message

1. Check if the radio software has been updated. Go to “Vehicle Settings” then select “System Information” and look for “Radio Version”.
2. Was the radio software at or above S27.10?
 - YES >>> This bulletin does not apply. Additional diagnostic may be needed.
 - NO >>> Proceed to [Step 3](#).
3. Has a ****32/64GB**** USB flash drive been created?
 - YES>>> Proceed to [Step 12](#).
 - NO>>> Proceed to [Step 4](#).
4. Go to DealerCONNECT>Service>Uconnect Command Center>Uconnect>More Information >Dealer software downloads to download the files.
5. If a security message appears “Do you want to view only the web page content that was delivered securely?” [Fig. 1](#). Press “No” to continue.

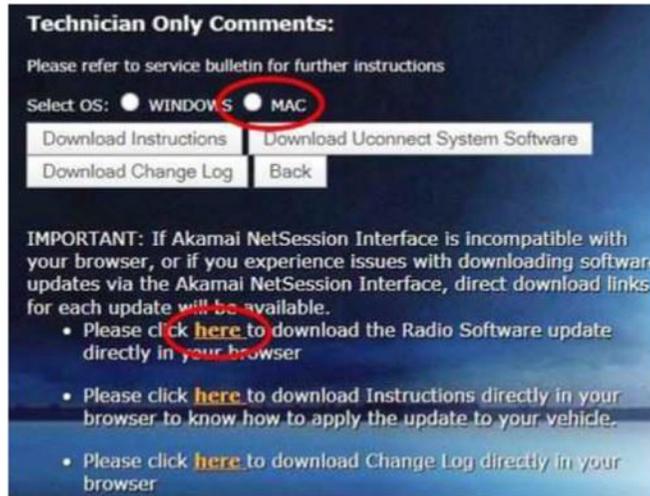
Fig. 3
MAC Radial Button

- 7. Download the software update file to your local PC's desktop. Make sure to select the "MAC" radial button for all downloads [Fig. 2](#), [Fig. 3](#).

NOTE: When downloading the software file, always select the MAC version, regardless of the computer being used.

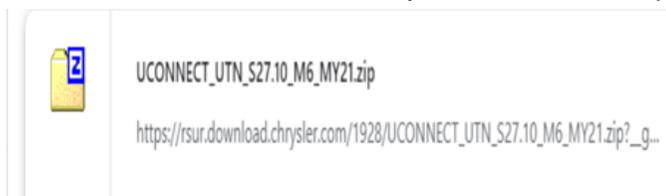
Fig. 4
Zip Folder

- 8. Download the radio SW from DealerConnect to a blank USB flash drive. The USB flash drive should be at least ****32/64GB**** and formatted to NTFS.
- 9. There should only be one file on the USB root directory labeled as a ".zip" folder [Fig. 4](#).

- 10. Do not unzip the folder/file and move all contents to the root directory of the USB.
- 11. Once the USB flash drive have been created, it is recommended to label the USB flash drive with the bulletin number and proper radio Sales Codes.
- 12. Start the vehicle and insert the correct USB flash drive with new software into the USB port.

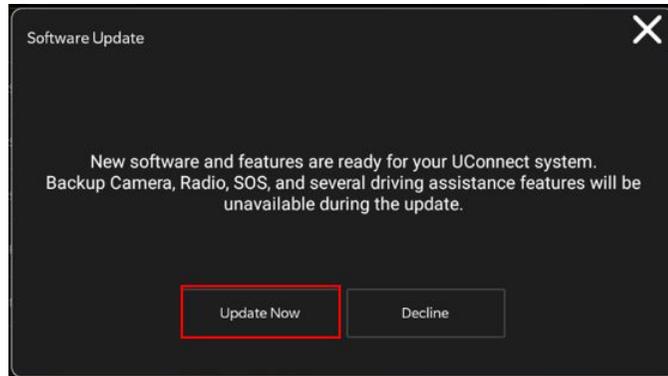
Fig. 5

13. Once the system has verified there is an available update, press the “Update Now” button. Make sure the vehicle is in park. **Do NOT turn the ignition off until the two minute timer has expired. The ignition doesn't have to be turned off to update the radio's software** Fig. 5.

Software Update

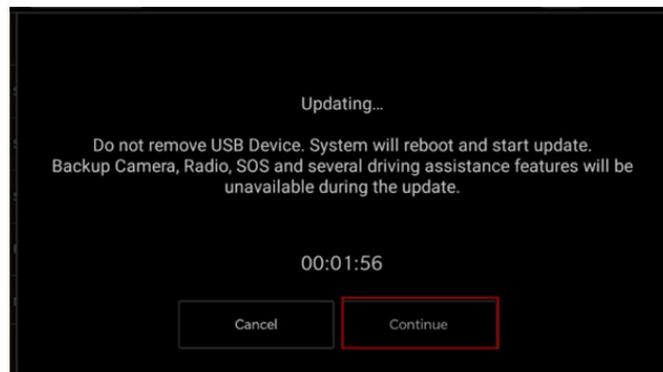
Fig. 6

14. Press the “Continue” on the display screen Fig. 6.

Software Updating

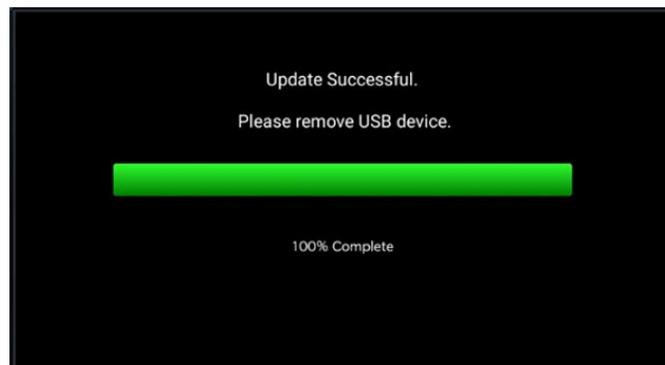
Fig. 7

15. The radio will reboot and the update will begin. The update should only take 30 minutes Fig. 7.
NOTE: Do Not turn off the vehicle when the software update is completed and told to remove the USB flash drive.

Update Successful

16. **Do Not** turn off the ignition at this point. The update is still in process, wait until the radio restarts and the home screen is displayed. This should take around five minutes.

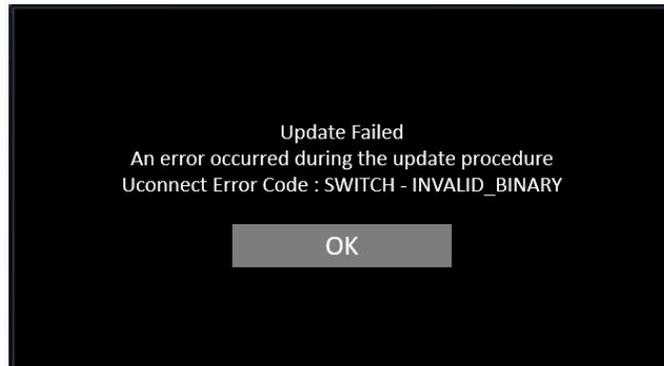
17. Sometimes the radio will display an error pop up “ SWITCH-INVALID_BINARY” after successful radio update. Please ignore this error message and press “OK” to continue [Fig. 8](#).

Fig. 8
Update Failed

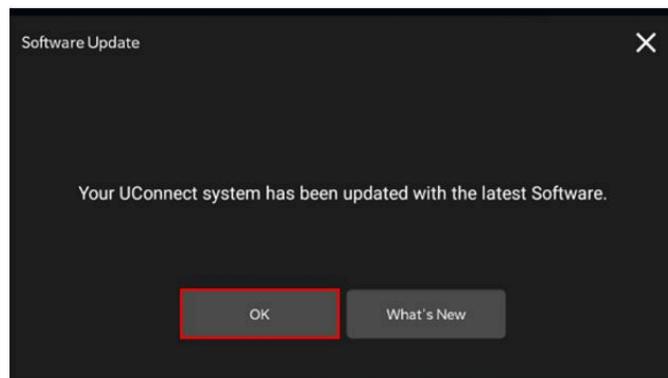
18. Press “OK” to continue [Fig. 9](#).

Fig. 9
Completed Update
