Service Bulletin

Bulletin No.: 23-NA-071

Subject: Engine Control Module Service Update for MIL Illuminated on DIC with DTC's Set

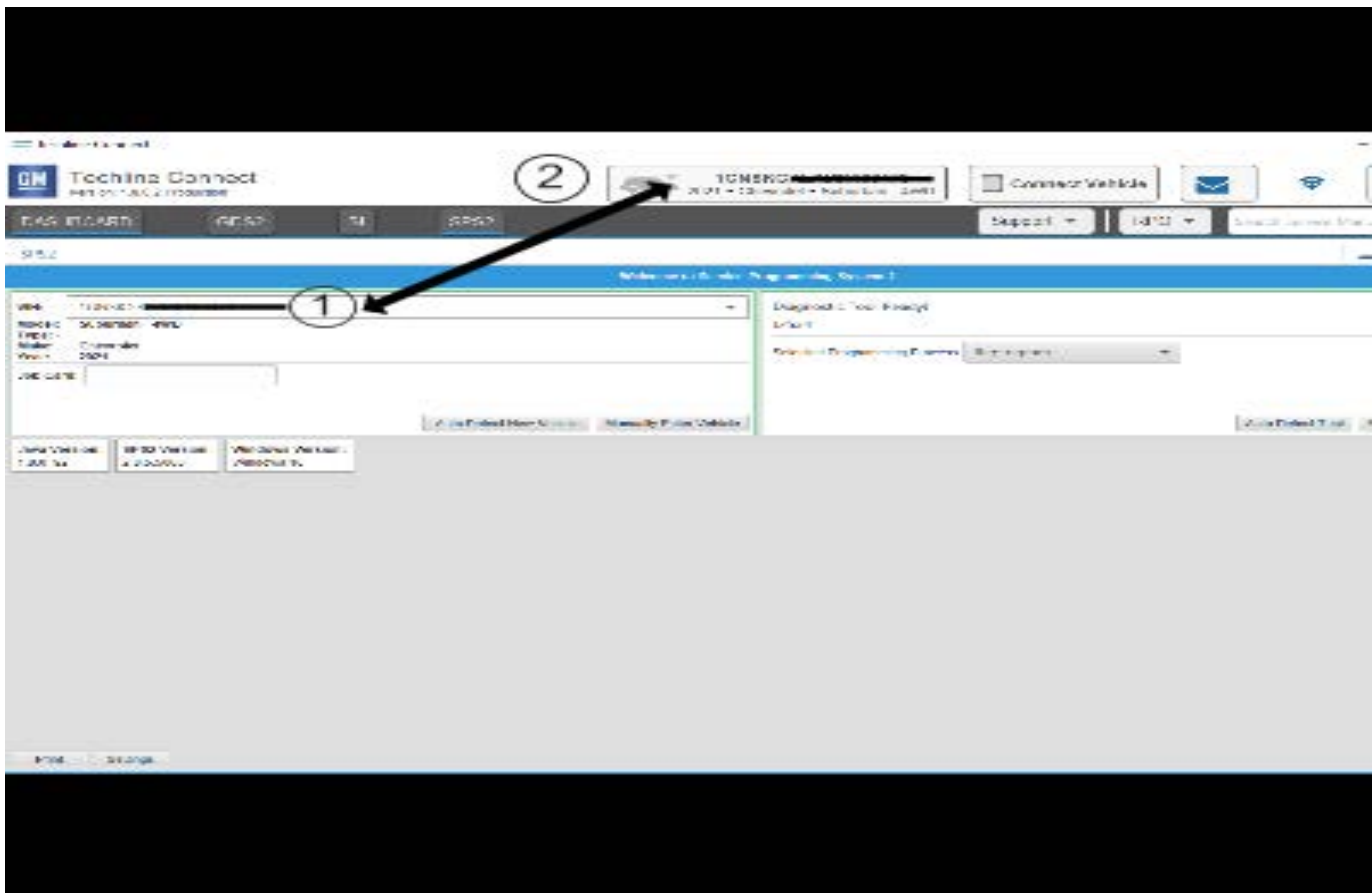
Caution: Be sure the VIN selected in the drop down menu (1) is the same as the vehicle connected (2) before beginning programming.
