GROUP	MODEL
	ELE	2020-2023MY Multiple Models w/ AVN5W
	NUMBER	DATE
	320	December 2023

TECHNICAL SERVICE BULLETIN

SUBJECT: AVN 5.0 WIDE SCREEN FREEZING OR MAP DELAY WITH WIRED APPLE CARPLAY®

This bulletin provides information to update the software on 5th Generation AVN wide on certain 2020-2023MY Kia vehicles (refer to model list on page 3) to remedy an inaccurate map location, freezing AVN screen, or experiencing a delay when using Google Maps™ or Waze™ through wired Apple CarPlay®. Follow the procedure outlined in this publication to update the software on 5th Generation AVN wide units using the applicable USB Flash Drive 'A' or Navigation Updater.

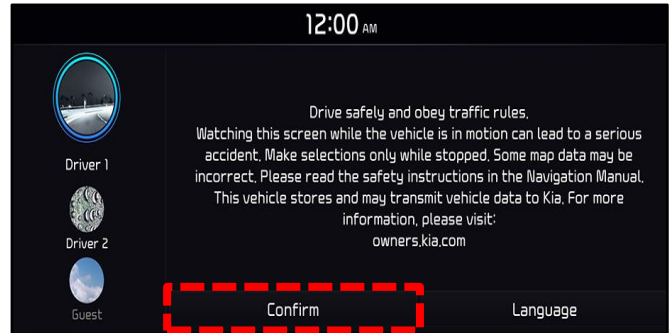
1. Turn the engine 'ON'.
2. Select 'Confirm' on the AVN screen.

Note: The software update is possible with the AVN 'OFF'.

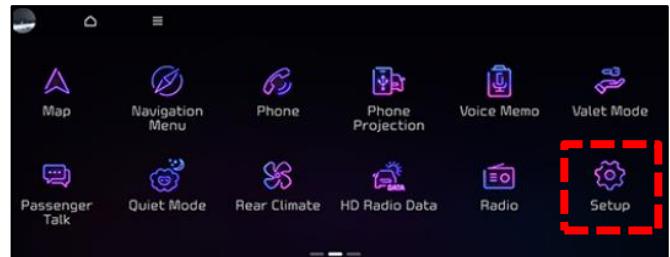
3. Select 'Setup'.

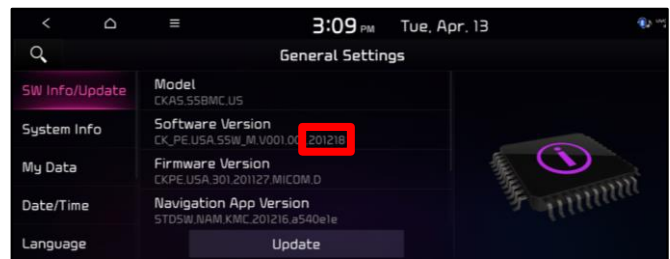
5. Inspect the last six (6) digits of the AVN Software Version displayed in 'General Settings'.

- If the current software version shown in 'General Settings' is before 230203 (Feb 03, 2023), then proceed to step 6.
- If the current software version shown in 'General Settings' is 230203 - (Feb 03, 2023) or newer, **this TSB does not apply.**

10. Once the update has completed, repeat steps 3-5 to confirm the Software Version has been correctly updated.

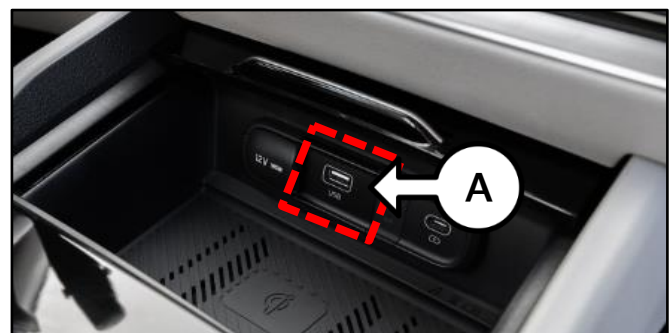
6. Insert the USB Flash Drive (refer to the table below) into the USB slot (A) located underneath the AVN unit.

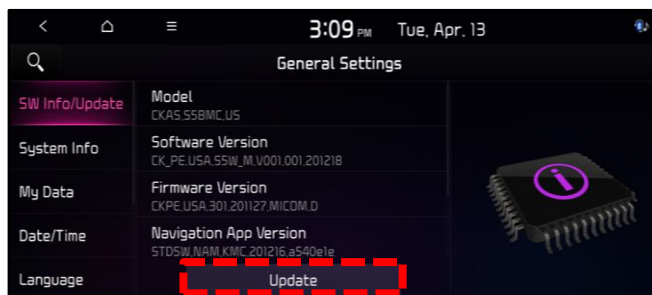
- On the 'General Settings' screen, select 'SW Info/Update', then select 'Update'.

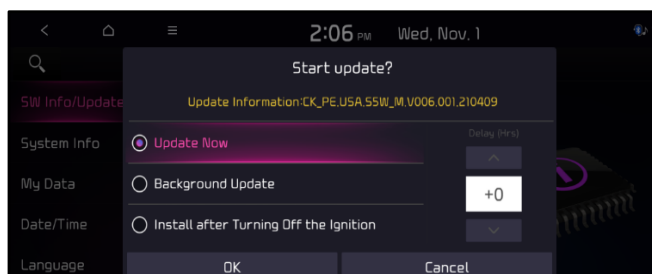
- Select 'OK' on the pop-up screen.

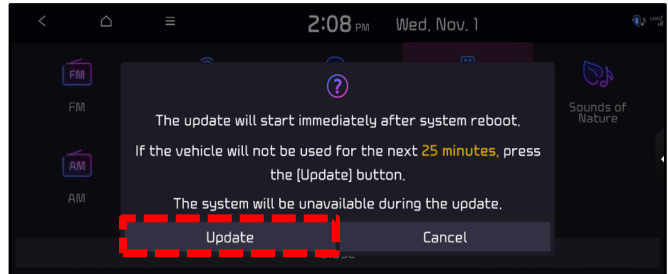
9. Select 'Update' on the pop-up screen.

Note: In some cases, the software update may take up to 2 hours and 30 minutes to complete. During this dwell time, it is acceptable to work on other vehicles.
