# Service Bulletin

CRF1100L/LD/L4/L4D #2

### 2022 CRF1100L/LD/L4/L4D AFRICA TWIN ECU UPDATE

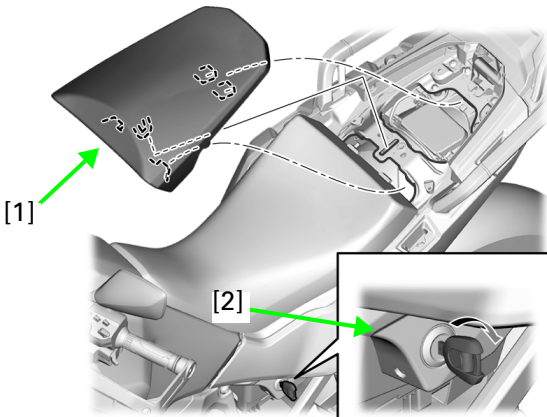
1. Connect the MCI to the computer using the USB cable.
2. Locate the DLC connector by unlocking the pillion seat [1] using the key [2]. Remove the pillion seat.
  - Refer to the service manual for instructions.

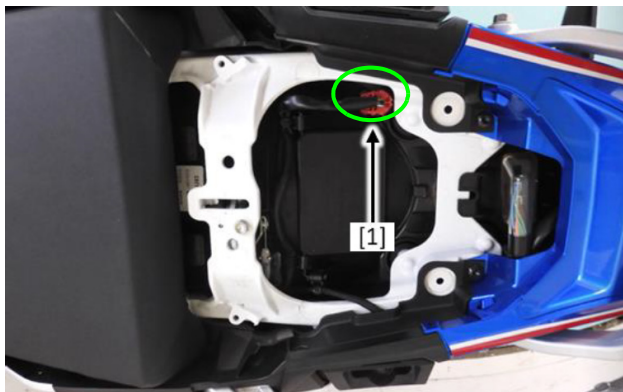
3. Remove the dummy connector from the DLC connector [1], and then connect the MCI to the DLC connector.

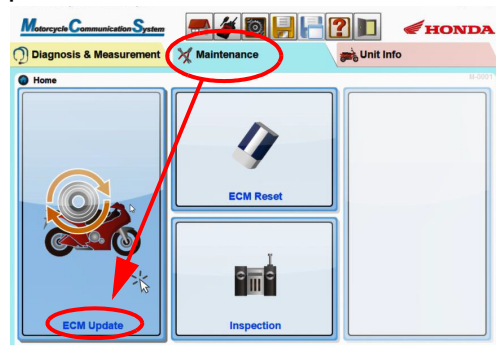
2. Select the Maintenance tab then ECM Update.

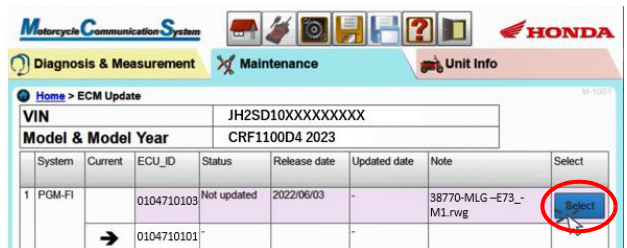
3. Select the PGM-FI file from the table as shown, click the Select button next to the software revision file.

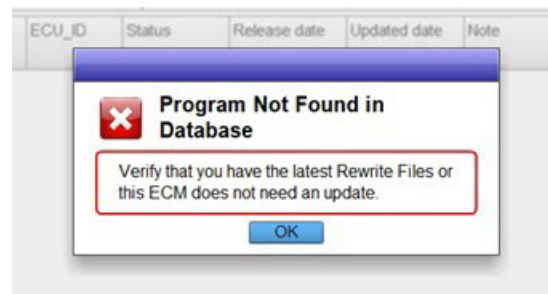
**Note:** If files are not saved correctly, an error may appear like shown below. Check the files are uploaded in the correct location (see Download the ECM Update File section above).

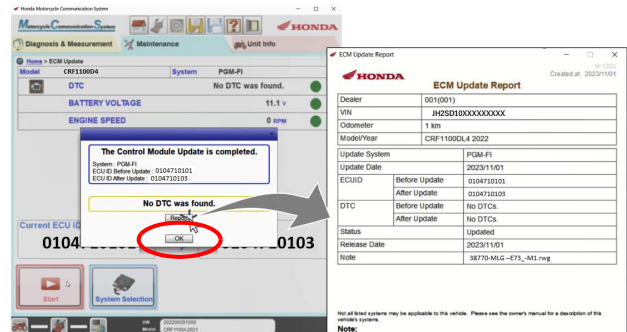
6. When the **Control Module Update Completed** window appears, click **OK**.

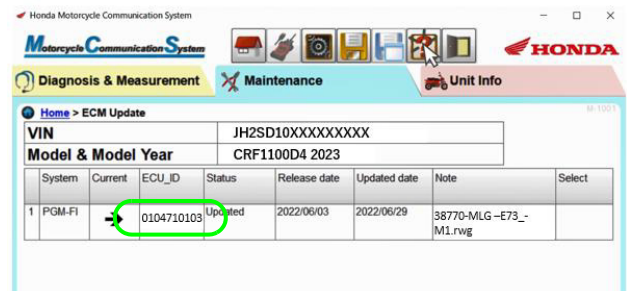
The ECU ID should change from 0104710101 (depending on the model and year) to 0104710103.

\* The leading eight (8) digits of the ECU ID will vary based on the model and year.

\*See image below
