**TECHNICAL INSTRUCTIONS**  
**FOR**  
**SPECIAL SERVICE CAMPAIGN 23TC06**  
**Electronic Parking Brake (EPB) DTC C059704**  
**Certain 2022 & 2023 Model Year Tundra**

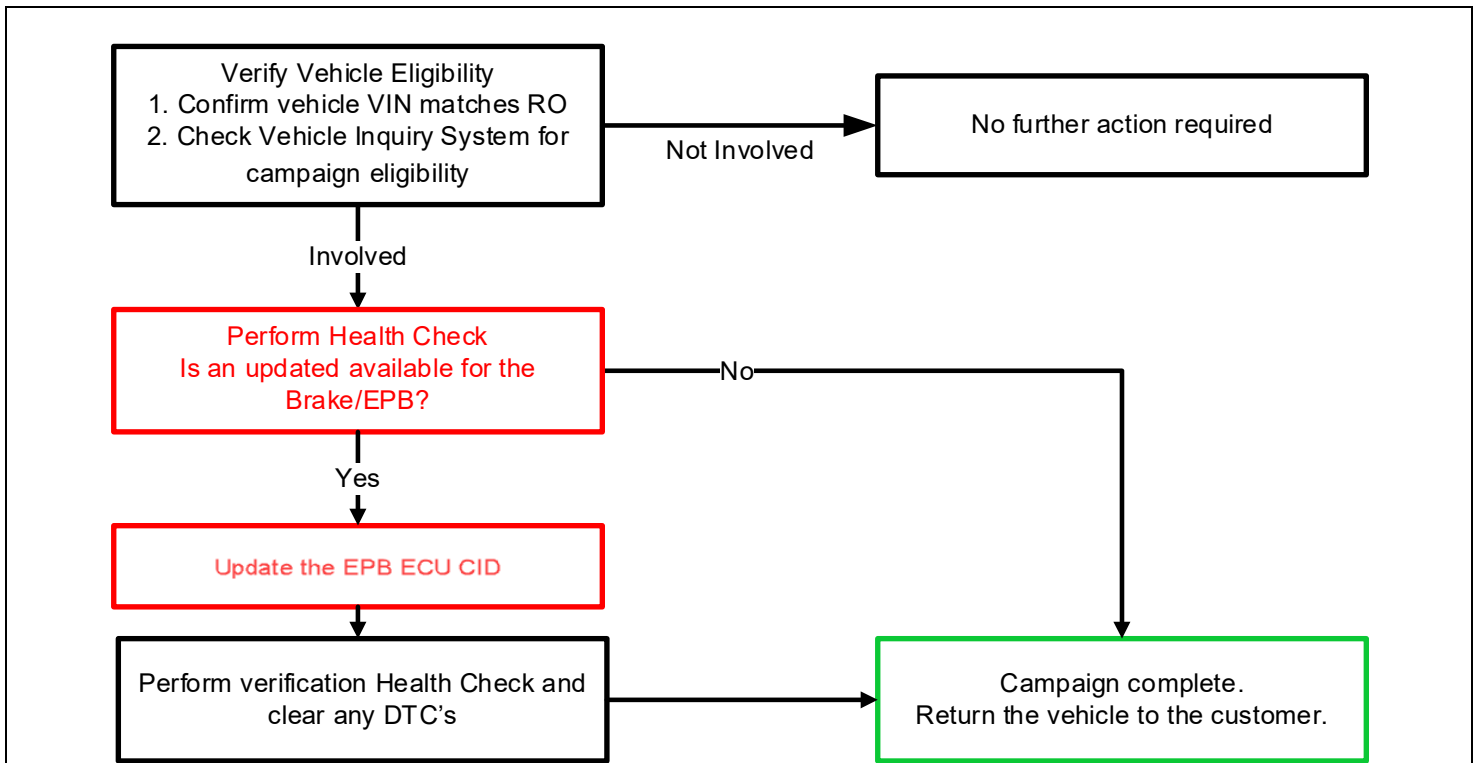
## I. OPERATION FLOW CHART

The flow chart is for reference only. **DO NOT** use it in place of the full technical instructions. Follow **ALL** steps as outlined in the full technical instructions to confirm the campaign is completed correctly.

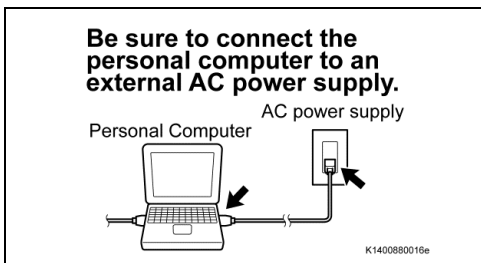
### 1. STABILIZE THE POWER TO THE PERSONAL COMPUTER SIDE

- a) Be sure to connect the personal computer to an external AC power supply.

The ECU could be damaged if the battery voltage of the personal computer drops while reprogramming.

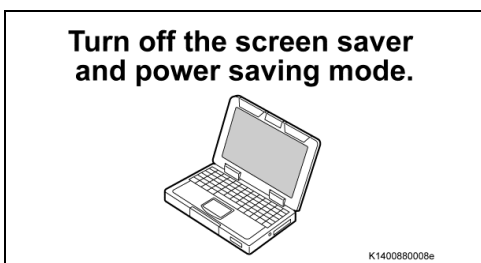
- b) Turn off the screen saver and power saving mode of the personal computer so that the power to the hard disk is kept supplied.

If the screen saver or power saving mode launches while reprogramming, the communication may be disconnected, resulting in the damage of the ECU.

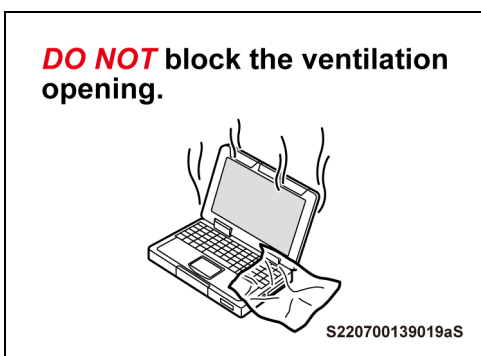
- c) **DO NOT** block the ventilation opening for the cooling fan of the personal computer.

If the ventilation opening for the cooling fan is blocked with a sheet cover or the like, the personal computer may be heated excessively, causing the operation of the personal computer to stop. Due to the stop of the operation, the communication for reprogramming signals could be stopped, resulting in the damage of the ECU.

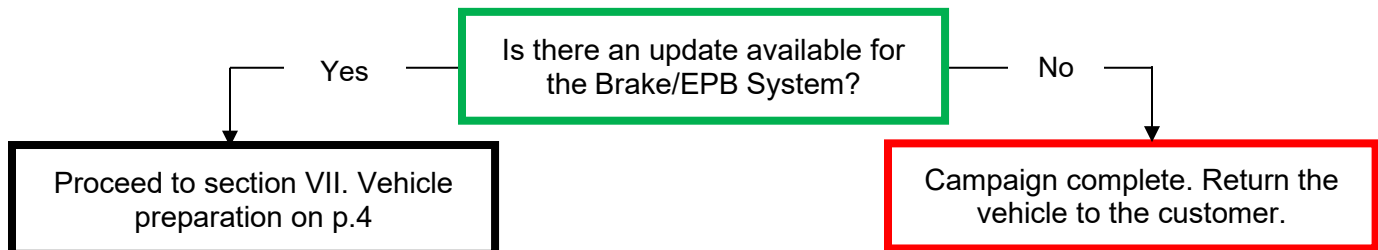
### 2. CHECK CURRENT CALIBRATION

- Locate the Update column for the Brake/EPB System in the Health Check tab for this vehicle (Click the "+" to the left of the System to expand the system menu).
- Determine the status of an available update; indicated by a YES or NO.

**HINT: If the CID's indicate 'Yes', proceed with the update procedure.**

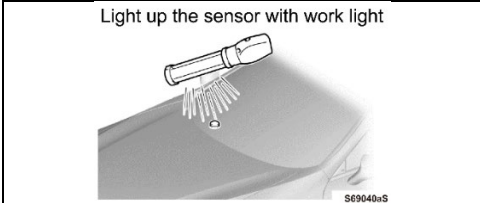
a) Confirm the following conditions:

- Vehicle in the IG position (engine off).
- Transmission in Park.
- Parking brake engaged.

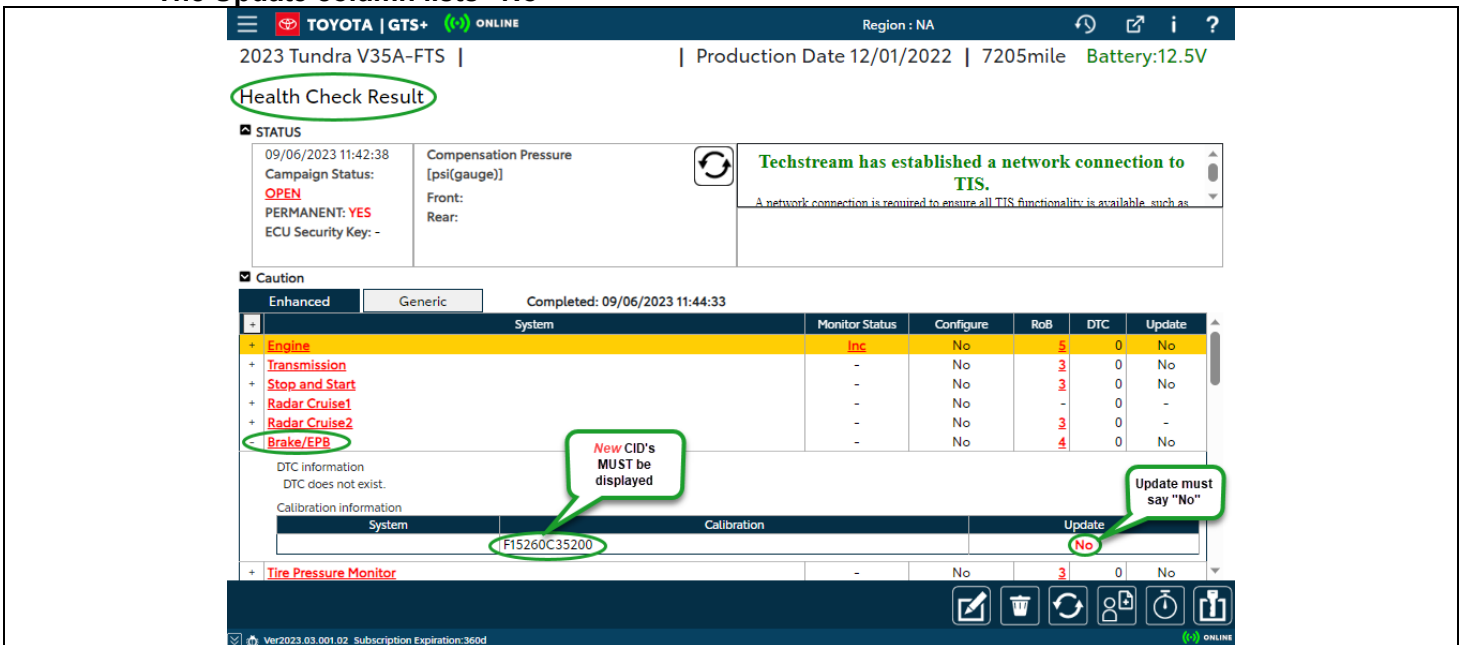
### 3. CONFIRM CID UPDATE

- On the Stored Data tab, confirm the following for the Brake/EPB System:
  - The Calibration number has the "New CID" number.
  - The Update column lists "No"

Confirm the CID's has been updated successfully to the NEW CID's by someone other than the individual who performed the repair. Refer to p.5.

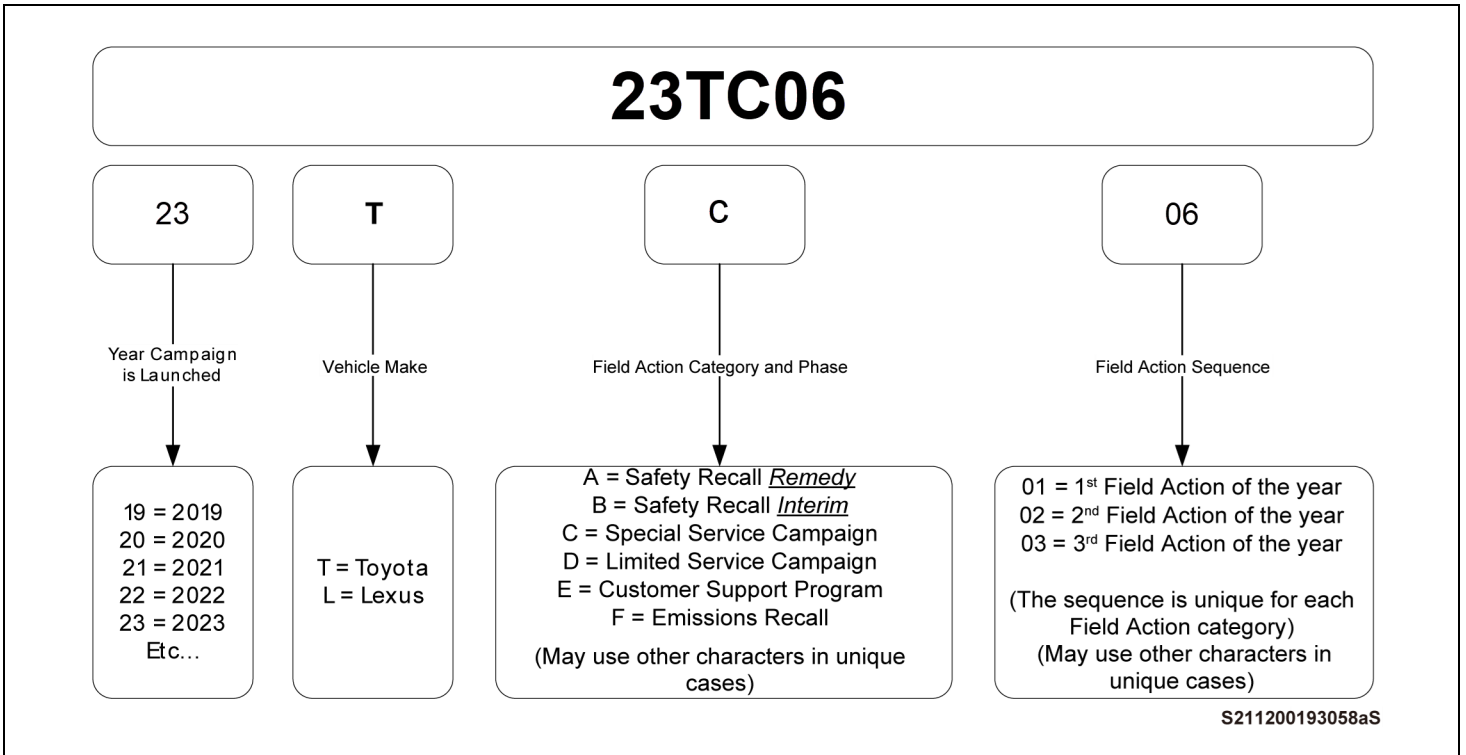
**A. CAMPAIGN DESIGNATION DECODER**

**Examples:**

- 19TA01 = Launched in 2019, Toyota, Safety Recall Remedy Phase, 1st Safety Recall Launched in 2019**  
**20TC02 = Launched in 2020, Special Service Campaign, 2nd Special Service Campaign Launched in 2020**  
**21TE05 = Launched in 2021, Customer Support Program, 5th Customer Support Program Launched in 2021**
