GROUP	MODEL
ELE	2021-2023MY Seltos (SP2)
NUMBER	DATE
325	December 2023

## TECHNICAL SERVICE BULLETIN

### CLUSTER UPGRADE FOR INTERMITTENT DISPLAY RESTARTING

This bulletin provides information to upgrade the Cluster (CLU) software logic on certain 2021-2023MY Seltos (SP2) vehicles equipped with a 7 in. TFT display instrument cluster, produced from November 20, 2019 through March 2, 2023. The affected vehicles may exhibit the instrument cluster intermittently restarting after entering a destination into the navigation and starting route guidance. When the route guidance is cancelled, this concern is no longer present. Follow the procedure outlined in this publication to upgrade the CLU software to correct this concern on the applicable vehicle.

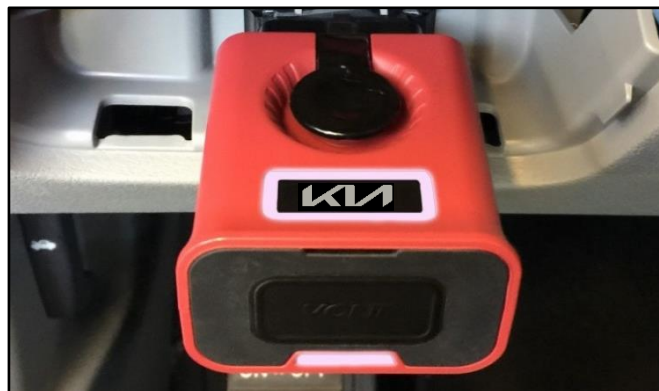
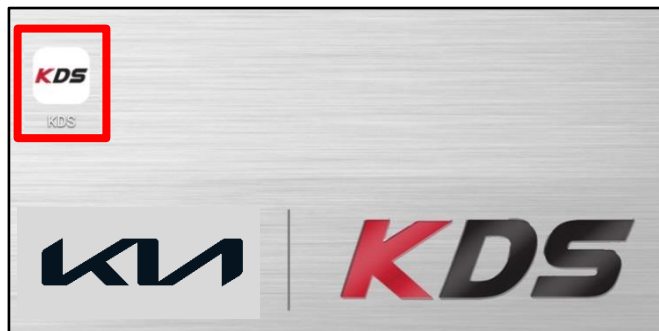
- With the ignition ON, turn ON the KDS tablet. Select 'KDS' from the home screen.

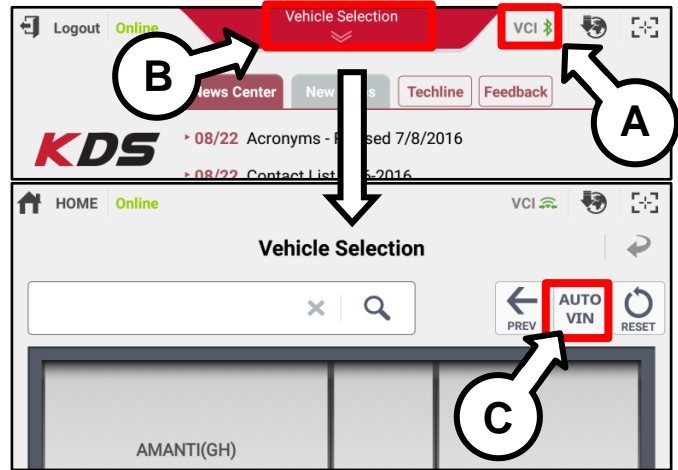
- Confirm communication with VCI (A) and then configure the vehicle (B) using the 'AUTO VIN' (C) feature.

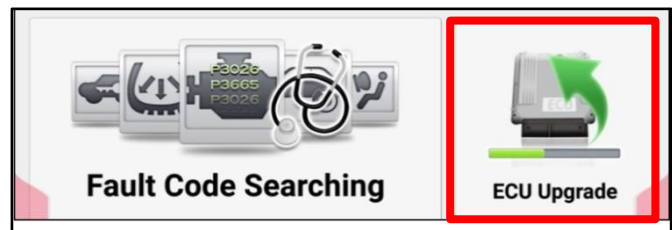
- Select 'ECU Upgrade'.

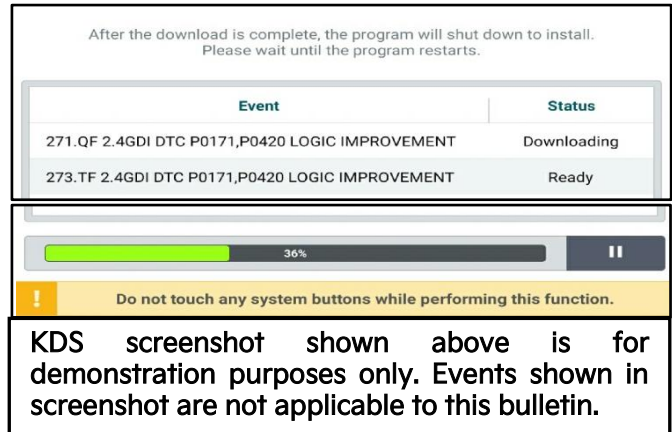
- The KDS will check the server for recently uploaded Events and then automatically download Upgrade Event #694.

The vehicle must be identified in Vehicle Selection to download an Event for that vehicle.

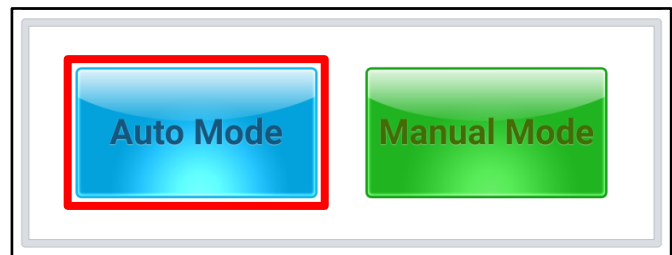
- Select Auto Mode.

Do NOT attempt to perform a Manual Mode upgrade UNLESS Auto Mode fails. Always follow the instructions given on the KDS in either Auto or Manual mode.

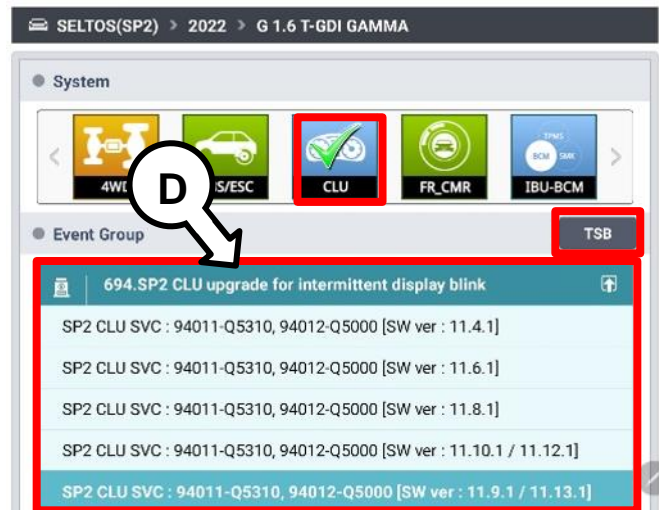
- Select 'ENGINE' system and applicable 'Event Group' (D) for the vehicle:

**Event #694.SP2 CLU upgrade for intermittent display blink**

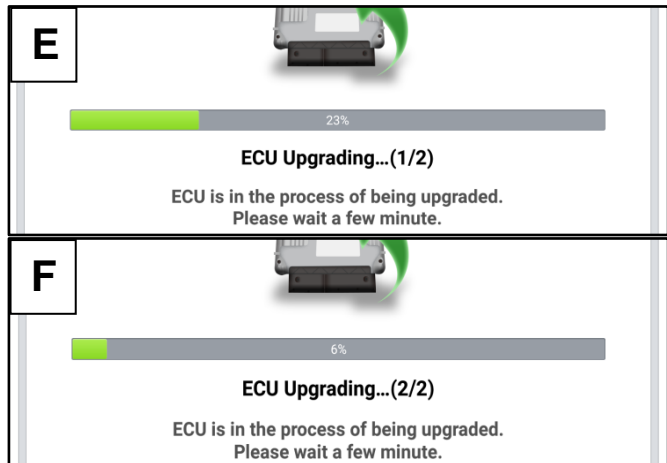
- The ECU upgrade will begin, and the progress of the upgrade will appear on the bar graph. Upgrade part (1/2) (E) will download the upgrade event to the VCI-II. Upgrade part (2/2) (F) will upgrade the ECU.

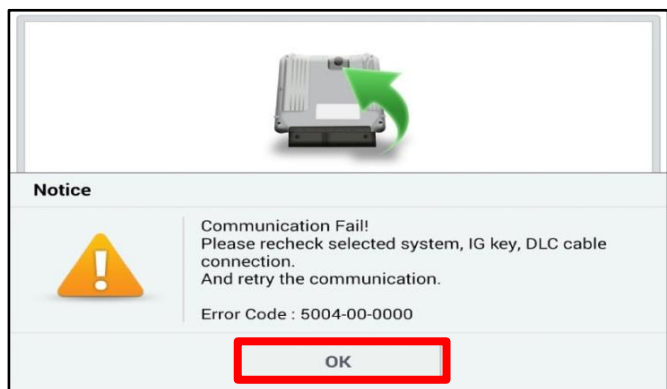
- If a "Communication Fail" screen appears, verify that the VCI-II and KDS are communicating properly. Select 'OK' and restart the from step 4.

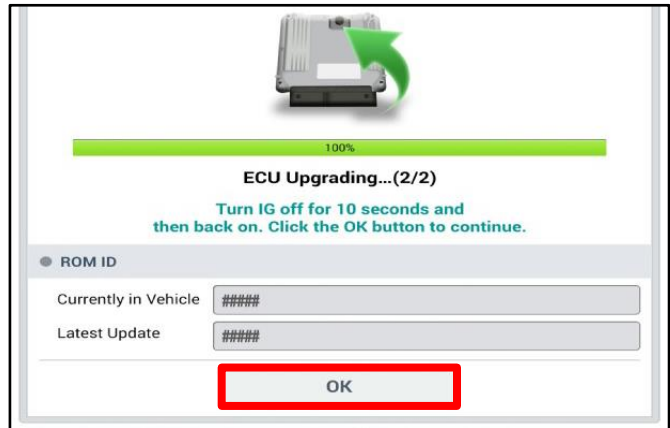
10. When instructed on the KDS, turn the ignition **OFF** for ten (10) seconds then back on. Select **'OK'** to continue.

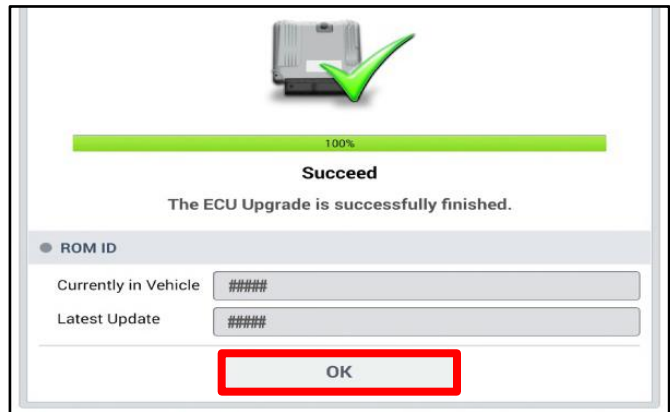
11. Once the upgrade is complete, select **'OK'** to finalize the procedure.

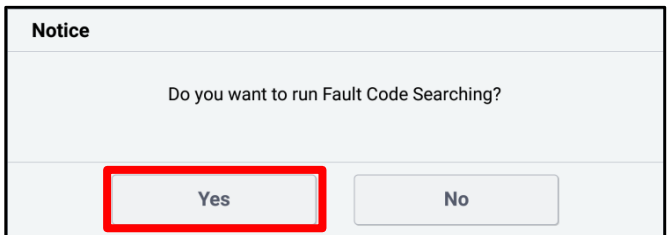
12. When prompted, select **'YES'** to check for Diagnostic Trouble Codes (DTC) and erase any DTCs stored such as EPS, ESC, and TPMS that may have been set during the upgrade.
