# Technical Service Bulletin

<b>Subject:</b>  NO SOUND FROM AUDIO SYSTEM OR UNABLE TO CHANGE AUDIO SOURCE	<b>Bulletin No.:</b> 09-039/23
	<b>Last Issued :</b> 12/12/2023

2024 CX-90 vehicles with VINs lower than JM3 KK\*\*\*\* \*\* 126101 (Produced before July 31, 2023)

2022-2023 MX-30 vehicles with VINs lower than JM1DR\*\*\*\*\*200910 (Produced before May 30, 2023)

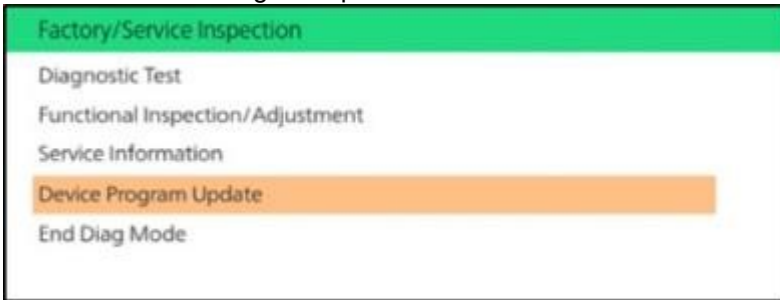
9. Select "Device Program Update" on the screen below.

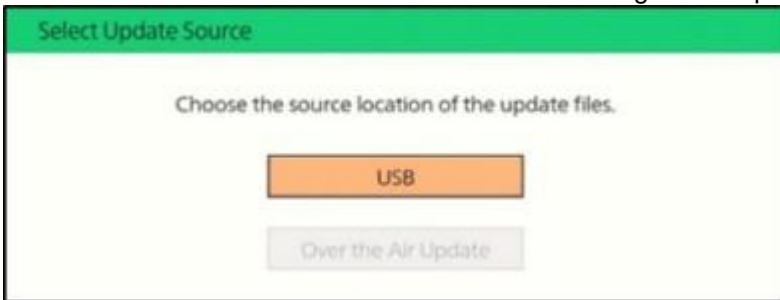
11. Select "USB" on the screen below to start checking for the update file.

**NOTE:** If the "Update file(s) not found" message appears, the wrong file may be stored in the USB flash drive or the vehicle has already been updated.

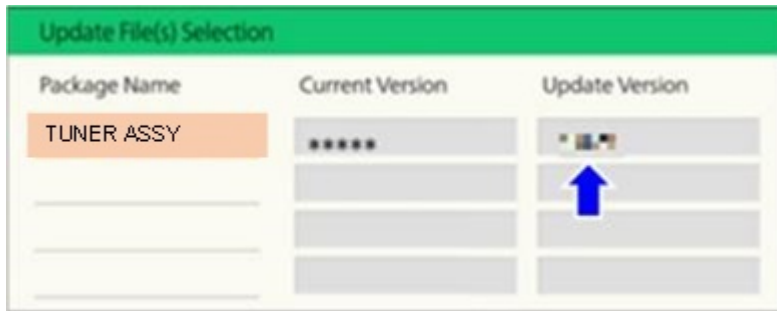
12. Confirm the correct software version is shown under "Update Version" and select "TUNER ASSY" on the screen below.

Update Version

(Refer to step 4)

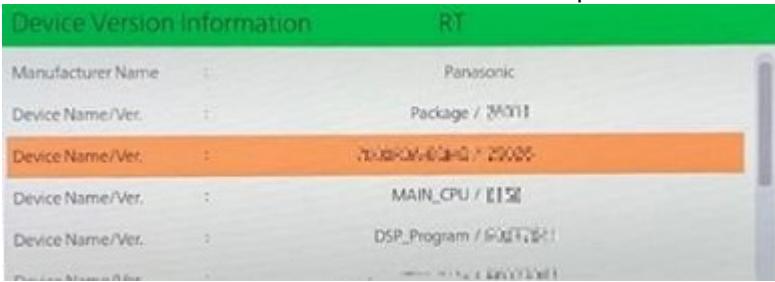
21. Confirm that the software version has been updated.

File Name

(Refer to step 4)
