Technical Service Bulletin

Mazda North American Operations
Irvine, CA 92618-2922

| Subject: DTC U3000:04-TCU STORED AFTER CONNECTED SERVICE CONTRACT HAS BEEN DISCONTINUED | Bulletin No.: 09-001/23 |

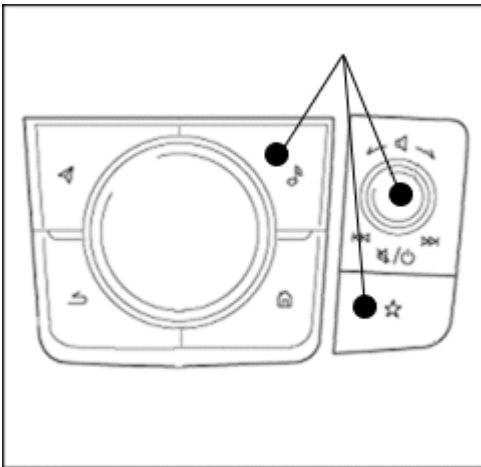
Mazda3, CX-30, MX-30 and CX-50

g. Press and hold the Volume knob, then press and hold the Entertainment and Favorites buttons at the same time for 3-5 seconds and the Factory/Service Inspection screen will appear.

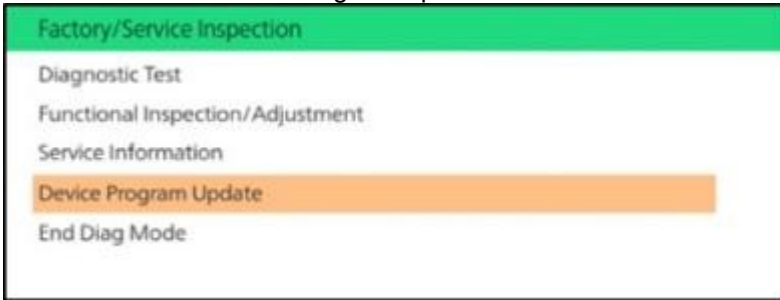
h. Select "Device Program Update" on the screen below.

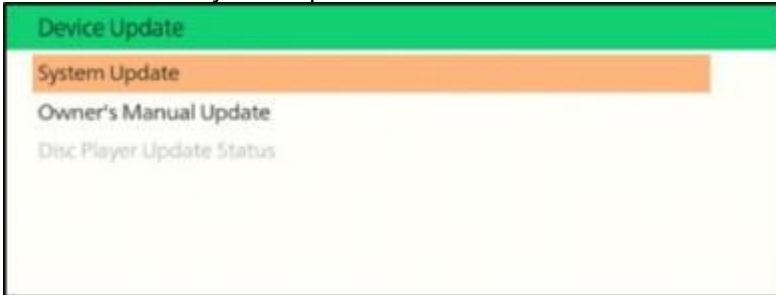
i. Select "System Update" on the screen below

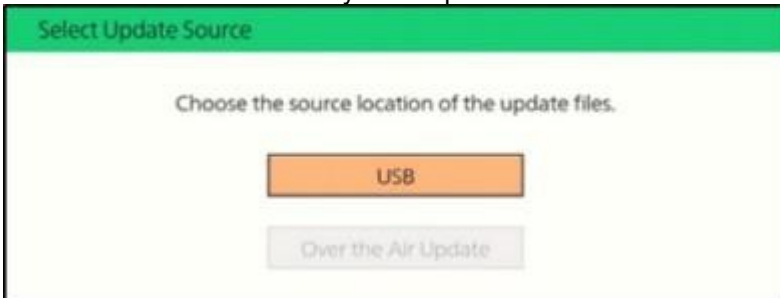
j. Select "USB" on the screen below to start checking for the update file.

NOTE: If "Update file(s) not found" message appears, the wrong file may be stored on the USB memory stick or the vehicle has already been updated.

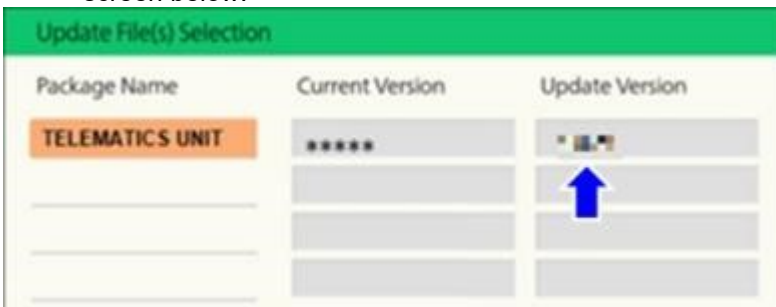
k. Confirm the correct software version is shown under "Update Version" and select "TELEMATICS UNIT" on the screen below.

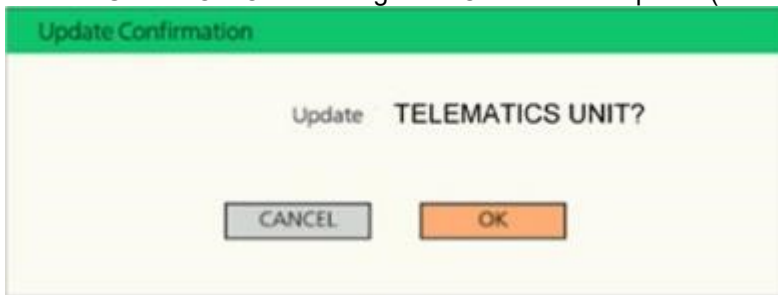
l. Select "OK" on the screen below and wait until the update (loading) is completed.

NOTE: DO NOT switch ignition OFF until the update (loading) is completed.

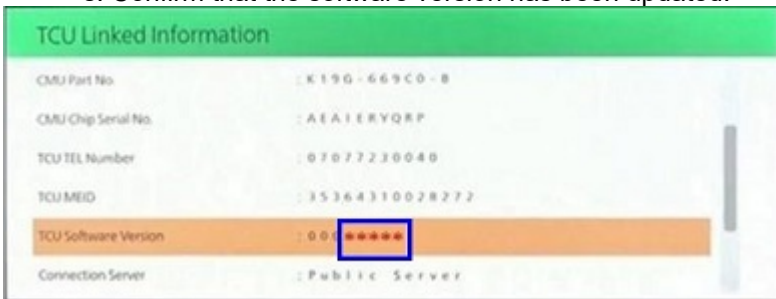
r. Select "TCU Linked Information", then scroll down to TCU Software Version.

s. Confirm that the software version has been updated.
