REFERENCE:	TSB: 08-244-23 GROUP: 08 - Electrical	Date:	November 15, 2023	REVISION:	-						
VEHICLES AFFECTED:	<p>2023 (DT) RAM 1500 Pickup 2023 (DJ) RAM 2500 Pickup 2023 (DD) RAM 3500 Cab Chassis 2023 (D2) RAM 3500 Pickup 2023 (DP) RAM 4500/5500 Cab Chassis 2023 (DF) RAM <10K Cab Chassis</p> <ul style="list-style-type: none"> • This bulletin applies to DJ, DD, D2, DP, DF vehicles, equipped with of the Uconnect 5 W 8.4" Display (Sales Codes UFD, UPD UBD and UED) built on or before July 10, 2023 (MDH 0710XX). • This bulletin applies to DT vehicles, equipped with of the Uconnect 5 W 8.4" Display (Sales Codes UFD, UPD UBD and UED) built on or before August 02, 2023 (0802XX). 			<p>MARKET APPLICABILITY:</p>

CAUSE:	Radio software

This bulletin involves inspecting the software level and updating the software with USB to R255.45.06.

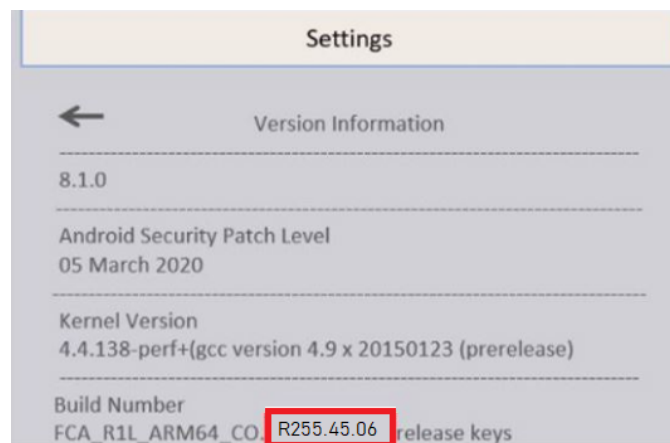
Fig. 1

1. On the radio display screen go into “Vehicle Settings”.
2. Select “System Information”.
3. Select “Version Information”.
4. Under the “Build Number”, radio software version is listed. For example, the software version here is R255.45.06 [Fig 1](#).

Radio Software Level Screen Example

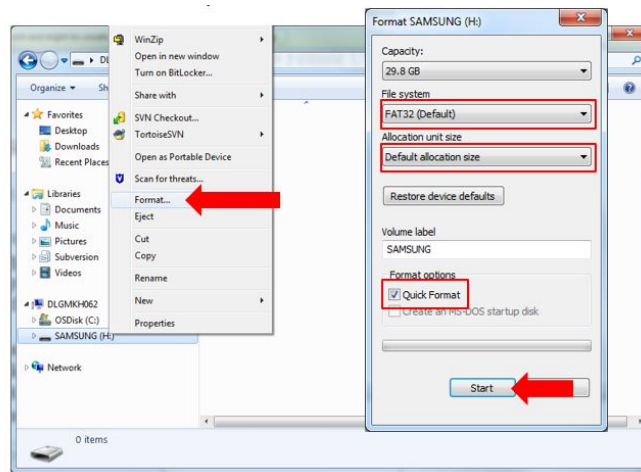
Fig. 2

Formatting The USB Flash Drive

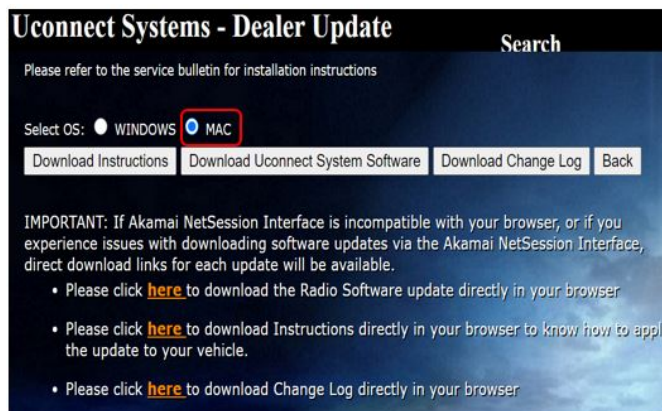
Fig. 3

- Use a blank USB flash drive with at least 4 GB of space. Follow the on-screen instructions to download the software files.
- Download the software update file to your local PC's desktop. Make sure to select the "MAC" radial button for all downloads Fig. 3.

MAC Download Steps

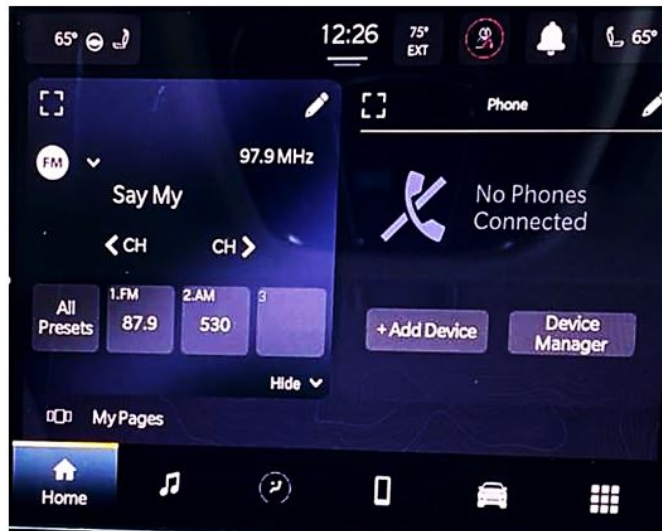
18. Start the vehicle and insert the USB flash drive into the USB port.
19. Vehicle must be out of “Ship Mode”. Starting at the radio ‘Home’ screen [Fig. 4](#).

Fig. 4
Home Screen

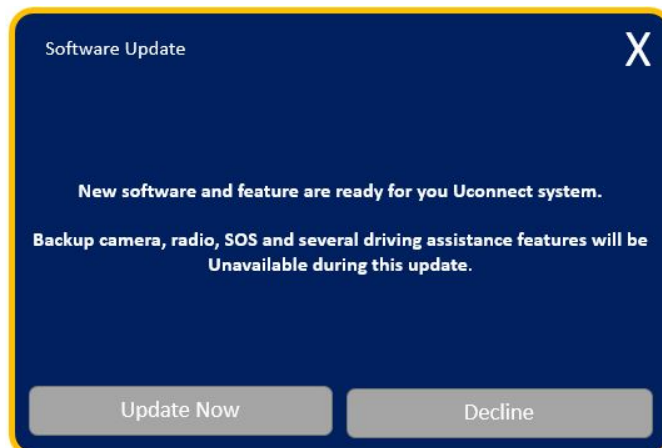
20. Insert the USB flash drive into the USB port.
21. The radio will prompt you if you want to update to the newest software version [Fig. 5](#).

Fig. 5
Software Update Screen

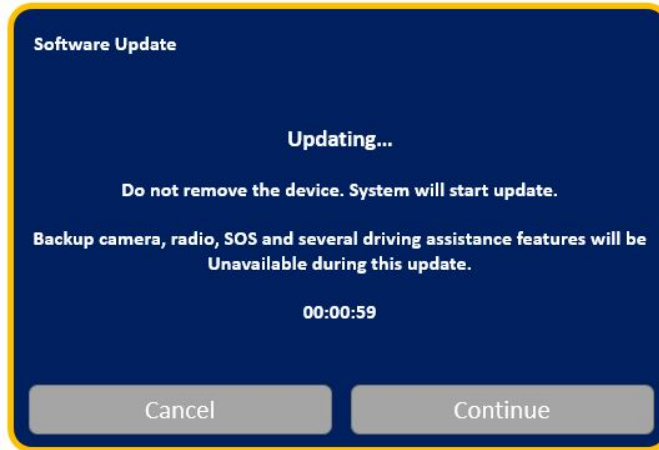
23. The radio will prompt you if you want to continue updating to the newer software [Fig. 6](#).

Fig. 6
Software Updating Screen

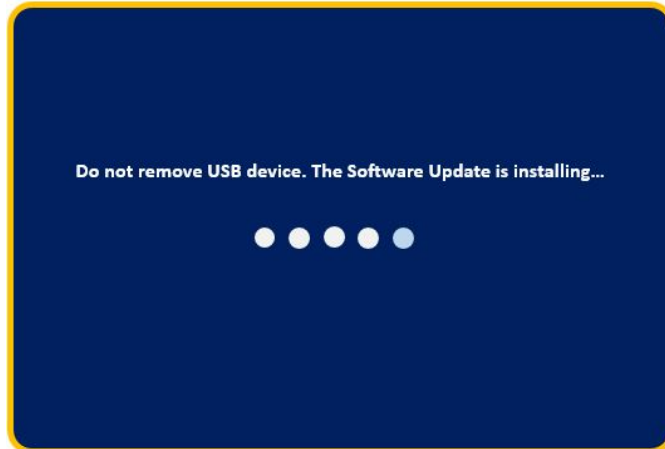
24. Select "Continue" [Fig. 7](#).

Fig. 7
Installing Update Screen

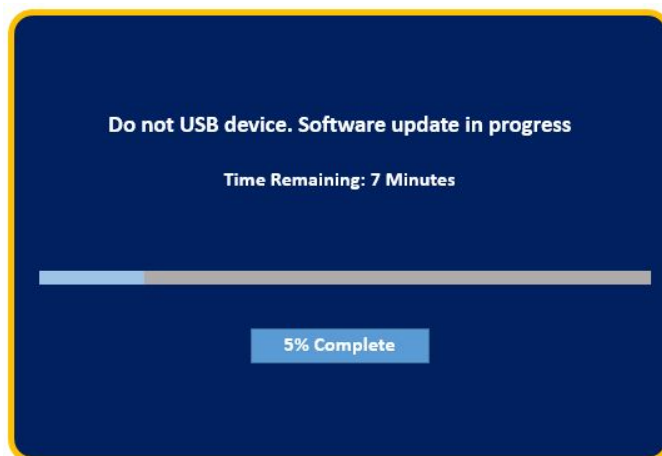
25. The update will take approximately 15-20 minutes [Fig. 8](#).

Fig. 8
Update In Progress Screen

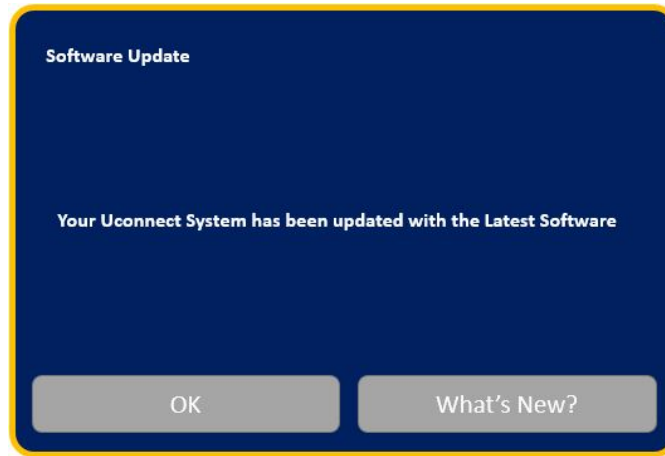
Fig. 9

26. The radio will reboot and you will observe the update screen after the splash screen once the update has been successful [Fig. 9](#).

Software Updated Screen
