Customer Satisfaction Program

N232425590 Inadvertent Trunk Opening

Release Date: January 2024

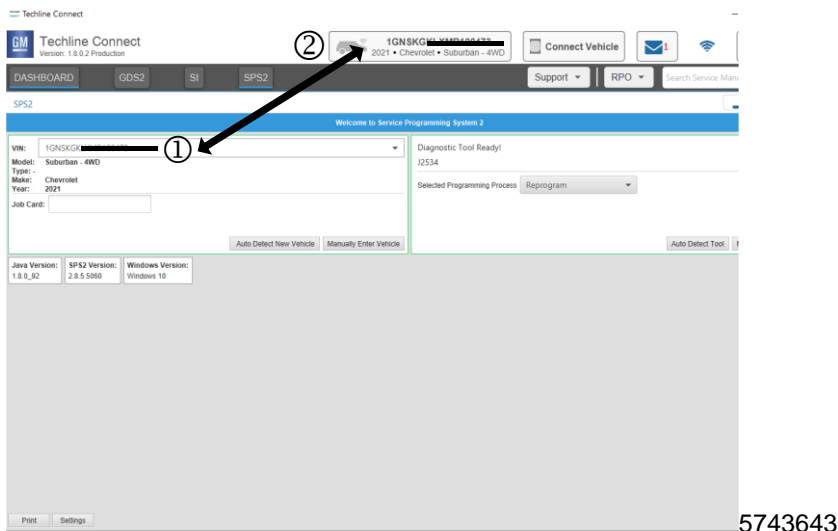
Caution: Be sure the VIN selected in the drop down menu (1) is the same as the vehicle connected (2) before beginning programming.

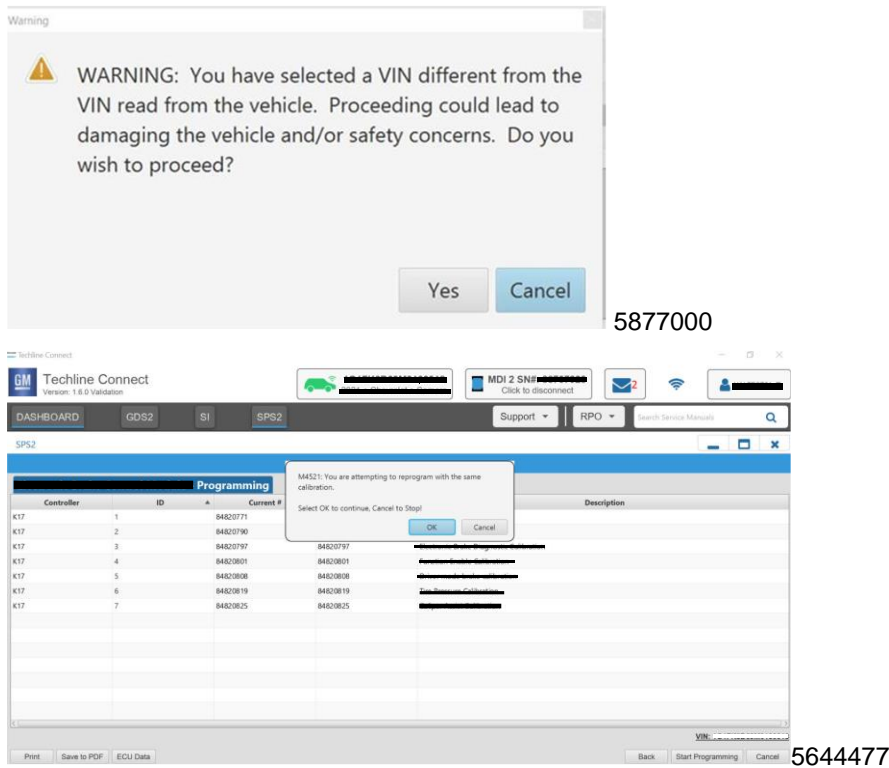
Important: If the vehicle VIN DOES NOT match, the message below will be shown.

Important: Techline Connect screens shown above.

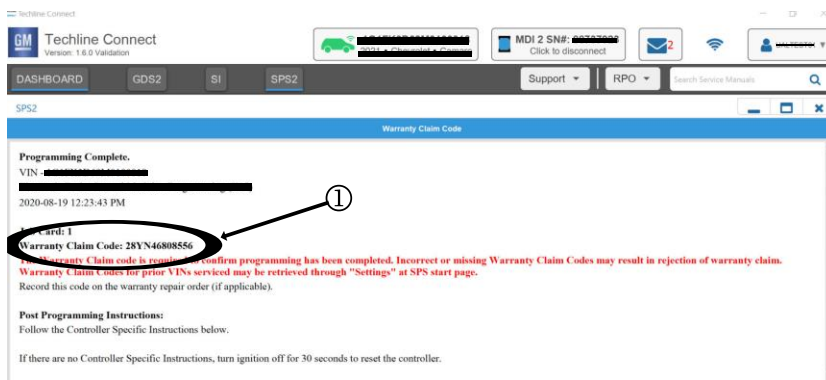
Note: The screenshot above is an example of module programming and may not be indicative of the specific module that is being programmed. Module selection and VIN information have been blacked out.

Important: To avoid warranty transaction rejections, you **MUST** record the warranty claim code provided on the Warranty Claim Code (WCC) screen shown above on the job card. Refer to callout 1 above for the location of the WCC on the screen.
