GROUP	MODEL
ELE	2024MY EV9 (MV)
NUMBER	DATE
326	January 2024

TECHNICAL SERVICE BULLETIN

SERVICE ACTION: POWER SEAT MODULE OPERATION LOGIC IMPROVEMENT (SA557)

This bulletin provides the procedure to update the software logic of the Power Seat Module (PSM) system on certain 2024MY EV9 (MV) vehicles produced from September 24, 2023 through November 6, 2023 to improve the front seat Easy Assist and Leg Rest operation, preventing the driver's leg rest from extending while driving. In addition, the software also improves the logic of the cargo area power folding seat buttons, so that the left seat will fold partially if the front row seat is too far back, which is the existing logic for the right seat. Follow the procedure outlined in this publication to apply the improved logic to the 'PSM' system using the KDS ECU Upgrade function as described in this bulletin. For confirmation that the latest reflash has been applied to a vehicle you are working on, verify the ROM ID using the table on page 6 of this bulletin.

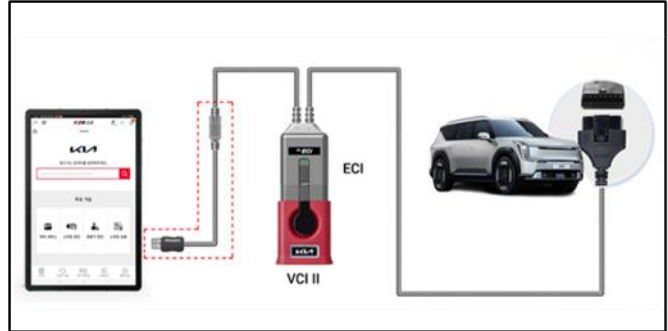
- 1a. Connect the ECI DLC connector to the OBD-II connector, located under the driver’s side of the instrument panel.
- 1b. Connect the ECI USB C connector to the KDS tablet.
- 1c. Connect the VCI II to the ECI OBD-II connector
2. Select ‘OK’.

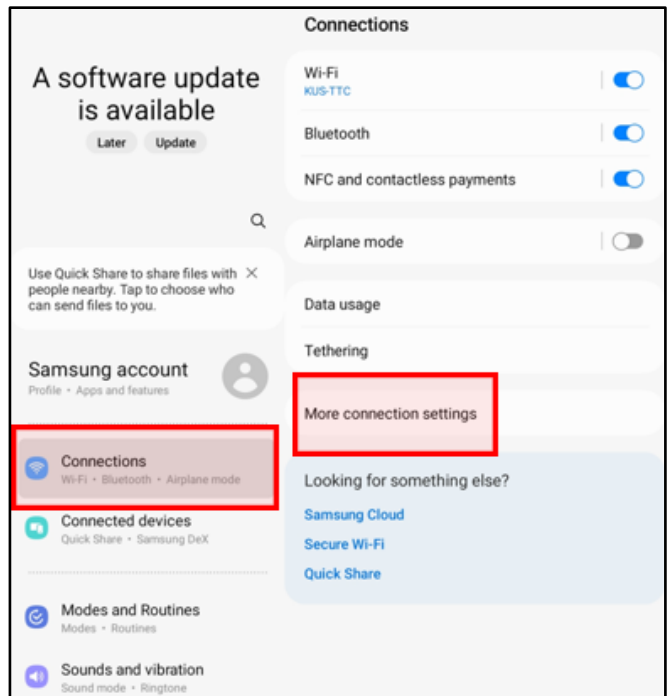
- 3a. Select ‘Settings’ on the KDS tablet.
- 3b. Select ‘Connections’.
- 3c. Select ‘More connection settings’.

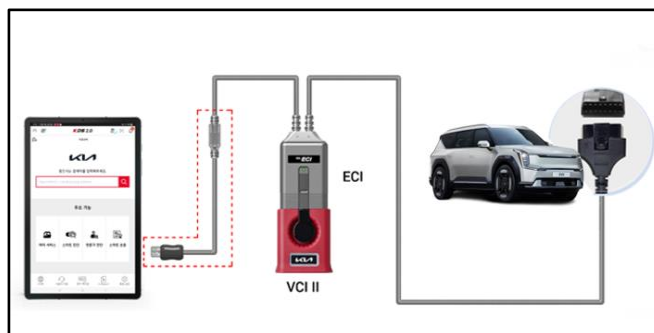
- 1a. Connect the ECI DLC connector to the OBD-II connector, located under the driver's side of the instrument panel.
- 1b. Connect the ECI USB C connector to the KDS tablet.
- 1c. Connect the VCI II to the ECI OBD-II connector

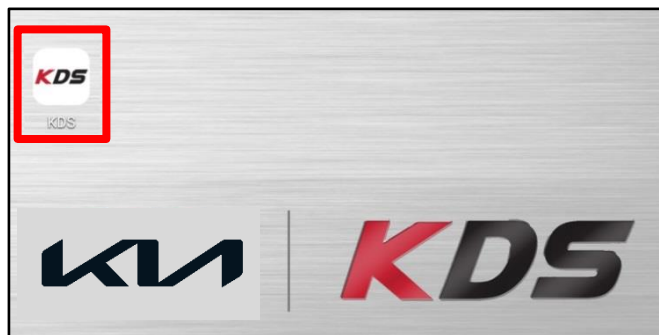
2. With the ignition **ON**, turn **ON** the KDS tablet. Select '**KDS**' from the home screen.

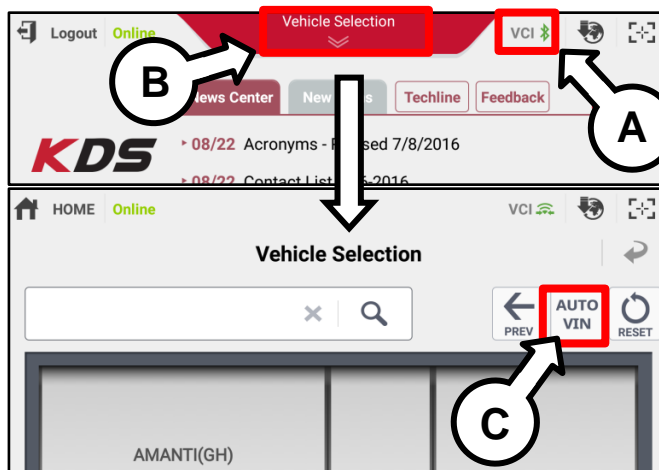
3. Confirm communication with VCI (A) and then configure the vehicle (B) using the 'AUTO VIN' (C) feature.

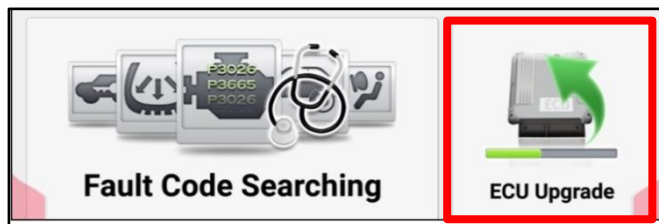
4. Select 'ECU Upgrade'.

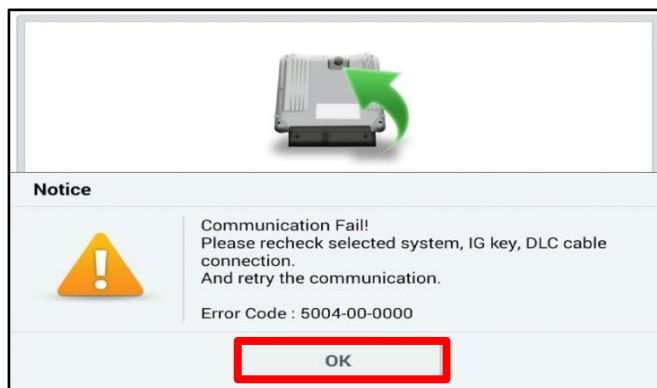
9. If a "Communication Fail" screen appears, verify that the VCI-II and KDS are communicating properly. Select 'OK' and go back to step 4.

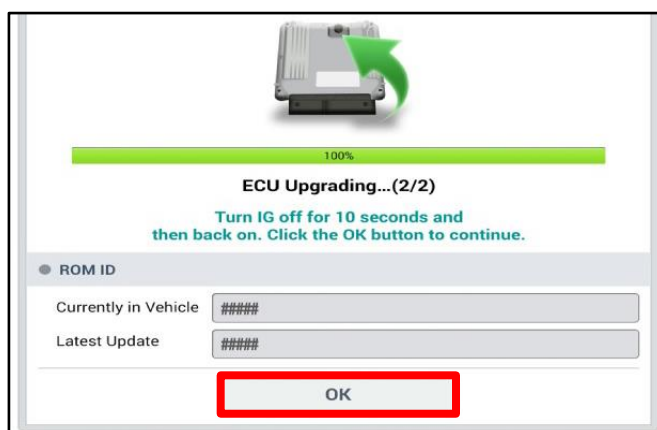
10. When instructed on the KDS, turn the ignition OFF for ten (10) seconds then back on. Select 'OK' to continue.

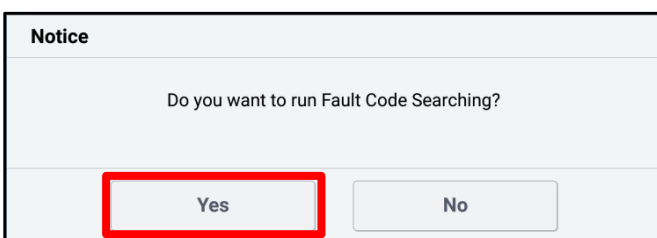
12. When prompted, select 'YES' to check for Diagnostic Trouble Codes (DTC) and erase any DTCs stored such as EPS, ESC, and TPMS that may have been set during the upgrade.
