Subject: N232409842 - Service Update  
Fuel Injector Flow Rate Control

Models: 2023 Chevrolet Silverado 1500  
2023 GMC Sierra 1500  
Equipped with ENGINE-GAS, 4 CYL, L4, 2.7L, SIDI, VVT, TURBO,  
DOHC, ALUM (RPO L3B)

## N232409842 Fuel Injector Flow Rate Control

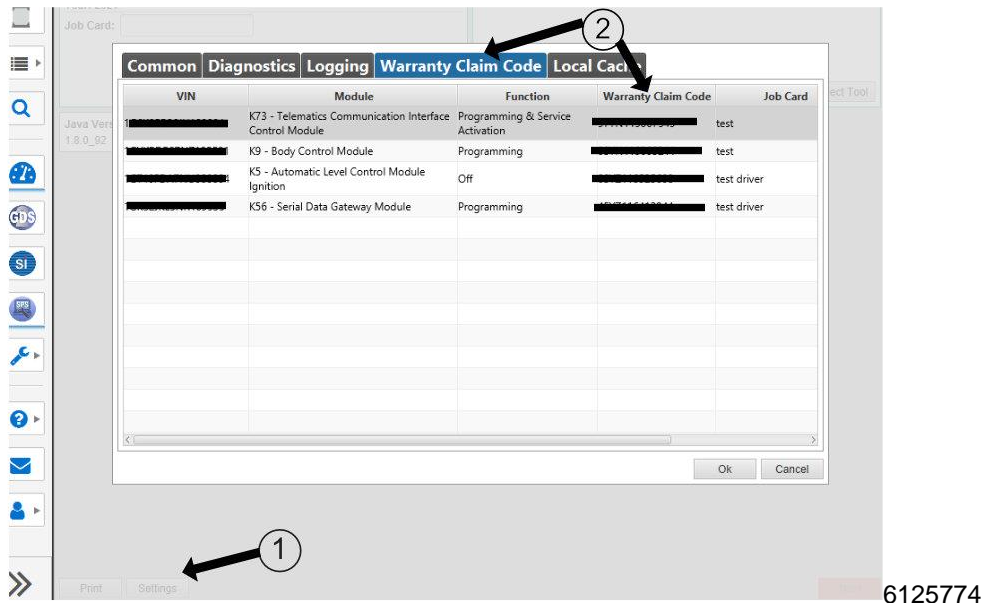
If the Warranty Claim Code was not recorded on the Job Card, the code can be retrieved in the SPS2 system as follows:

1. Open TLC on the computer used to program the vehicle.
2. Select and start SPS2.
3. Select Settings (1).
4. Select the Warranty Claim Code tab (2).

The VIN, Warranty Claim Code and Date/Time will be listed on a roster of recent programming events. If the code is retrievable, dealers should resubmit the transaction making sure to include the code in the SPS Warranty Claim Code field.
