Technical Journal Title Unintentional VIDA Wi-Fi Connection Leading to 12V Battery Drain		Ref. No. TJ 36426.1.2	
Issuer (Dept.) Technical Service		Issue Date 1/4/24	Status Date 1/4/24
Car Market United States and Canada	Partner 3 US 7510 Volvo Car USA	Function Group 3111	
Function Description Battery, complete		Page Page 1 of 52

SUPPORT DOCUMENT FOR HELPDESKS

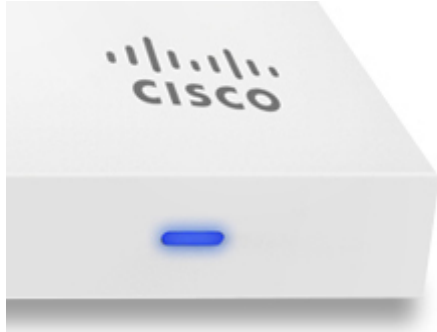
Access Points mounted at correct location and connected according to the installation Guide.

During normal working conditions, the LED indicator on the AP will be:

- Green - AP in Gateway mode with no clients
- Blue - AP in Gateway mode with clients

- Blinking Orange - AP can't find uplink
- Led not lit – No power supply or broken AP

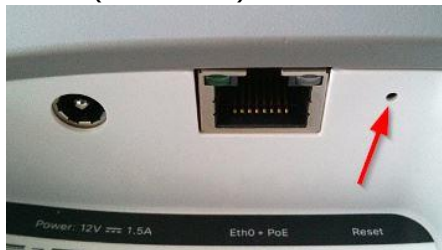
MR33 (Indoor AP)

The reset button is located adjacent to the power and Ethernet ports on the AP. Exact location will vary by model. Example for model:

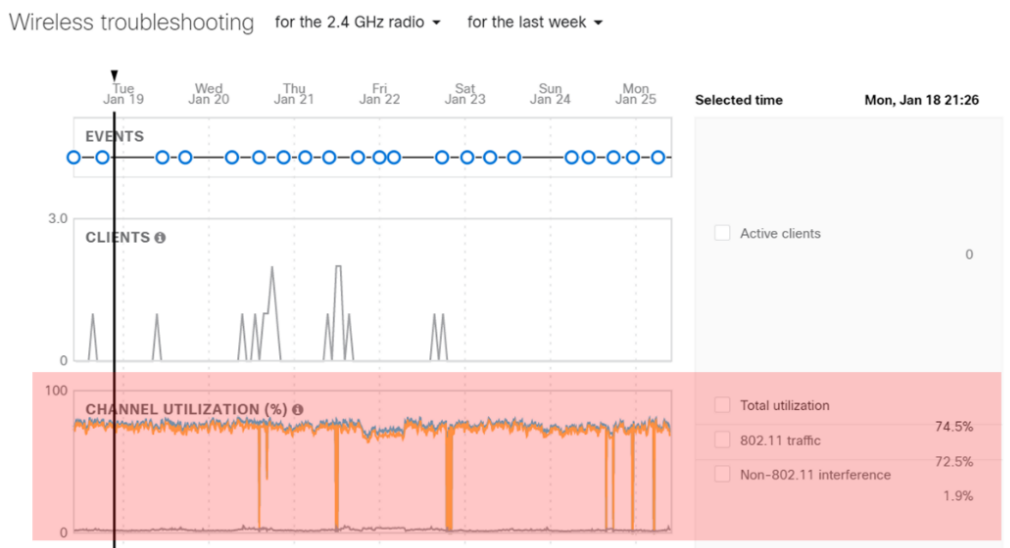
Option 2: Navigate to **Wireless -> Access points** and click on an access point. In the access point view click on the **RF** tab at the top of the window. Select **“for 2.4 GHz radio”** and **“for the last week”**. Check the channel utilization graph and see if there is high **802.11 traffic**. Analyze why the access point is seeing channel utilization: is it a constant high channel utilization? Is the channel utilization proportional to the number of clients connected to the AP and network usage? Are there specific time intervals with higher utilization? See figure below.

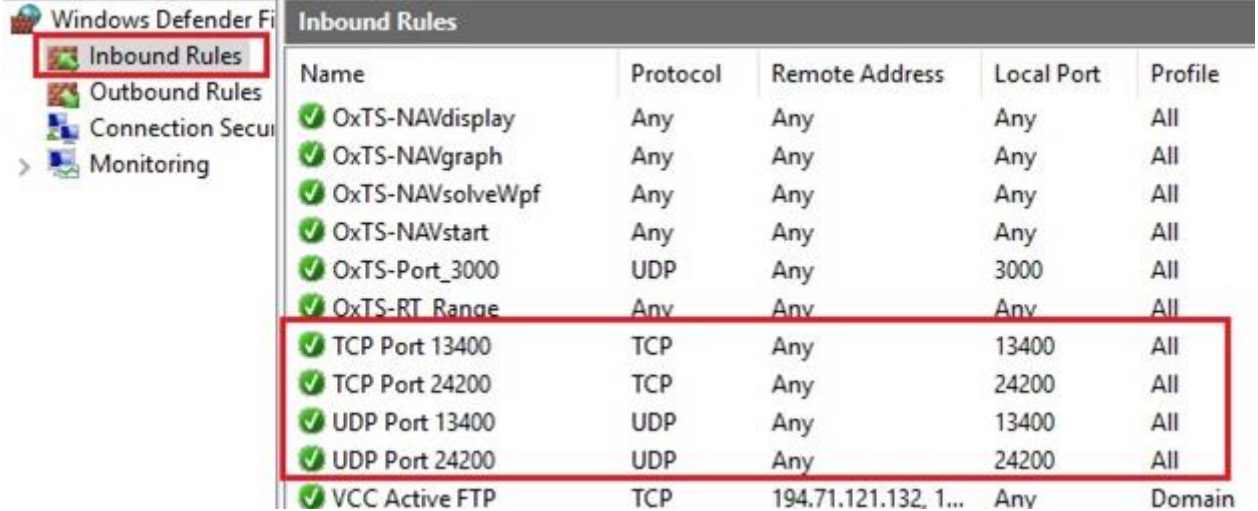
Vehicles appears in VIDA and below firewall rules have been added to the computer after the request has been approved and the computer has been restarted.

Name	Protocol	Remote Address	Local Port	Profile
✓ OxTS-NAVdisplay	Any	Any	Any	All
✓ OxTS-NAVgraph	Any	Any	Any	All
✓ OxTS-NAVsolveWpf	Any	Any	Any	All
✓ OxTS-NAVstart	Any	Any	Any	All
✓ OxTS-Port_3000	UDP	Any	3000	All
✓ OxTS-RT Range	Any	Any	Any	All
✓ TCP Port 13400	TCP	Any	13400	All
✓ TCP Port 24200	TCP	Any	24200	All
✓ UDP Port 13400	UDP	Any	13400	All
✓ UDP Port 24200	UDP	Any	24200	All
✓ VCC Active FTP	TCP	194.71.121.132, 1...	Any	Domain
