Service Action

Code: 97HC

Subject Vehicle Software Update 3.2.1

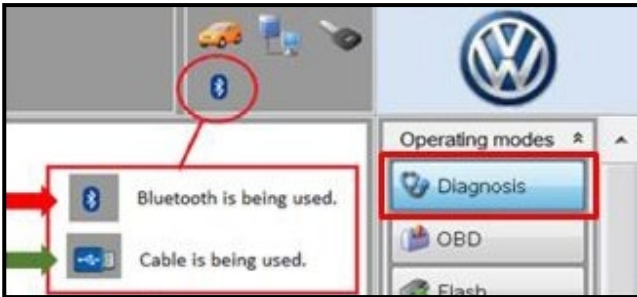
- Turn battery charger OFF, then back ON.
- Connect battery charger.
- Turn the hazards on.
- Confirm that scan tool is communicating with the diagnostic head by USB <Green Arrow>.
 - If the Bluetooth symbol is shown <Red Arrow> then disconnect the diagnostic head from the vehicle and reconnect the USB cable to the diagnostic head and then reattach to the vehicle.
- Upon ODIS startup, verify the “Diagnosis” operating mode is selected <as shown>.
- Once the GFF scan is complete, select “Special functions” <arrow 1>, then “Adapting software” <arrow 2>, then select “Perform test” <arrow 3>.
