# Service Bulletin

Bulletin No.: 23-NA-132

**Subject:** Turn Signals and/or Daytime Running Lights Intermittently Inoperable

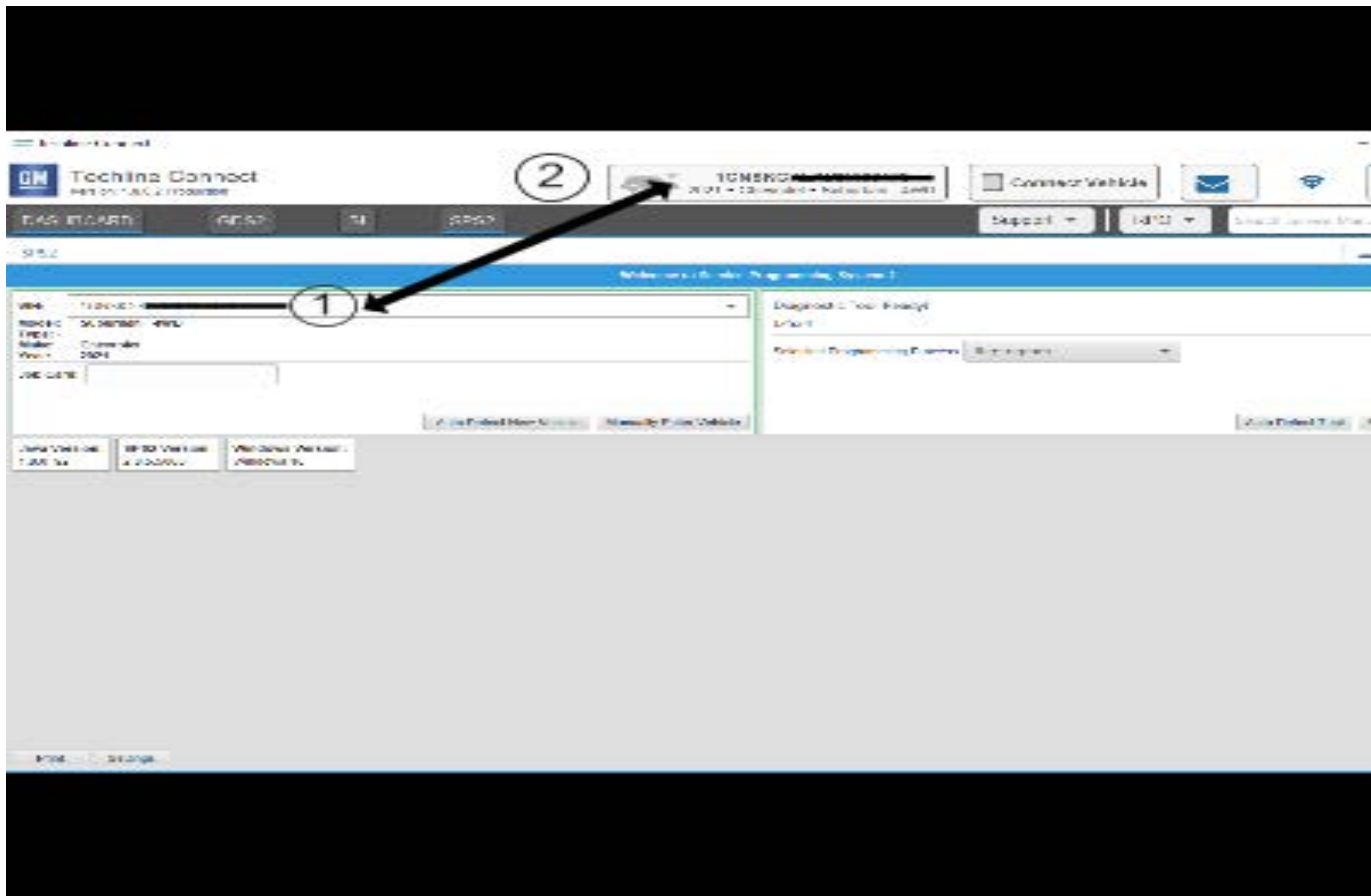
5743643

**Caution:** Be sure the VIN selected in the drop down menu (1) is the same as the vehicle connected (2) before beginning programming.

**Important:** Techline Connect screens shown above.

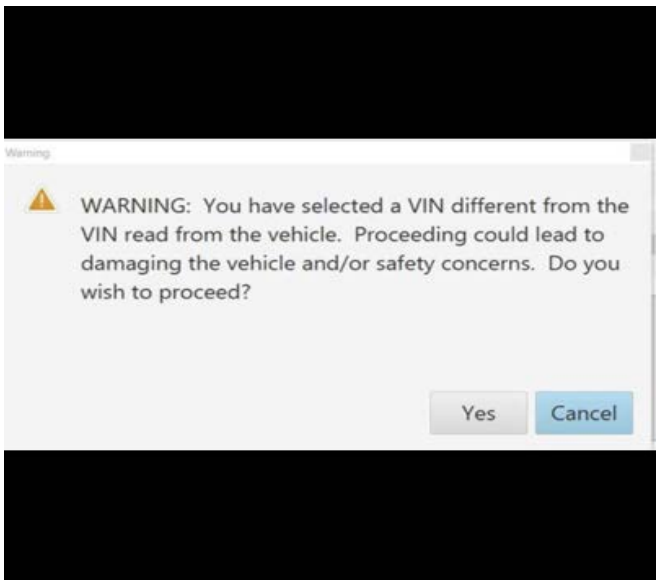
5877000

**Important:** If the vehicle VIN DOES NOT match, the message below will be shown

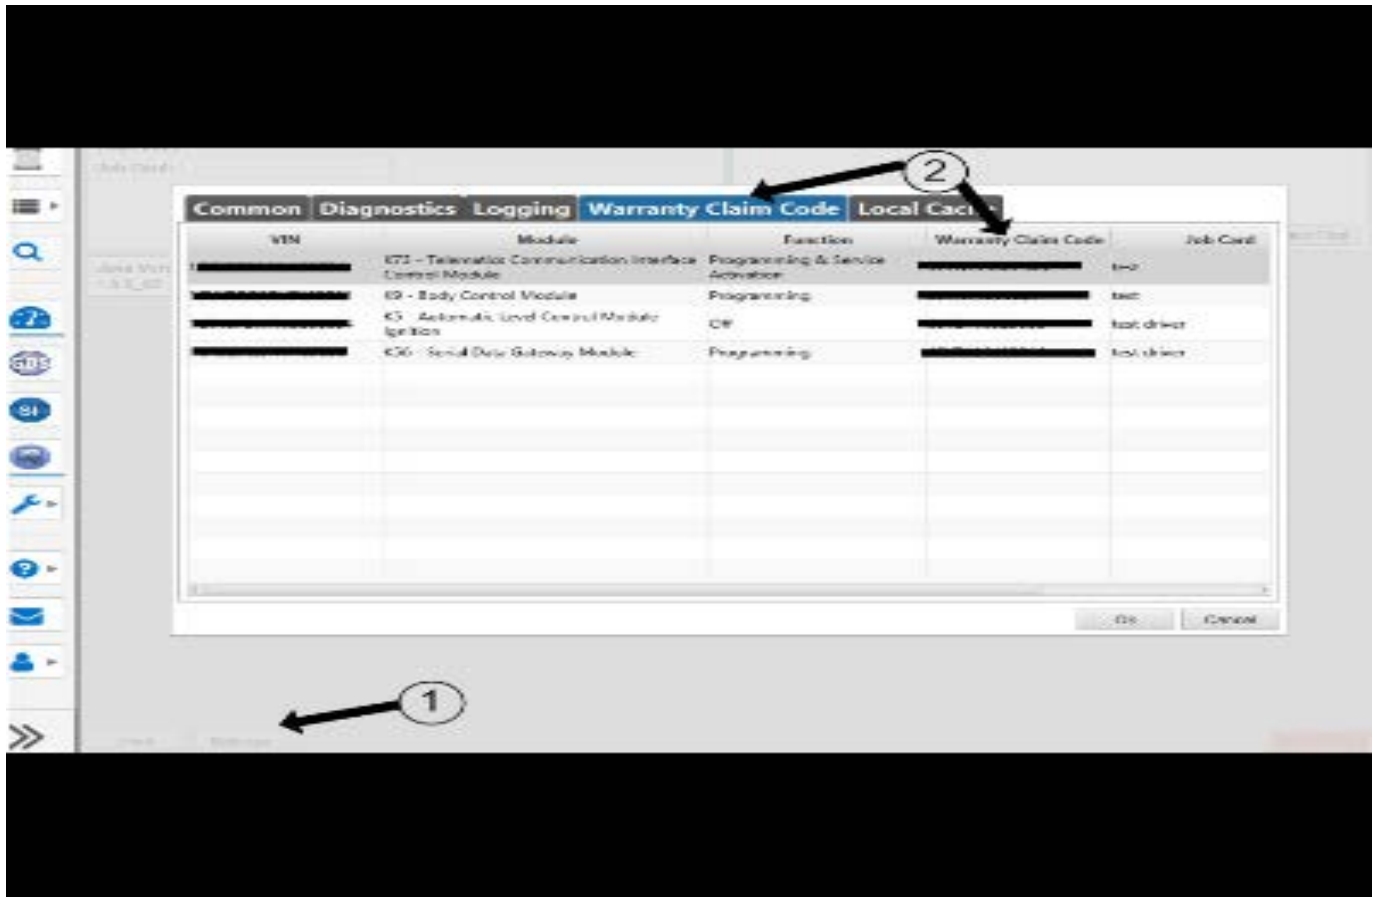
6125774

Warranty Claim Code Information Retrieval

If the Warranty Claim Code was not recorded on the Job Card, the code can be retrieved in the SPS2 system as follows:

The VIN, Warranty Claim Code and Date/Time will be listed on a roster of recent programming events. If the code is retrievable, dealers should resubmit the transaction making sure to include the code in the SPS Warranty Claim Code field.
