GROUP	MODEL
ELE	2024MY EV9 (MV)
NUMBER	DATE
330	January 2024

TECHNICAL SERVICE BULLETIN

SUBJECT: SERVICE ACTION: ICCU-VCU S/W UPGRADE FOR FOR EWP OPERATION (SA560)

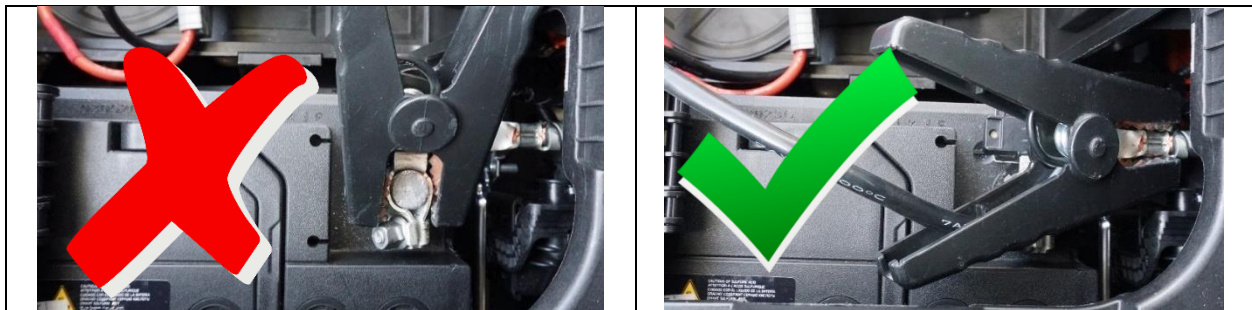
Note: When connecting the external battery pack, in-vehicle operation built-in CAM might be issued by impossible charging amount sensing of the battery sensor.

[Connect the negative \(-\) terminal to the battery as shown below.](#)

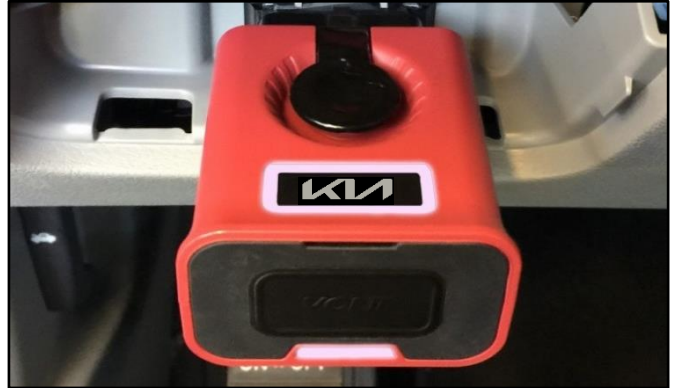
1. Connect the VCI-II to the OBD-II connector, located under the driver's side of the instrument panel.

The ECU upgrade function on KDS operates wirelessly. It is not necessary to perform the upgrade via USB cable.

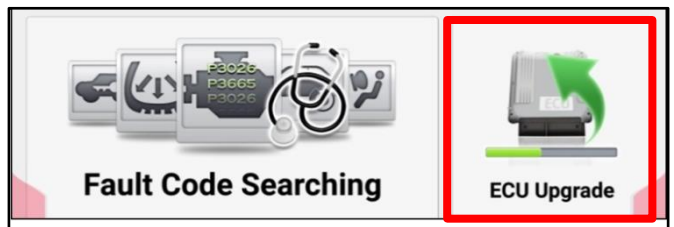
4. Select 'ECU Upgrade'.

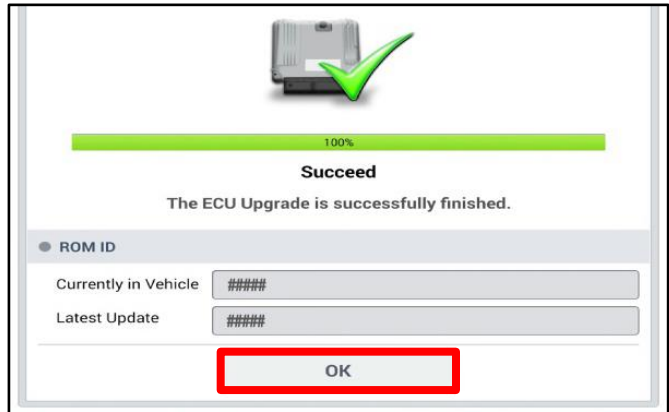
- Once the upgrade is complete, select 'OK' to finalize the procedure.

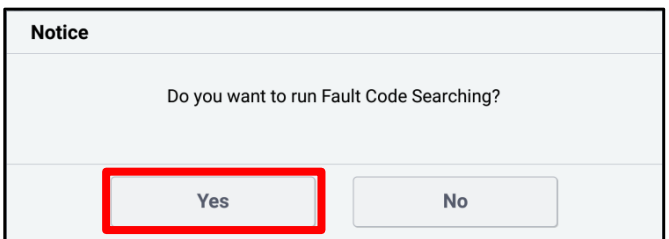
- When prompted, select 'YES' to check for Diagnostic Trouble Codes (DTC) and erase any DTCs stored such as EPS, ESC, and TPMS that may have been set during the upgrade.
