Technical Service Bulletin

GROUP	NUMBER
CAMPAIGN	24-01-005G
DATE	MODEL(S)
JANUARY 2024	GV80 (JX1)

SUBJECT: AVN SOFTWARE UPDATE - OVER-THE-AIR (OTA) STUCK
(SERVICE CAMPAIGN T41G)

Description: This bulletin provides instructions to utilize a USB flash drive to update the AVN software for the GV80 (JX1) that experienced an unexpected OTA stop.

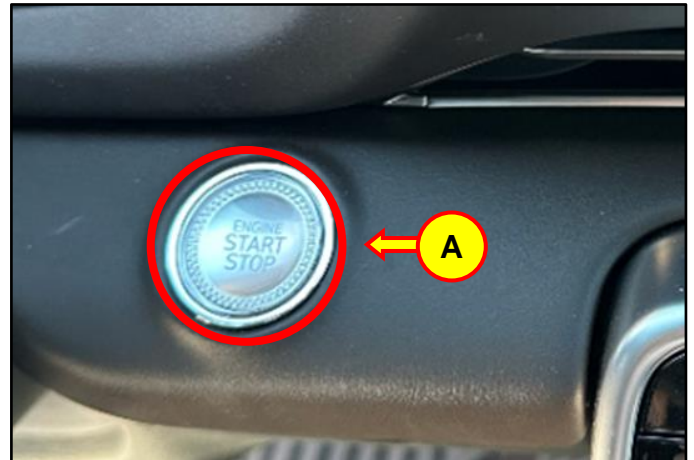
1. Turn **ON** the ignition (A).

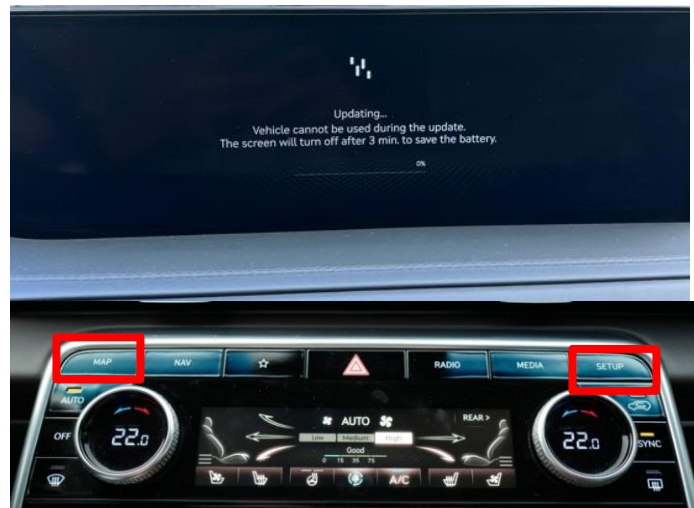
2. To exit out of the updating screen, press and hold the **MAP** and **SETUP** hard key buttons for 5 seconds until screen turns black to reset the unit.

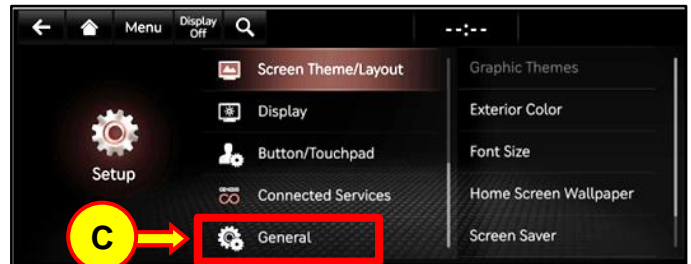
4. Select **General** (C).

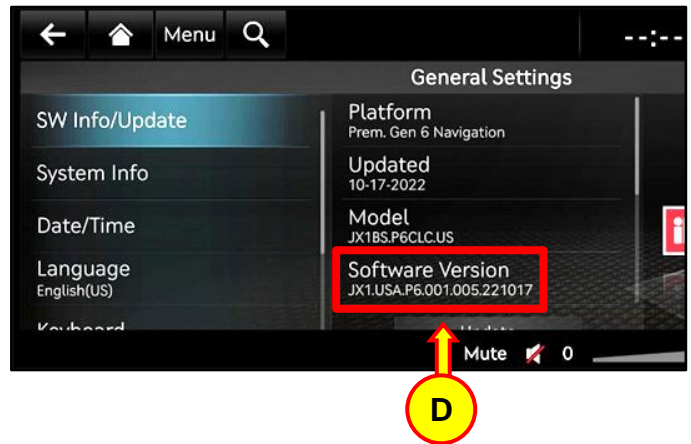
5. Identify the software version (D) and verify the update is required:

- **JX1.USA.P6.001.005.221017** or **JX1.USA.P6.001.005.221025**
 - If the software version does **NOT** match, update is not required.

The updated software version is **JX1_22.USA.P6.001.007.231101** or later. Any version from **231101** to the latest is acceptable.

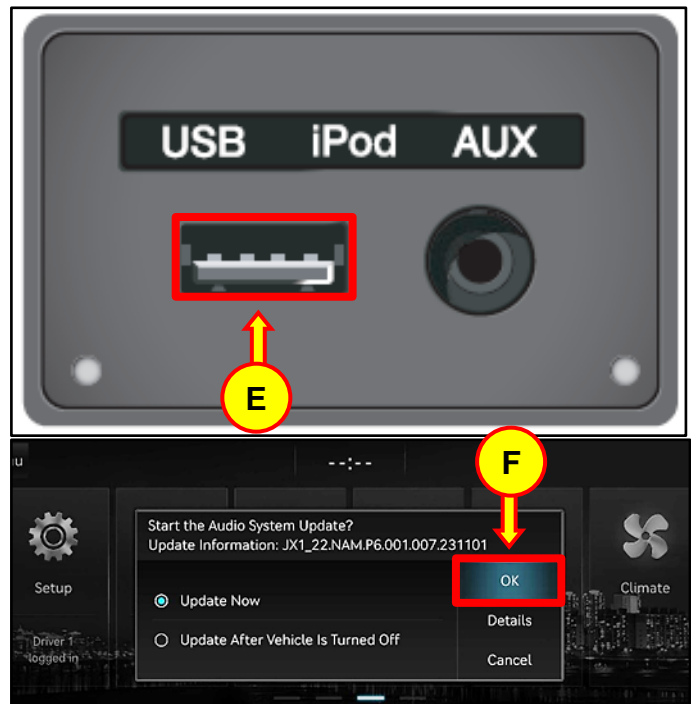
6. Insert the USB flash drive into the USB port (E).

Select **OK** (F) on the pop-up window.

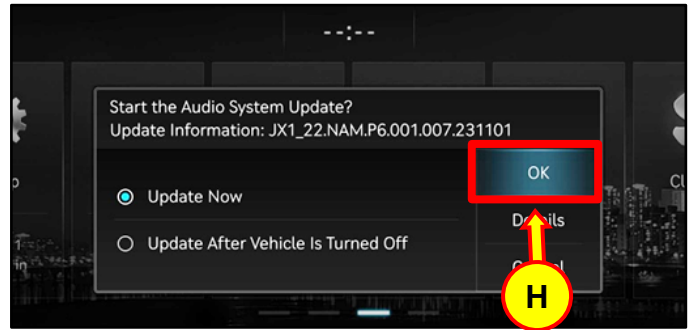
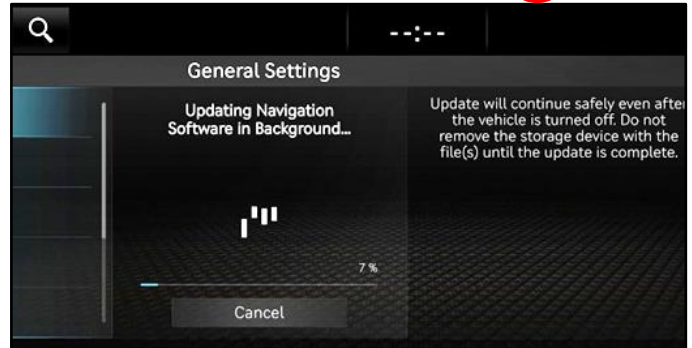
8. Select **OK** (H).

Update will run in the background. To monitor the update on the home screen, go to: **Settings > General > System Info/Update > General Settings**

Expect multiple instances of the Hyundai logo or a black screen during the update; this is a normal part of the process.

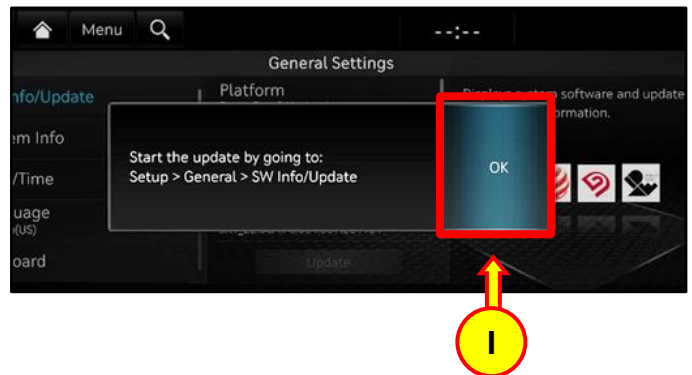
9. If this pop-up window appears, then remove and reinsert the USB flash drive to restart the update.

Select **OK** (I).

Only in this scenario should the USB be removed during the repair.

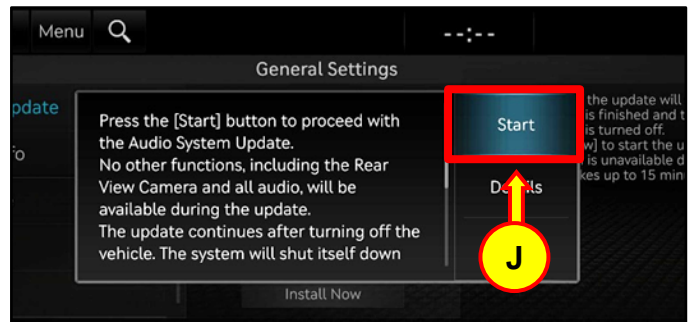
10. Select **Start** (J) to proceed to the Audio System Update.

Once the Audio System Update is complete, then the system will automatically reboot.

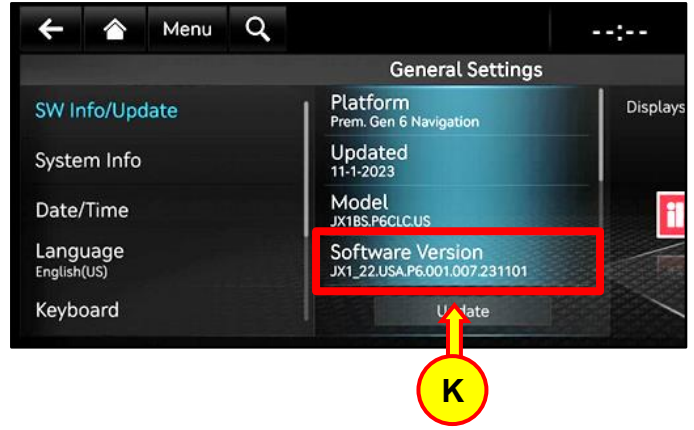
- 11. Verify the latest software version by going to:
 - **Setup > General > SW Info/Update > General Settings**

Ensure that the **Software Version (K)** is **JX1_22.USA.P6.001.007.231101** or later.

Any version from **231101** to the latest is acceptable.

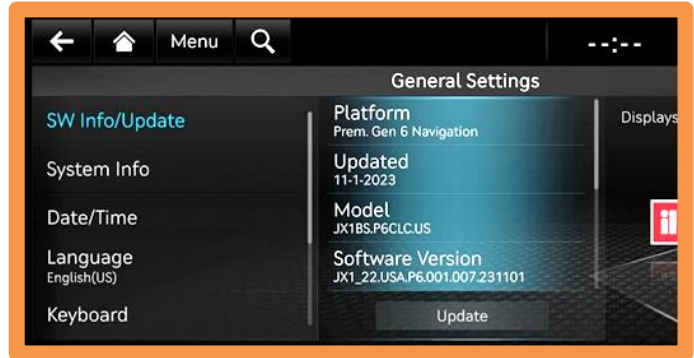
- 12. **STUI**   Take a screenshot with the latest software version installed using your tablet and upload to STUI.
