GROUP	MODEL
ELE	2024MY EV9 (MV)
NUMBER	DATE
326 (Rev 1, 2/02/2024)	January 2024

TECHNICAL SERVICE BULLETIN

SERVICE ACTION: POWER SEAT MODULE OPERATION LOGIC IMPROVEMENT (SA557)

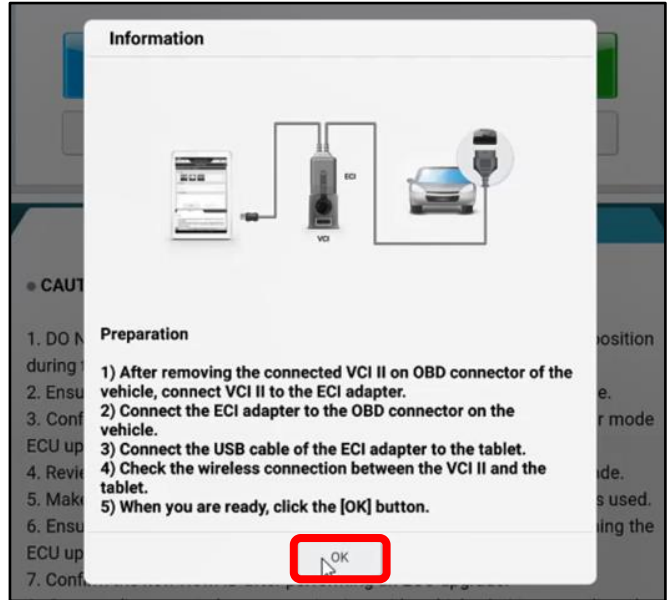
- 1a. Connect the ECI DLC connector to the OBD-II connector, located under the driver’s side of the instrument panel.
- 1b. Connect the ECI USB C connector to the KDS tablet.
- 1c. Connect the VCI II to the ECI OBD-II connector
2. Select ‘OK’.

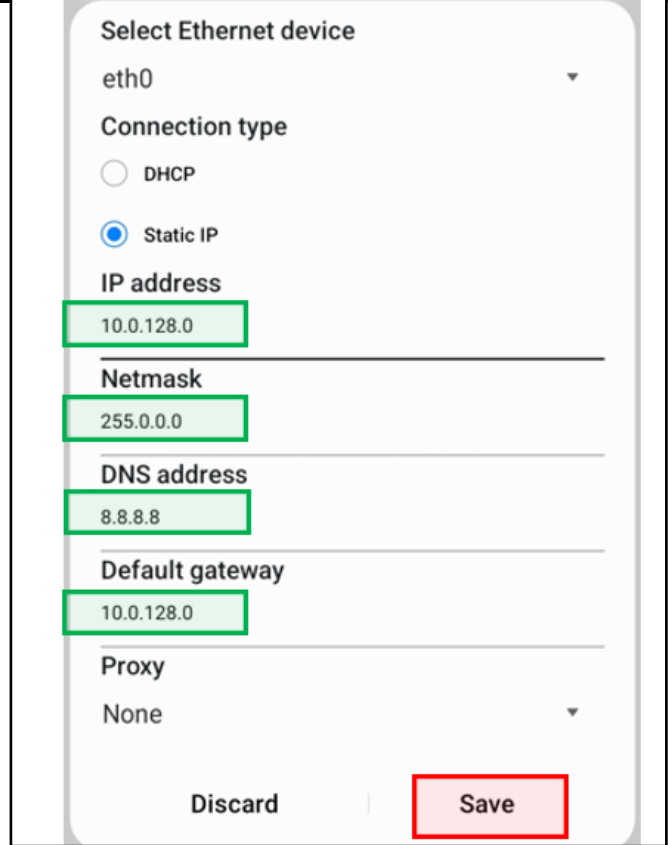
- 7a. Input 10.0.128.0 under 'IP address'.
- 7b. Input 255.0.0.0 under 'Netmask'.
- 7c. Input 8.8.8.8 under 'DNS address'.
- 7d. Input 10.0.128.0 under 'Default gateway'.
- 8. Select 'Save'.
