# Service Bulletin

Bulletin No.: 24-NA-025

**Subject:** Check Engine Light or Malfunction Indicator Lamp Illuminated with DTCs U0401 and/or U1611 Set

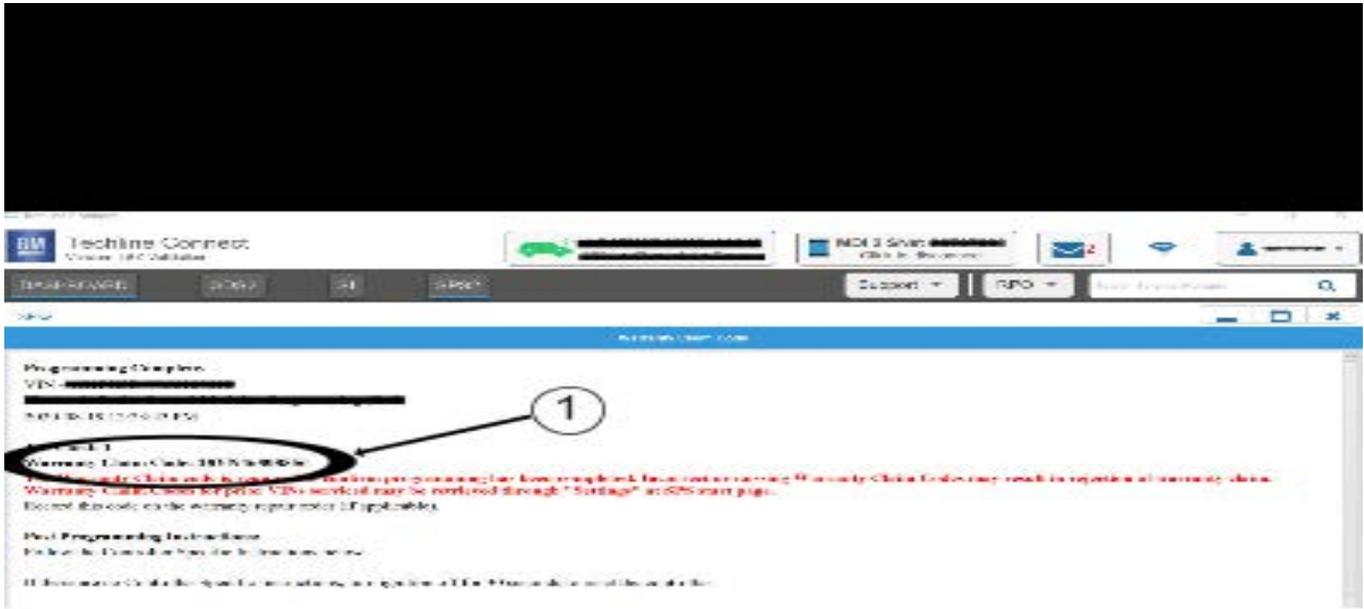
5644478

**Note:** The screenshot above is an example of module programming and may not be indicative of the specific module that is being programmed. Module selection and VIN information have been blacked out.

**Important:** To avoid warranty transaction rejections, you **MUST** record the warranty claim code provided on the Warranty Claim Code (WCC) screen shown above on the job card. Refer to callout 1 above for the location of the WCC on the screen.
