GROUP	MODEL
ELE	2024MY EV9 (MV)
NUMBER	DATE
331	February 2024

TECHNICAL SERVICE BULLETIN

SUBJECT: SERVICE ACTION: WIRELESS POWER CHARGER OPERATION LOGIC IMPROVEMENT (SA561)

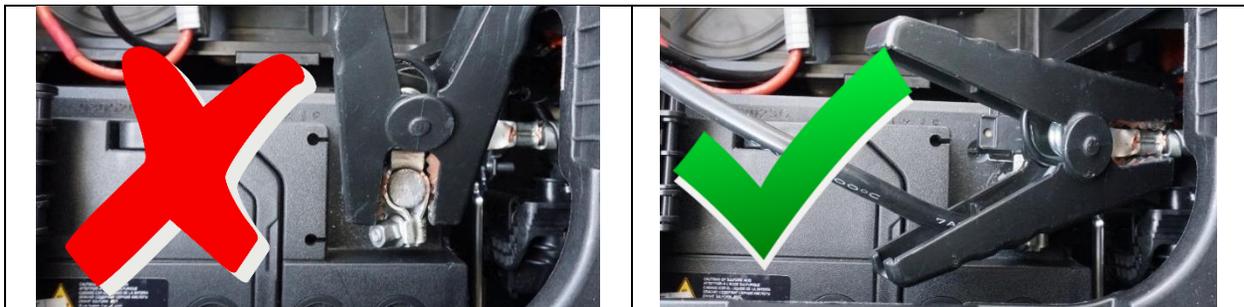
Note: When connecting the external battery pack, in-vehicle operation built-in CAM might be issued by impossible charging amount sensing of the battery sensor.

[Connect the negative \(-\) terminal to the battery as shown below.](#)

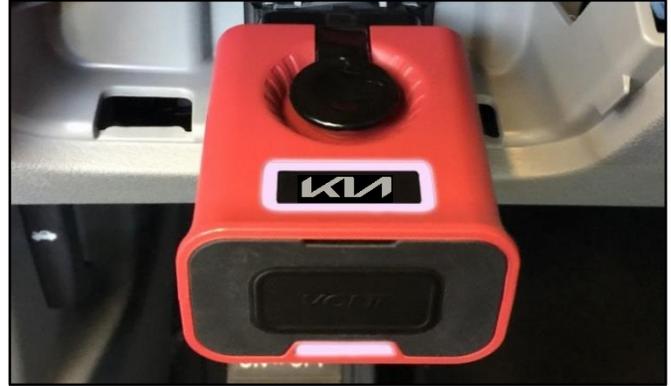
1. Connect the VCI-II to the OBD-II connector, located under the driver's side of the instrument panel.

The ECU upgrade function on KDS operates wirelessly. It is not necessary to perform the upgrade via USB cable.

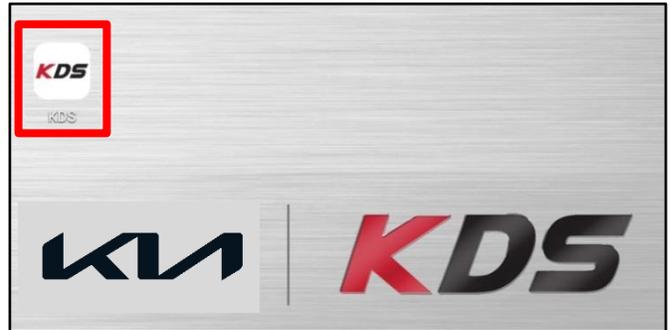
2. With the ignition ON, turn ON the KDS tablet. Select 'KDS' from the home screen.

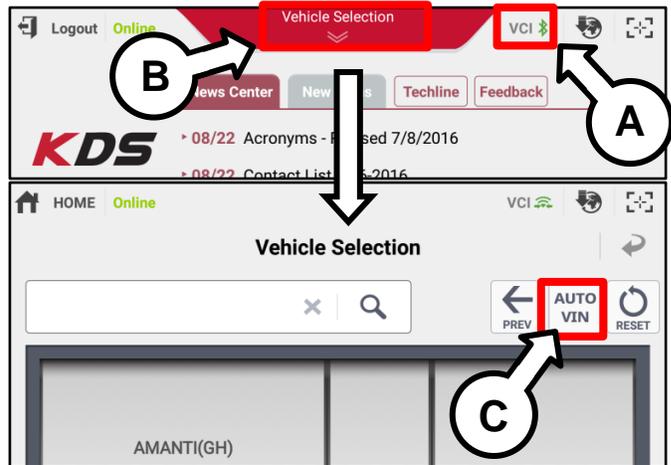
3. Confirm communication with VCI (A) and then configure the vehicle (B) using the 'AUTO VIN' (C) feature.

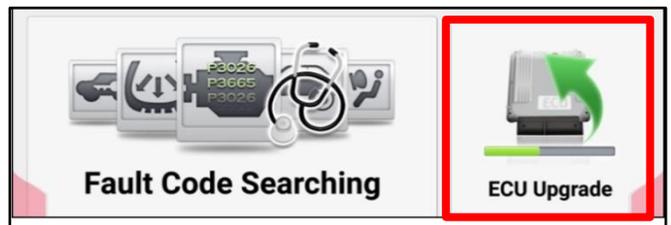
4. Select 'ECU Upgrade'.

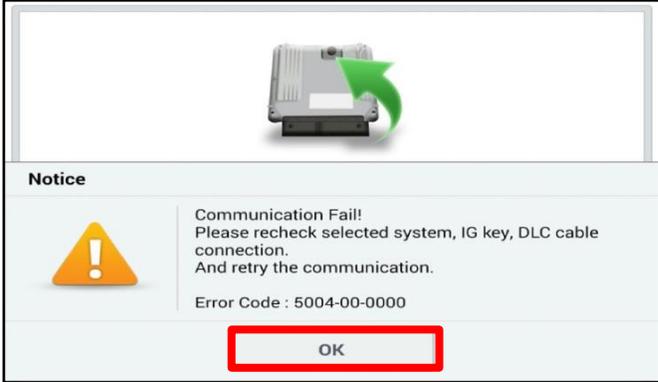
- If a "Communication Fail" screen appears, verify that the VCI-II and KDS are communicating properly. Select 'OK' and restart the from step 4.

If an error notice continues to appear or if the upgrade cannot be performed, DO NOT disconnect the KDS/VCI-II. Contact GIT America Help Desk at (888) 542-4371 or Techline.

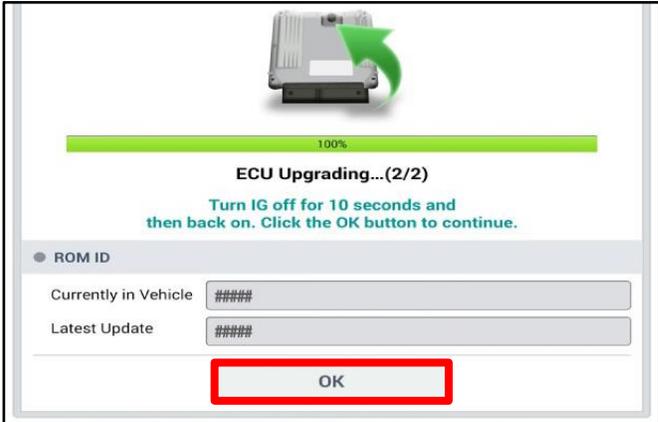
- When instructed on the KDS, turn the ignition OFF for ten (10) seconds then back on. Select 'OK' to continue.

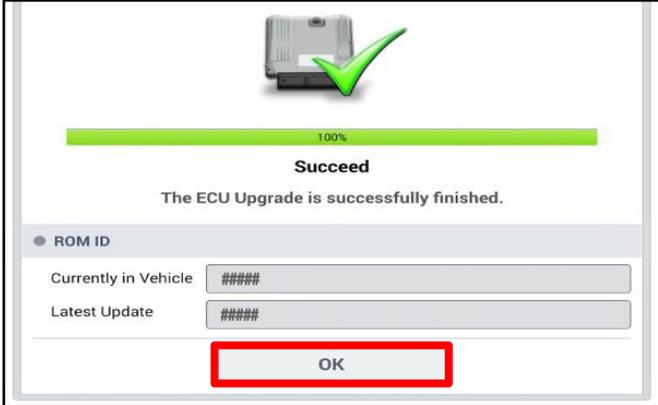
- Once the upgrade is complete, select 'OK' to finalize the procedure.

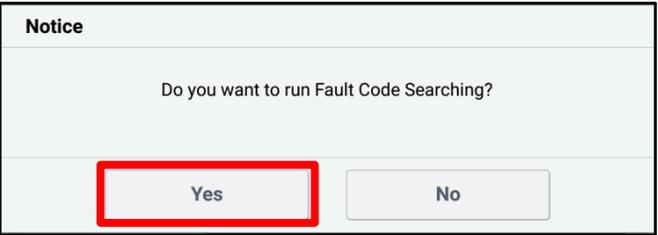
- When prompted, select 'YES' to check for Diagnostic Trouble Codes (DTC) and erase any DTCs stored such as EPS, ESC, and TPMS that may have been set during the upgrade.
