Release Date	4/26/2022	<b>Technical Service Bulletin</b>	
<b>93N6 UPDATE</b>

<b>Audi</b>
<b>Software Update for Battery Modules Control Unit – (NVLW)</b>

This Update has been proactively released to prevent the following condition(s) from occurring in the vehicle:	
Criteria	Technical Background
S1	A software update is necessary on Audi e-tron vehicles manufactured within a specific period. The battery system of an electric vehicle consists of a large number of individual battery cells. These cells have the same capacity and slightly different cell voltages. Without a balancing function, the capacity of the entire system would align itself with the capacity of the weakest cell. In addition, individual cells could be overloaded and age more rapidly. The efficiency of the balancing function may be affected by a possible error in the cell voltage measurement. This software update optimizes the function of the control unit with respect to balancing and stabilizes the cell voltage measurement.

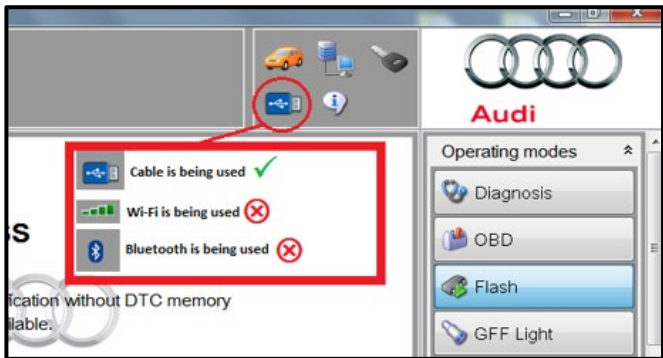
- Connect the VAS6150X/VAS6160X Diagnostic Tester to the vehicle.
- Start the ODIS program.
- Confirm that scan tool is communicating with the diagnostic head by USB cable.
  - If the Bluetooth or WiFi symbol is shown, then disconnect the diagnostic head from the vehicle and reconnect the USB cable to the diagnostic head and then reattach to the vehicle.

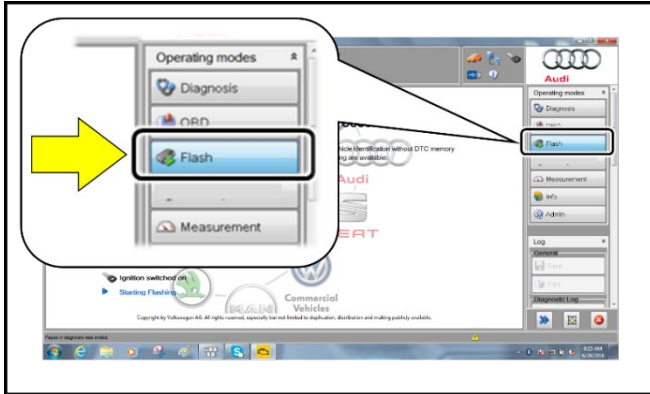
- From the home screen of the scan tool highlight “Flash” <1>.
- Follow the on-screen prompts.

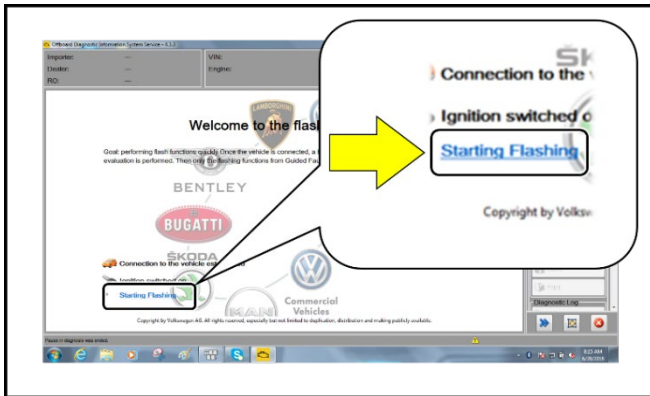
- Select “Starting Flashing” and follow the on-screen prompts.

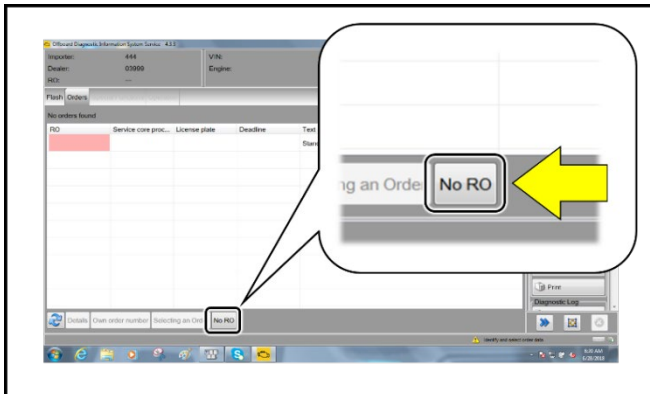
- Select “No RO”.

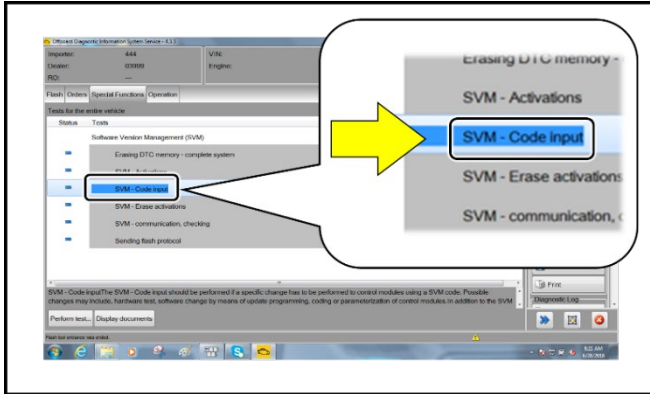
- Highlight “SVM – Code Input”.

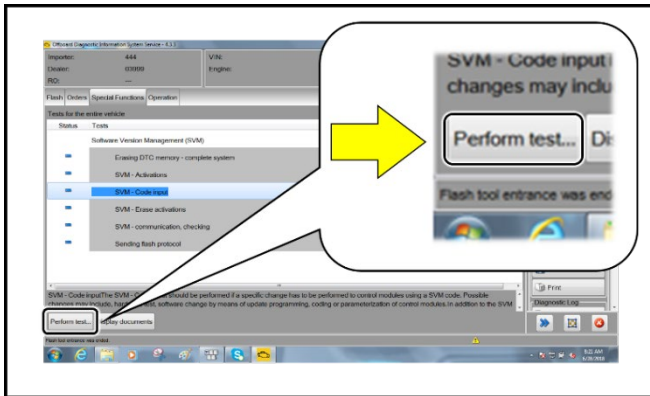
- Select “Perform test”.

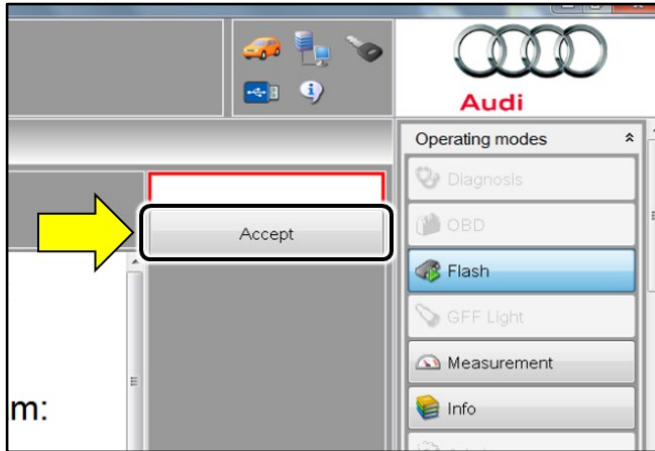
<b>SVM code</b>
<b>93N6A268</b>

- Enter the corrective action code (SVM code) as listed above.
- Select “Accept” <arrow>.
- Follow the on-screen prompts.
- After receiving confirmation that the flash completed successfully, select “Send” <arrow> to send the diagnostic protocol online.
- Follow the on-screen prompts.

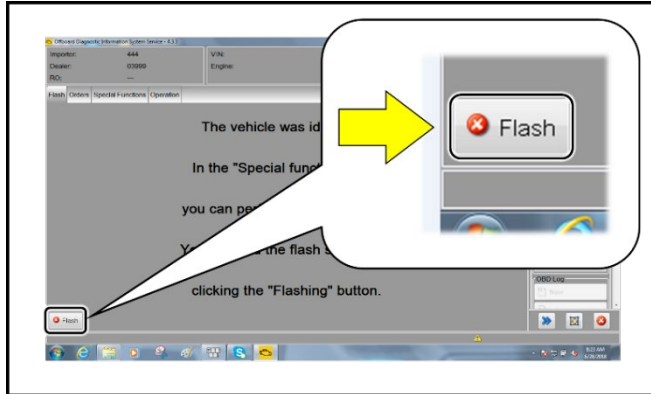
- Click "Flash" <arrow> to exit the flash session.
- Various event memory entries may be generated after the flashing procedure on some vehicles. Put the vehicle in a corresponding bus sleep mode after performing the update in order to clear the faults.
- To put the vehicle in bus sleep mode, disconnect the diagnostic tester, remove the key from the vehicle and lock the vehicle with the remote for 6 minutes.
