Service Action

Code: 93N1

Subject	Software Update for Remaining Range Display				
Document History	Date		Summary		
	2/14/2024		Updated work procedure information		
	12/16/2021		Original publication		
Affected Vehicles	Country	Beginning Model Year	Ending Model Year	Vehicle	Vehicle Count
	USA	2020	2021	E-TRON	3,101
	USA	2021	2021	E-TRON QUATTRO	6,071
	CAN	2020	2021	E-TRON	356
	CAN	2021	2021	E-TRON QUATTRO	337
	<p>Check Campaigns/Actions screen in Elsa on the day of repair to verify that a VIN qualifies for repair under this action. Elsa is the <u>only</u> valid campaign inquiry & verification source.</p> <ul style="list-style-type: none"> ✓ Campaign status must show "open." ✓ If Elsa shows other open action(s), inform your customer so that the work can also be completed at the same time the vehicle is in the workshop for this campaign. 				
About this Service Action	The remaining range display is being modified on Audi e-tron vehicles manufactured within a specific period.

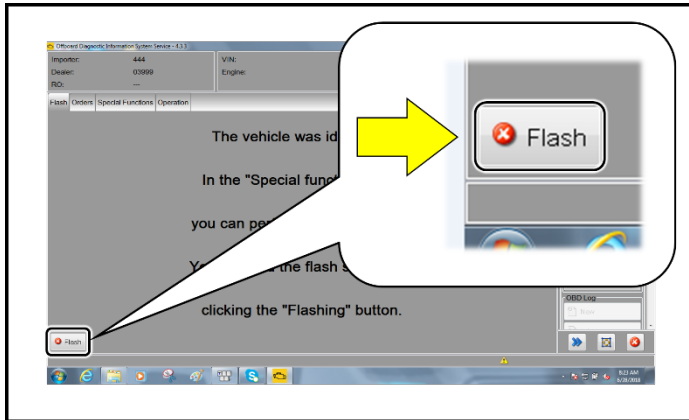
- Click “Flash” to exit the flash session.
