Service Bulletin

Bulletin No.: 22-NA-150

Subject: Malfunction Indicator Lamp (MIL) Illuminated, Service Emission System and/or DEF Level Low Message on Driver Information Center (DIC), DEF Level Sensor Reading Incorrectly, DEF Level Sensor Being Erratic, DEF Level Sensor Stuck

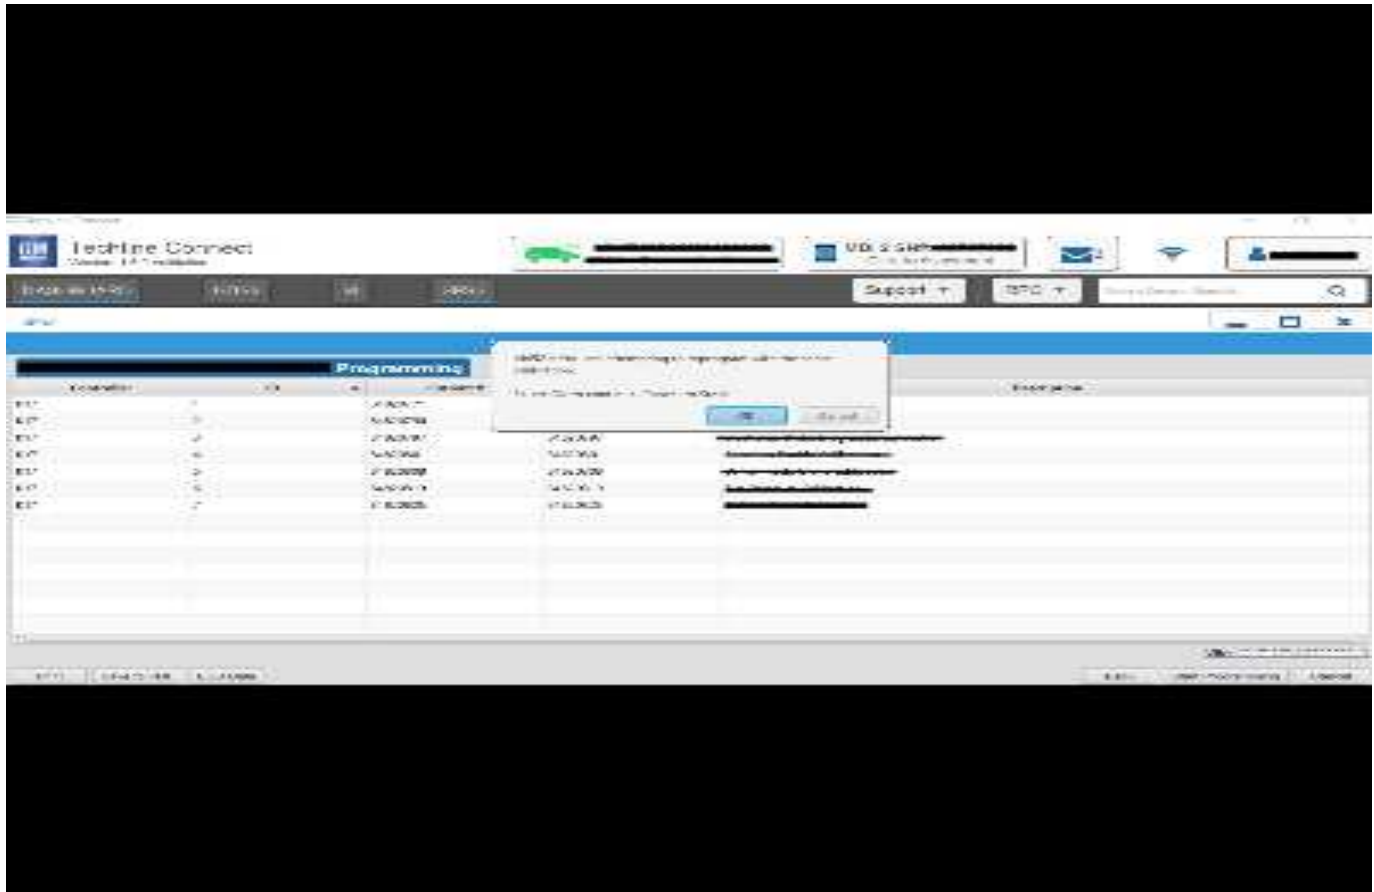
5877000

Important: If the vehicle VIN DOES NOT match, the message below will be shown

Important: Techline Connect screens shown above.
