Service Bulletin

Bulletin No.: 23-NA-227

Subject: Radio Software Version W27E-172.5.1-M169-SQBR4-126.1 – Multiple Updates for IVD & IVE

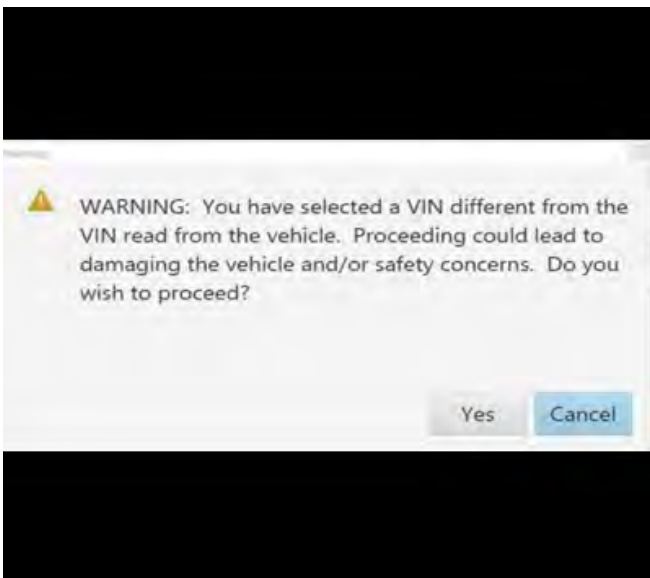
5877000

Important: If the vehicle VIN DOES NOT match, the message below will be shown

Important: Techline Connect screens shown above.

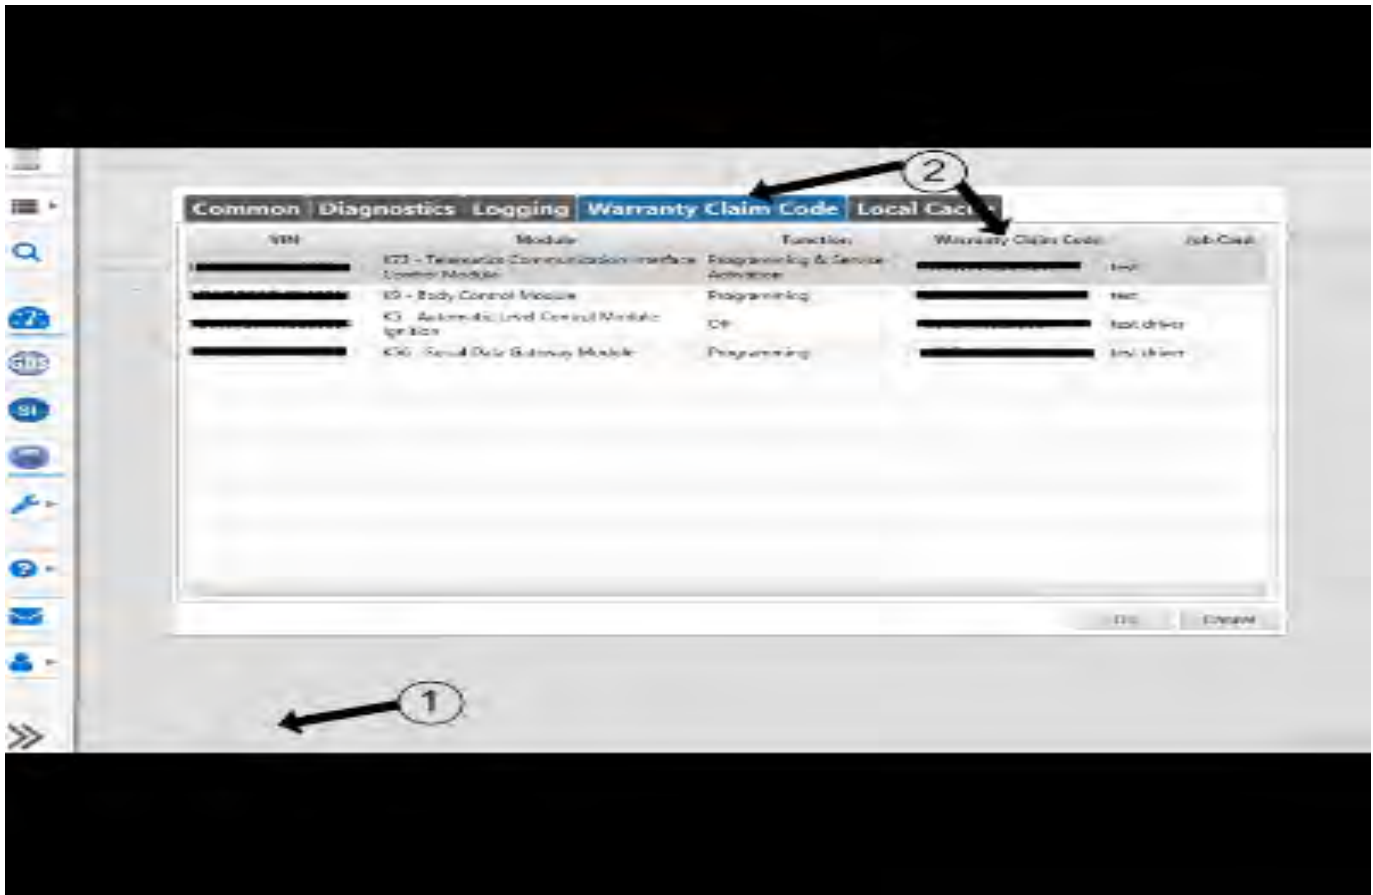
6125774

Warranty Claim Code Information Retrieval

If the Warranty Claim Code was not recorded on the Job Card, the code can be retrieved in the SPS2 system as follows:

The VIN, Warranty Claim Code and Date/Time will be listed on a roster of recent programming events. If the code is retrievable, dealers should resubmit the transaction making sure to include the code in the SPS Warranty Claim Code field.
