Service Bulletin

Bulletin No.: 23-NA-198

Subject: HVAC Inoperable During Remote Start

Brand:	Model:	Model Year:		VIN:		Engine:	Transmission:
		from	to	from	to		
Chevrolet	Trax	2024	2024	—	—	—	—

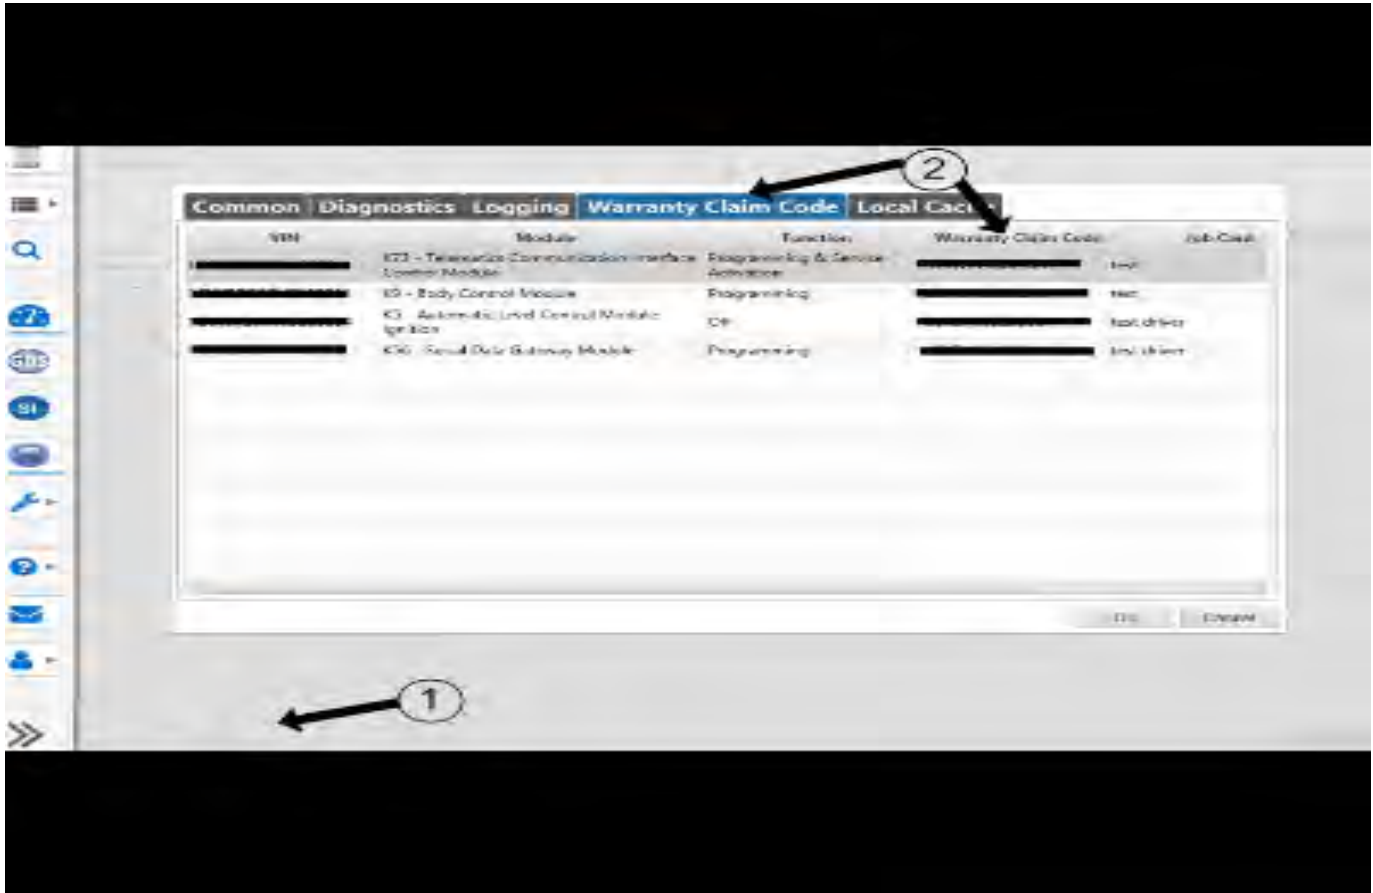
6125774

If the Warranty Claim Code was not recorded on the Job Card, the code can be retrieved in the SPS2 system as follows:

The VIN, Warranty Claim Code and Date/Time will be listed on a roster of recent programming events. If the code is retrievable, dealers should resubmit the transaction making sure to include the code in the SPS Warranty Claim Code field.
