GROUP	MODEL
FUE	2022-2023MY Carnival (KA4)
NUMBER	DATE
062 (Rev 1, 02/22/2024)	December 2022

TECHNICAL SERVICE BULLETIN

SERVICE ACTION: ECM LOGIC UPDATE FOR DTC P2118 AND THROTTLE BODY FREEZING (SA514)

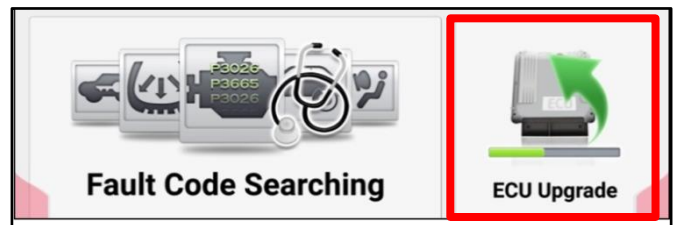
4. Select 'ECU Upgrade'.

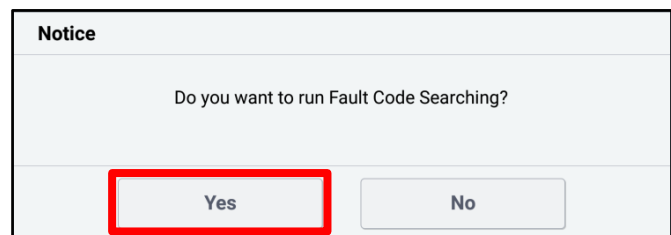
12. When prompted, select 'YES' to check for Diagnostic Trouble Codes (DTC) and erase any DTCs stored such as EPS, ESC, and TPMS that may have been set during the upgrade.
