GROUP	MODEL
ELE	2024MY EV9 (MV)
NUMBER	DATE
331 (Rev 1, 2/29/2024)	February 2024

TECHNICAL SERVICE BULLETIN

SUBJECT: SERVICE ACTION: WIRELESS POWER CHARGER OPERATION LOGIC IMPROVEMENT (SA561)

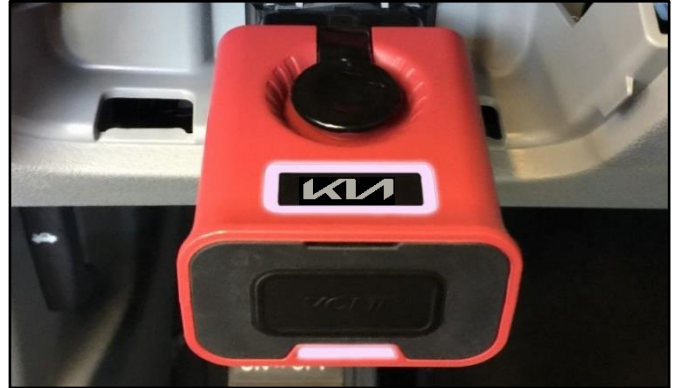
1. Connect the VCI-II to the OBD-II connector, located under the driver's side of the instrument panel.

The ECU upgrade function on KDS operates wirelessly. It is not necessary to perform the upgrade via USB cable.

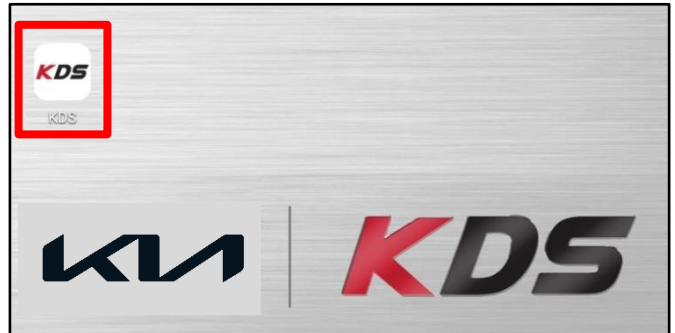
2. With the ignition ON, turn ON the KDS tablet. Select 'KDS' from the home screen.
