Head Unit Software Update (Panasonic)

Service Category Audio/Visual/Telematics

Section Navigation/Multi Info Display

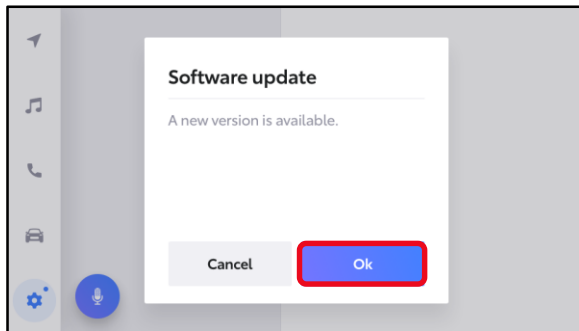
Figure 1.

Vehicle operators can perform this update directly by accepting the on-screen notification (see Figure 1), advising the software update is available, or by locating the software update from the Settings menu and initiating the available update (see Figure 2). The release notes text below will be displayed to the customer:

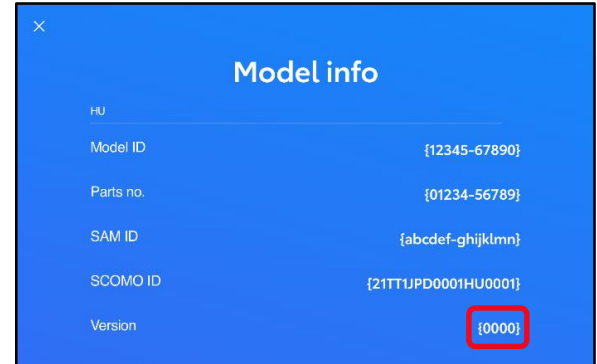
Figure 12.

4. Is the software up to date?
(Refer to Table 1 below.)
 - **YES** — This bulletin does NOT apply. Continue diagnosis using the applicable Repair Manual.
 - **NO** — Continue to step 5.

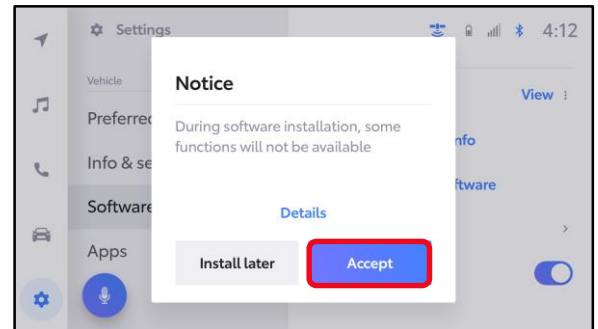
Figure 16.

8. Select Accept on the Notice pop-up message if it appears.

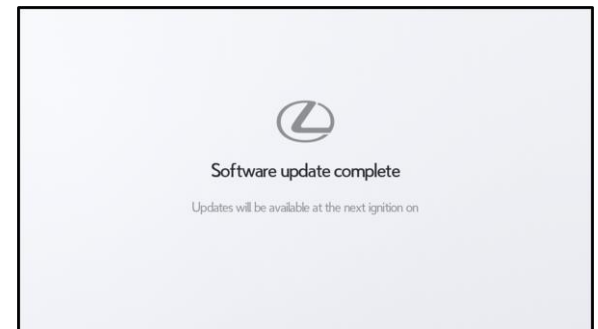
Figure 20.

- The software installation is complete when either a “Software installation complete” banner (Figure 19) or the “Software update complete” screen (Figure 20) is displayed.

If the vehicle has installed a major update, and the “Software update complete” screen is displayed, then an IG-OFF/ON will need to be performed prior to attempting to operate any of the infotainment functions.

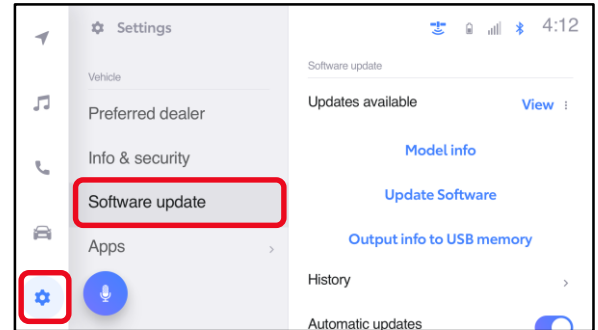
Figure 23.

2. Select the gear icon and scroll down to select Software update.

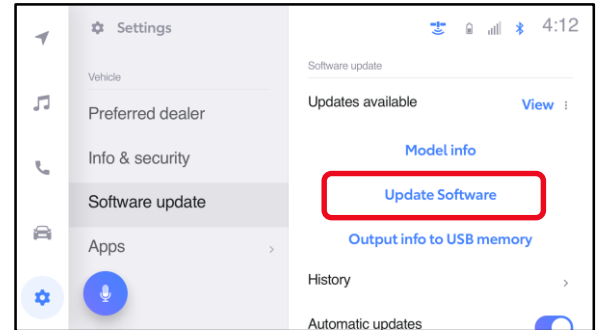
Figure 25.

The "Update Software" button may not be available immediately after inserting the USB flash drive. The head unit is unzipping the software update file, and it may take up to 15 minutes for this button to become available to press.

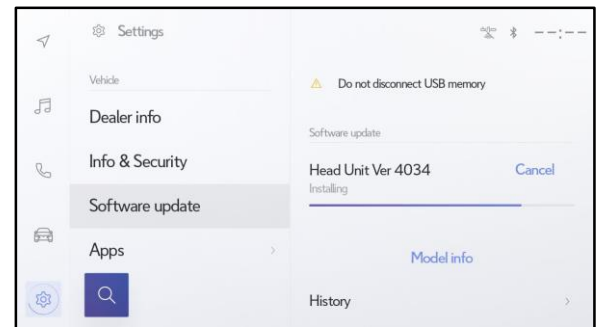
Figure 27.

- Wait for the update to download. Once the head unit software begins installation, the update will take about 15 minutes per update file.

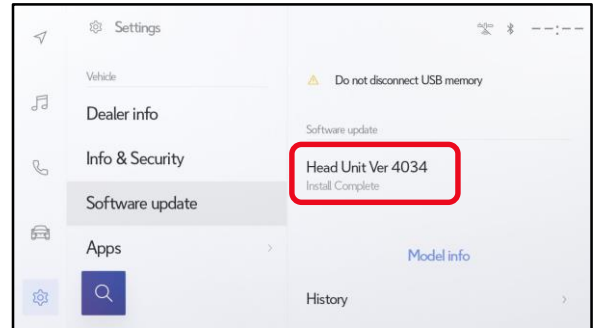
- A. When the update is complete, “Install Complete” will show on the head unit, as shown in Figure 28.
- B. The “Software installation complete” pop-up message may also appear, as shown in Figure 29.

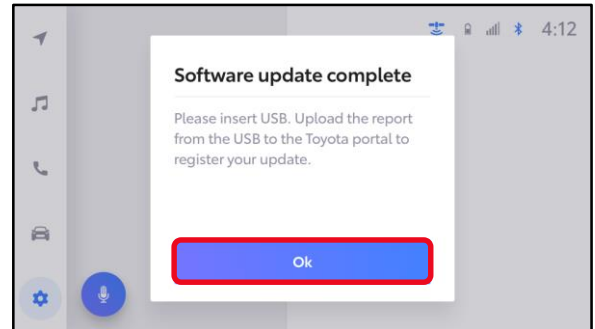
Figure 30.

If you are prompted to upload a report as shown in Figure 30, insert a blank USB to remove the .JSON files. These files are NOT needed.
